PRE-PURCHASE PROPERTY INSPECTION AT

(Some photos in the sample report have either been removed or cropped / shrunk to protect the client's privacy)

The property is a single story, timber weatherboard clad house on concrete pile foundation with a steel long run roof, with timber joinery. The section is sloping & terraced at the back with some grass with shrubs. Access is via a path only.

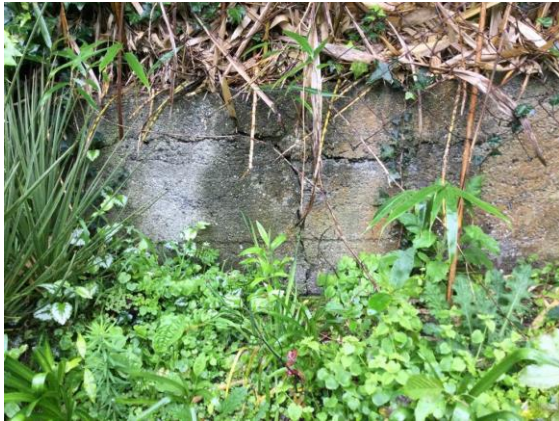
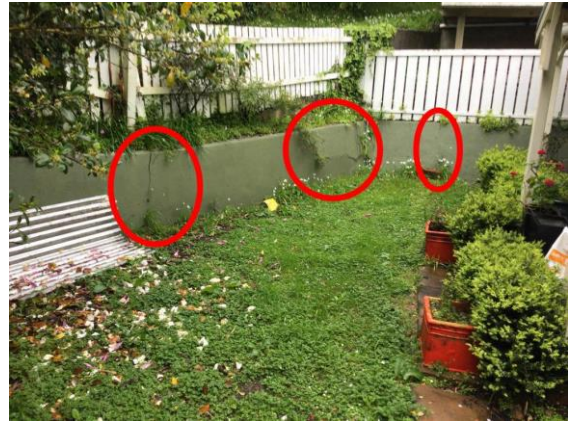
Visible cracks as per photos. Where does all the water go? There may be a drain in this area as you can hear water running continuously.

Visible cracks. There may be a drain in this area as you can hear water running continuously

Recommend further investigation by qualified builder.

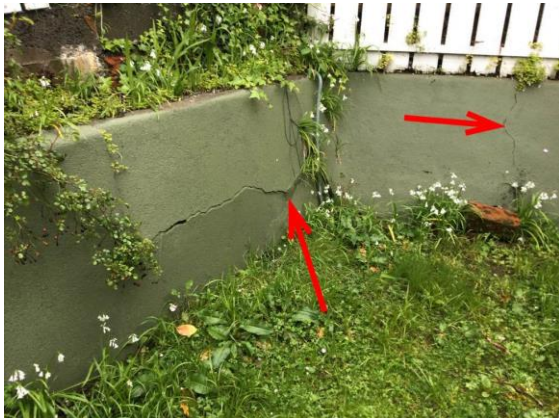
Visible cracks

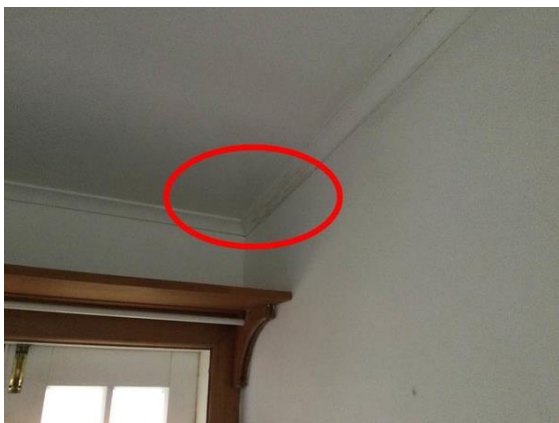
Sleepout ceiling as per photo has deterioration in this area

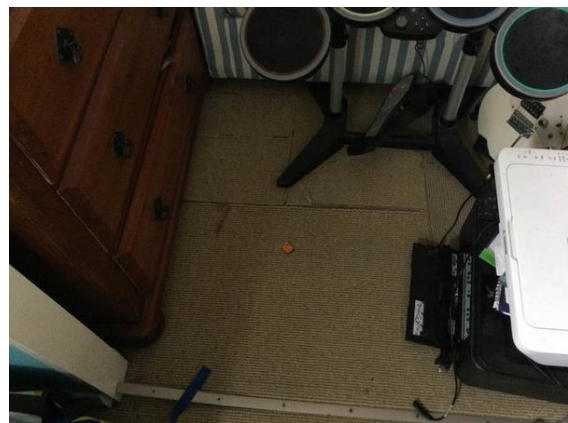
Sleepout carpet is patchy in some areas.
Floor is noticeably uneven in places

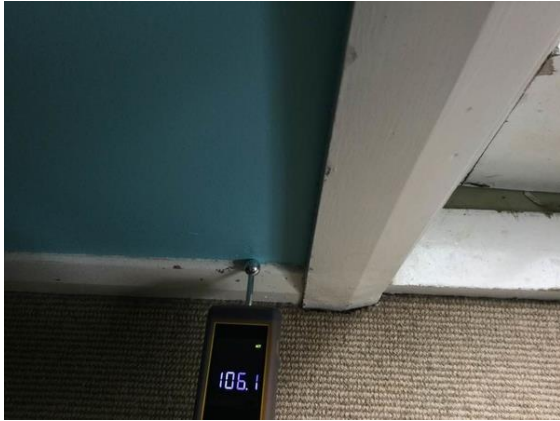
Moisture readings on door is 100.

Sleepout has a high moisture reading by the door

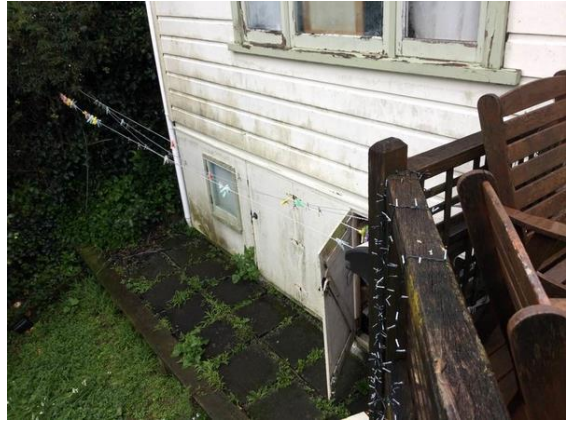
Rear side of sleepout is in bad condition

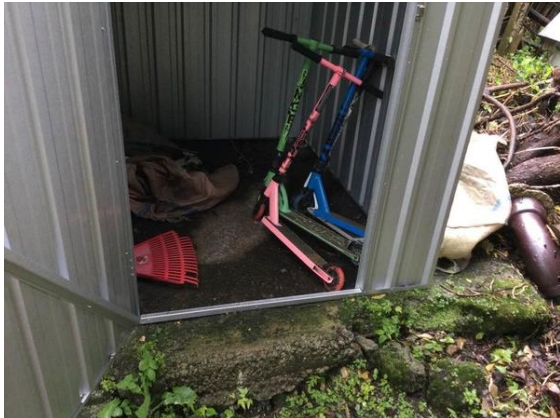
Last photo is of the tin shed at the rear of the property. Very wet.

Shed has water visible on the ground

Recommend further investigation by qualified builder.

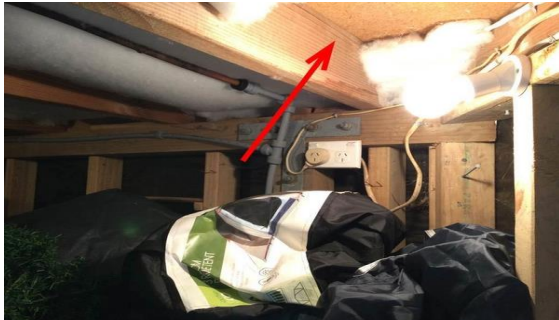
Rear side, missing piece of insulation

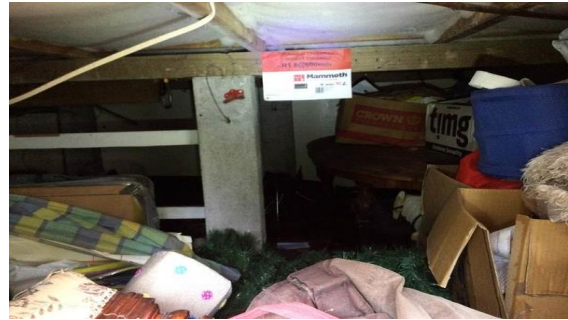
The areas I was able to view clearly indicates there is water under the house.

Under extension facing the street. Water visible

Recommend further investigation by qualified builder.

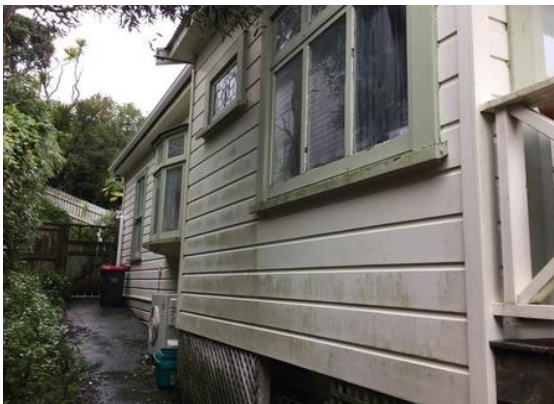
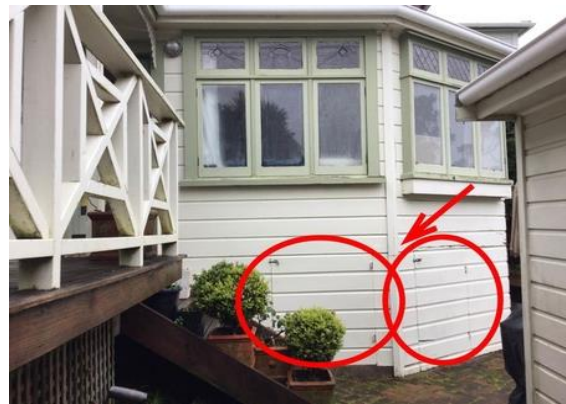
These rear side access panels may look easy on the eye, But are not a good design as they can encourage water ingress. Red arrow indicates horizontal join on facing board

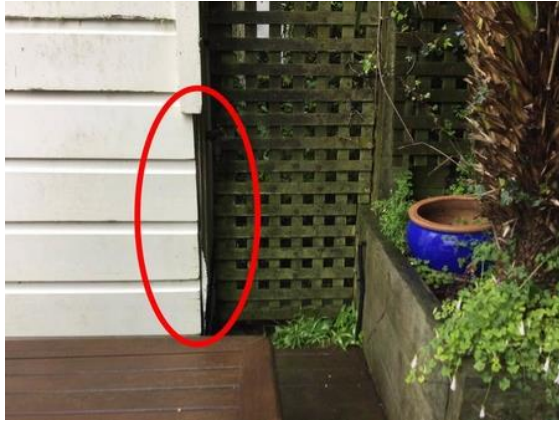
Missing cladding

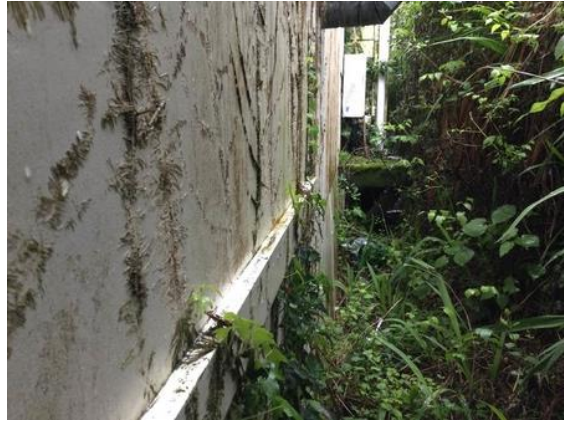
Photo is of the left side of the property facing the street. No access to assess this side but clearly not acceptable condition

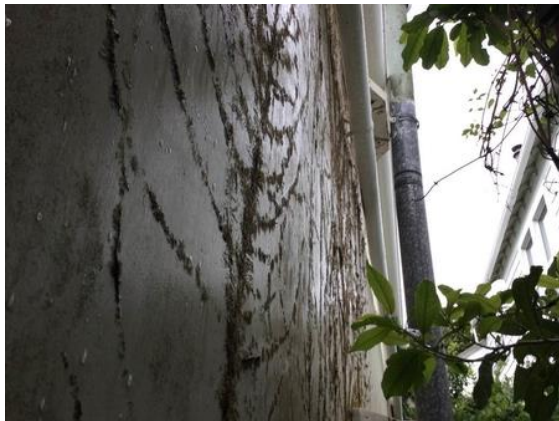
Photo is of the left side of the property facing the street. No access to assess this side but clearly not in acceptable condition

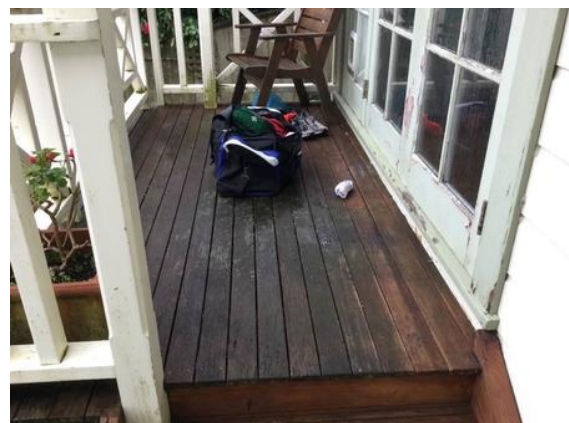
No gap between cladding and the timber decking

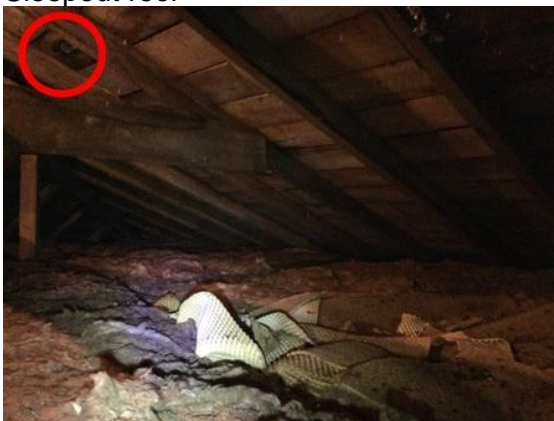
Main ceiling space as per photo shows water stains that may be from a previous leak or current leak. Most likely previous leak prior to the new roof installation.

Visible moisture stains

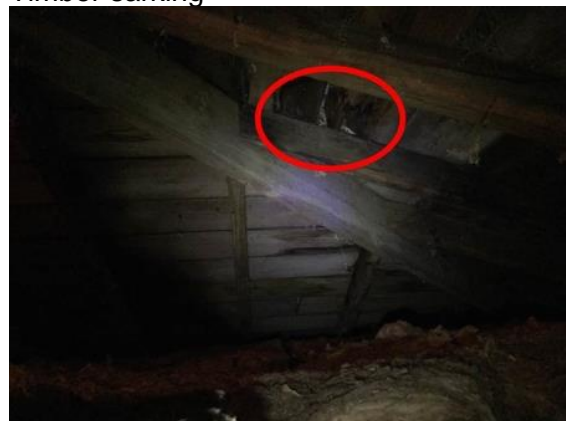
Visible moisture stains

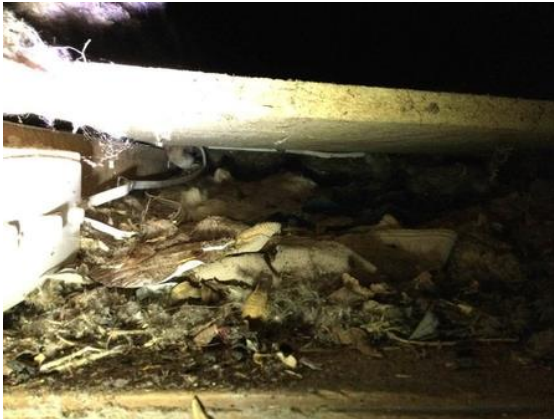
Some insulation missing in some areas

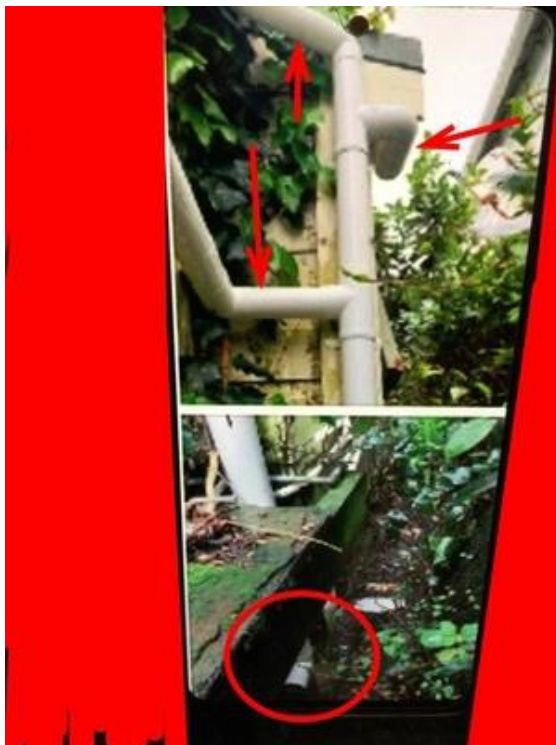
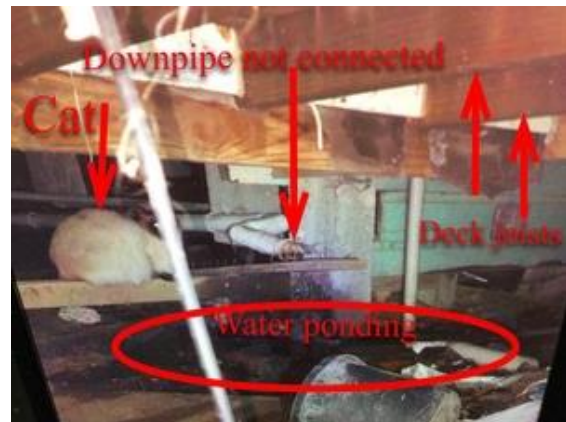
Rear side downpipe connection point not connected. Photo indicates the three connections from the rear side spouting and the left side spouting all goes to the one downpipe which just exits onto the ground. This is an issue as it's approx 70 % of the roof spouting.

Another downpipe sighted under the house also not connected to a stormwater drain. This is an issue as it just flows under the house (next to the cat in the photo) Recommend further investigation by qualified plumber., Recommend further investigation by qualified drain layer.

All three red arrows indicate all water from the three connections from the rear side and the left side goes to the one downpipe which just exits onto the ground which is an issue

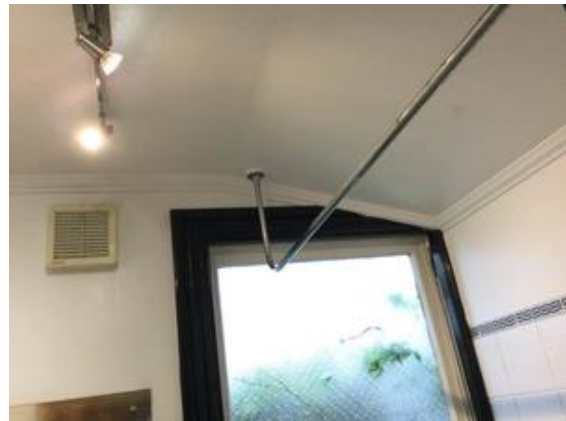
Bathroom ceiling

Acceptable condition
Some rooms have visible mold

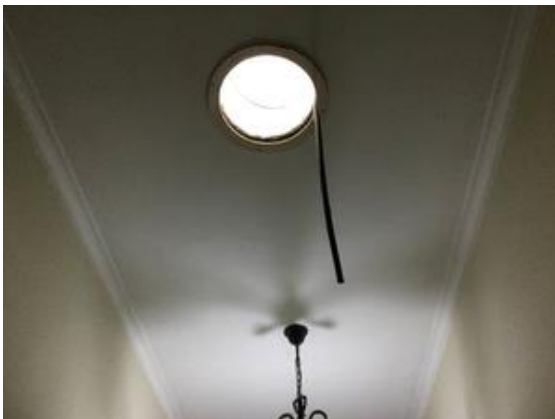
Main hallway solartube rubber is loose

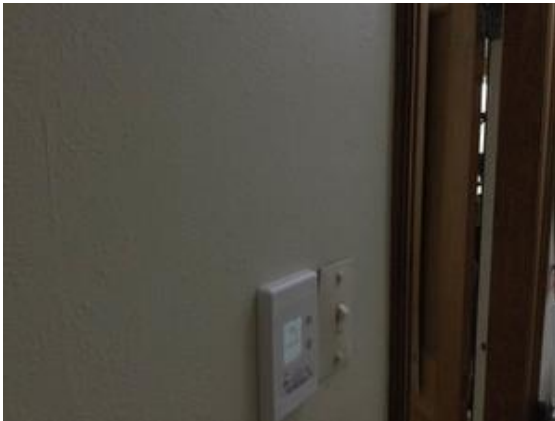
Hallway has wallpaper

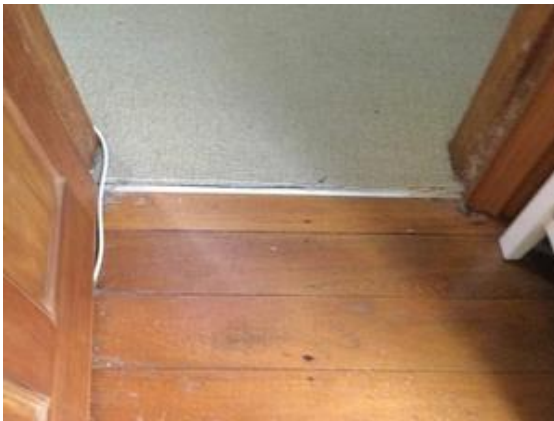
Carpet bar is loose

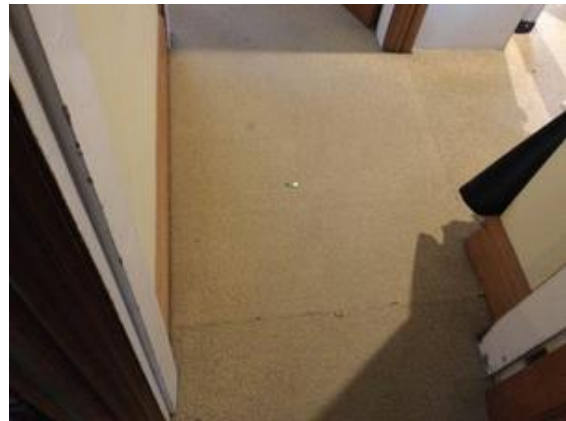
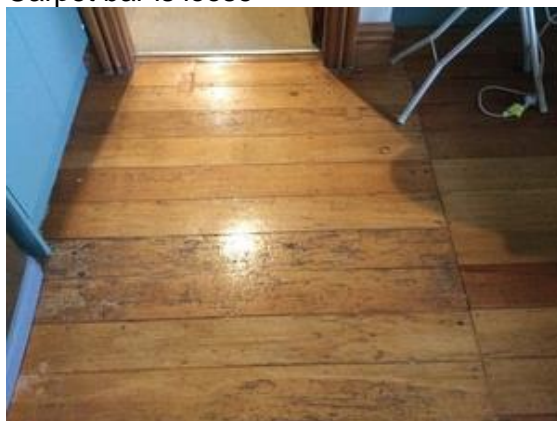
Borer damage

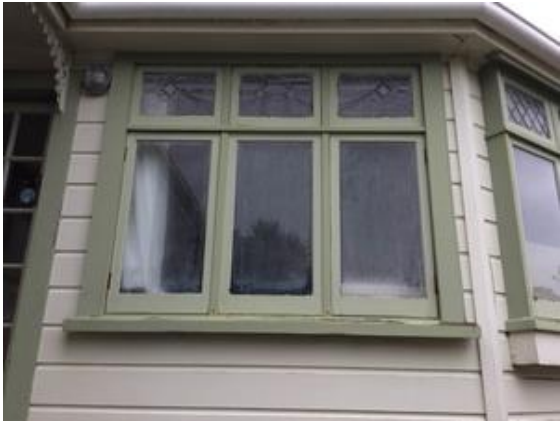
Rusted hinges on most windows

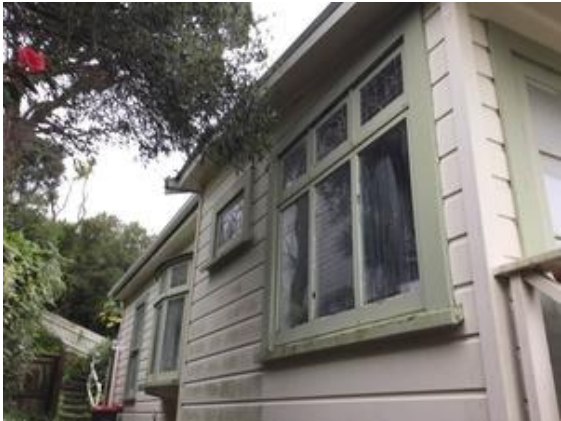
Lots of loose window glazing putty

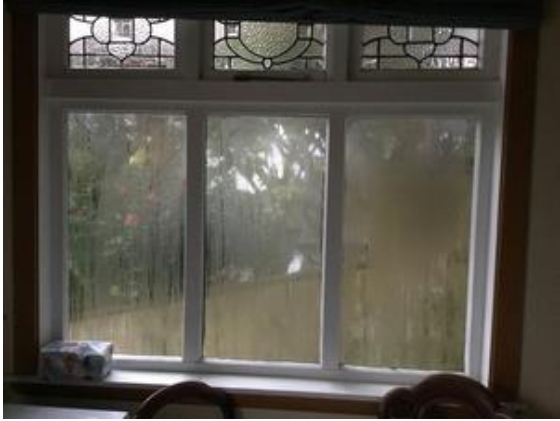
Condensation on most windows

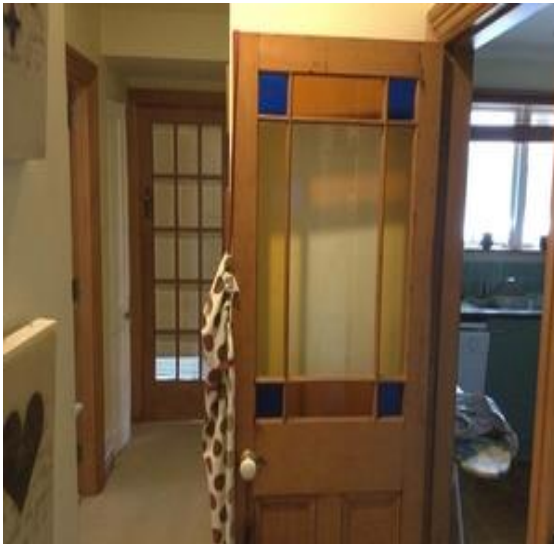
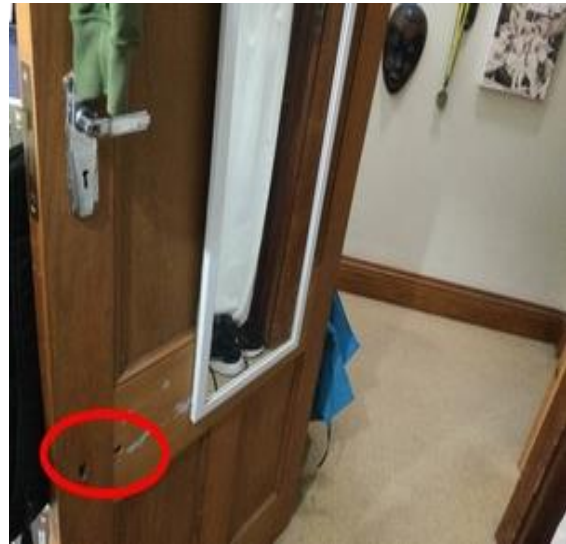
Red circle indicates where most doors have possibly had hardware previously removed

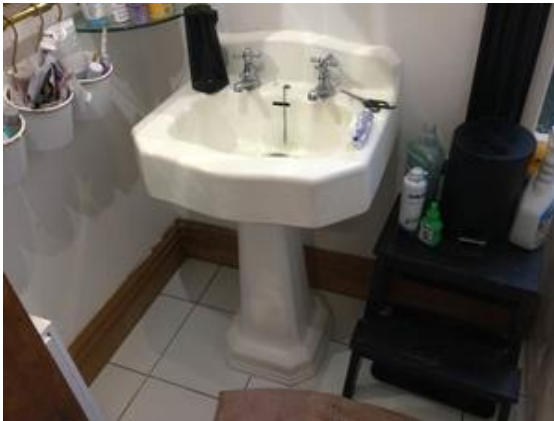
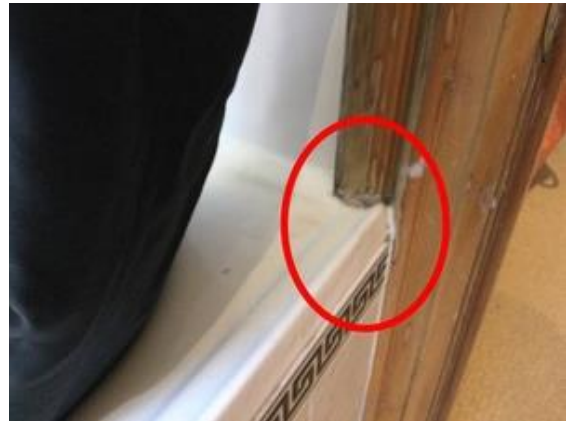
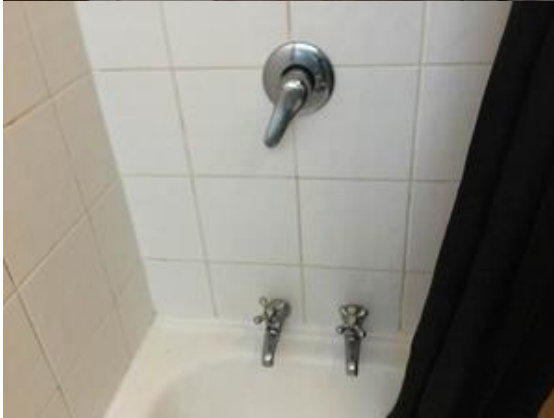
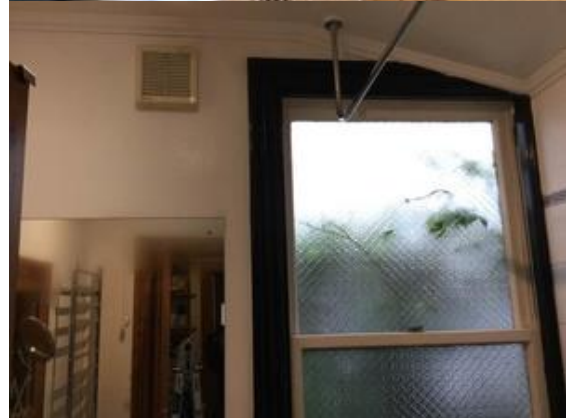
Very small bathroom and bath has a bad design where the top of the bath meets the shower linings
