PRE-PURCHASE PROPERTY INSPECTION AT

(Some photos in the sample report have either been removed or cropped / shrunk to protect the client's privacy)

The property is a single story, timber weatherboard clad house on concrete pile foundation with a steel long run roof, with timber joinery. The section is sloping & terraced at the back with some grass with shrubs. Access is via a path only.

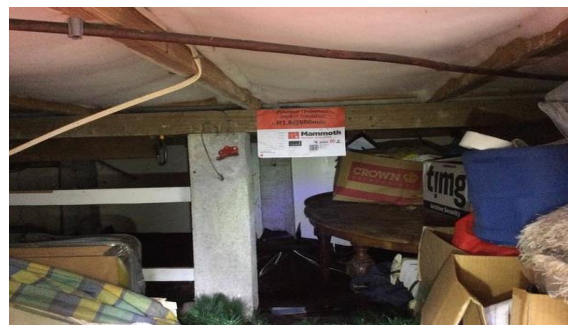
R1.9 insulation label underneath rear extension

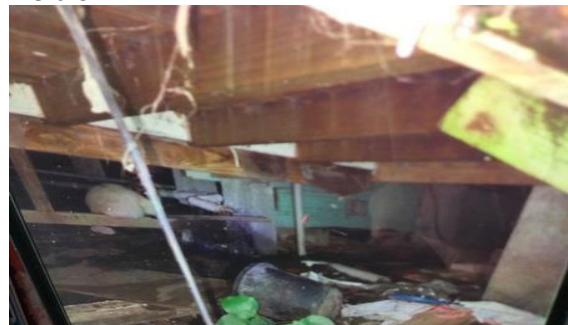
Under deck facing towards street has incomplete base board cladding

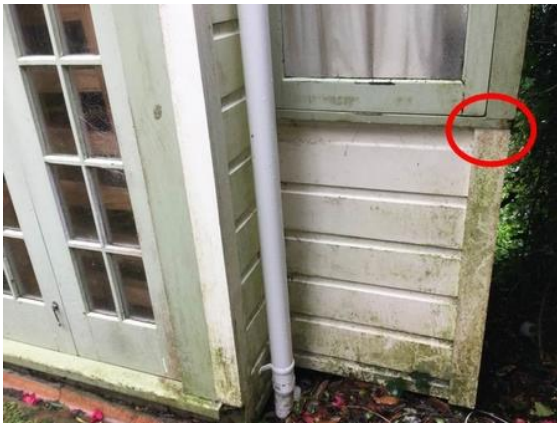
This detail on the sleepout circled in red is not ideal

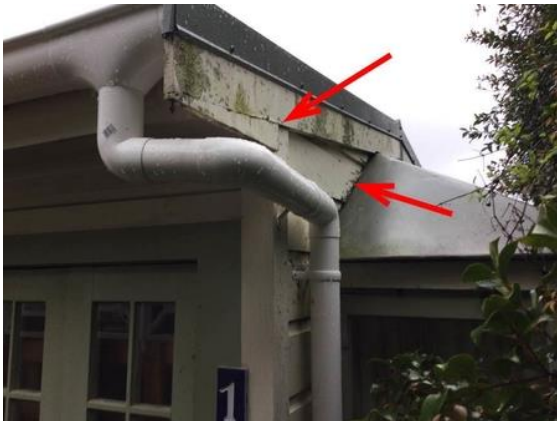
These details on the sleepout are not ideal (indicated with red arrows)

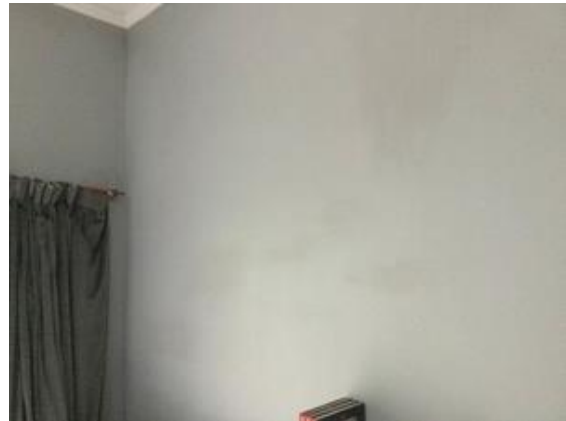
Bedroom one front right corner room has lots of markings visible
