PRE-PURCHASE PROPERTY INSPECTION REPORT

Inspection Date: 18 February 2026

Alert Building Inspections | Phone: 0800 4 Alert (425 378)
Email: info@alertbuildinginspections.co.nz

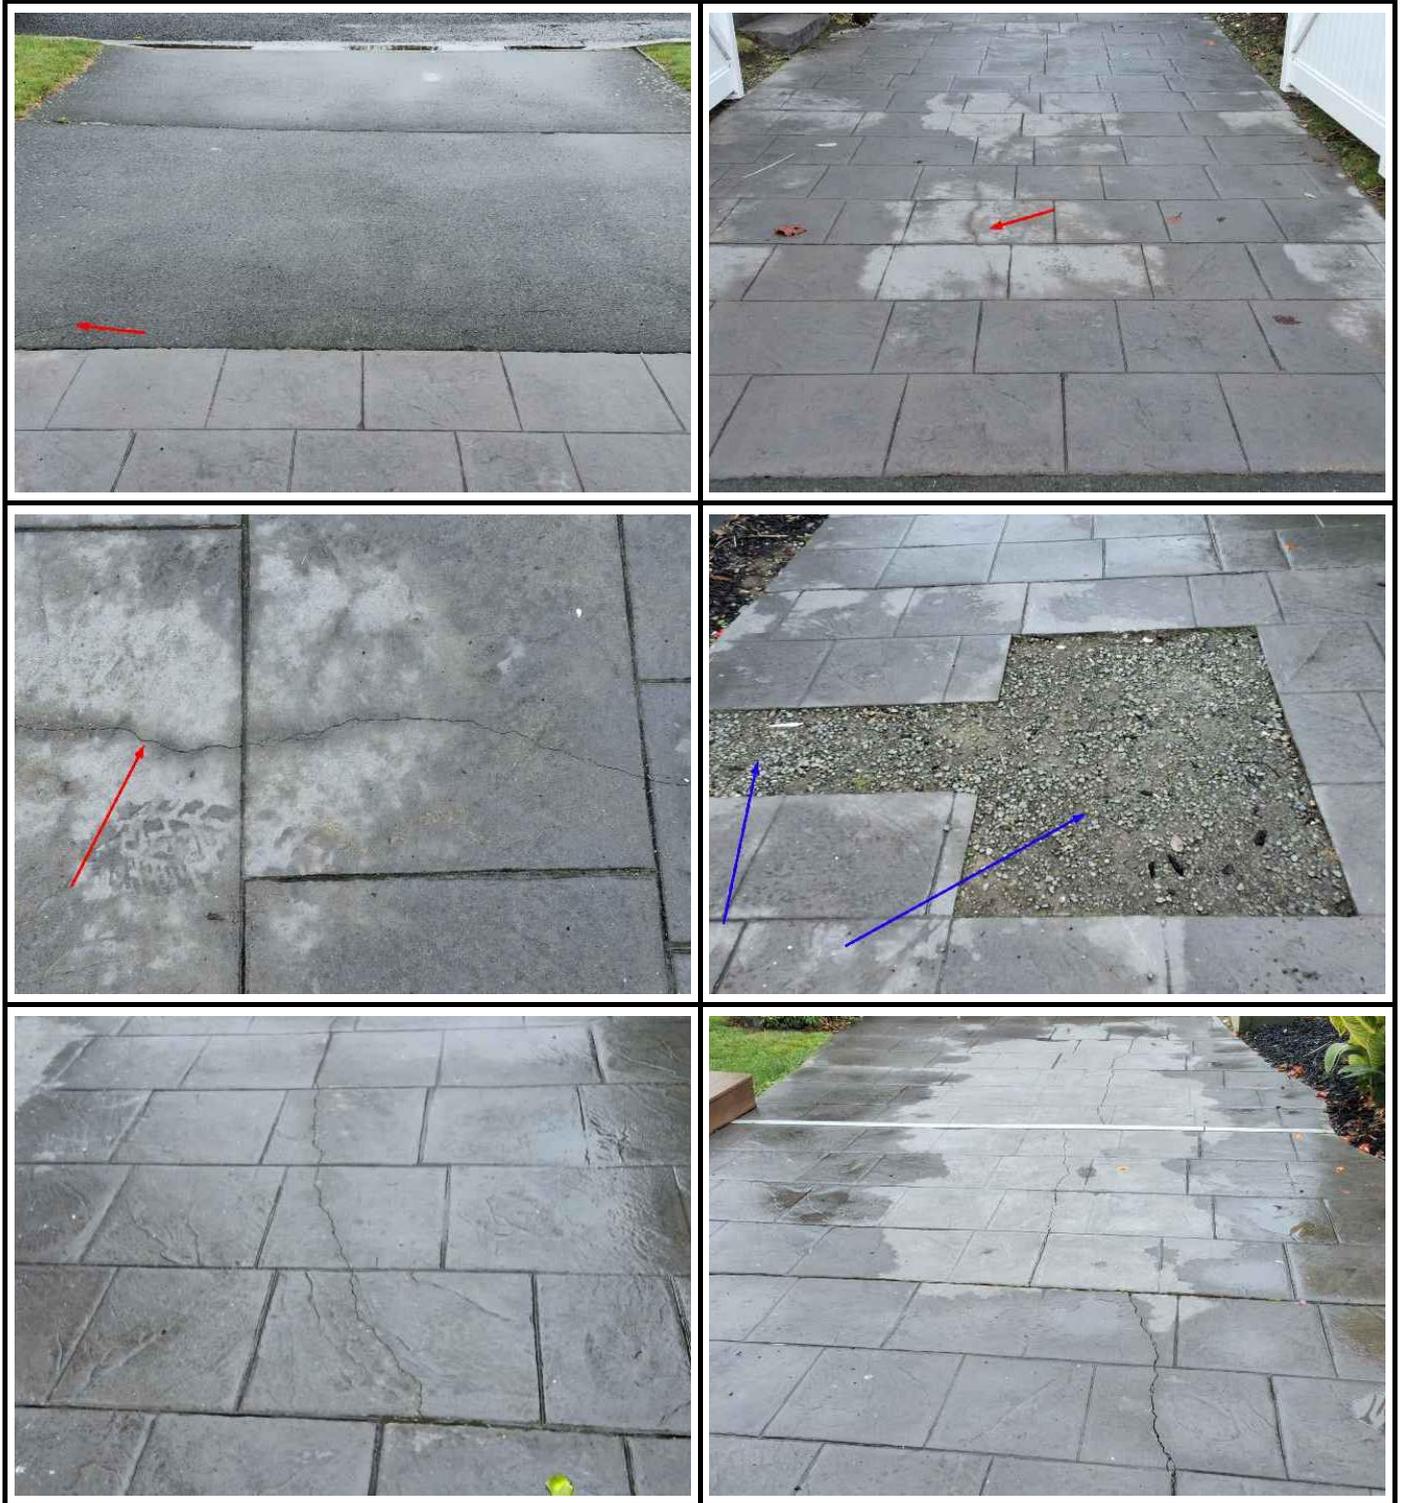
Driveway

Acceptable condition

The crossing is built with asphalt and is in a reasonable condition, however there is some minor cracking as shown with blue arrows. The driveway is built with concrete and is in a functional condition, however there is some cracking as shown with red arrows. There is also an unfinished section of concrete with gravel in place.

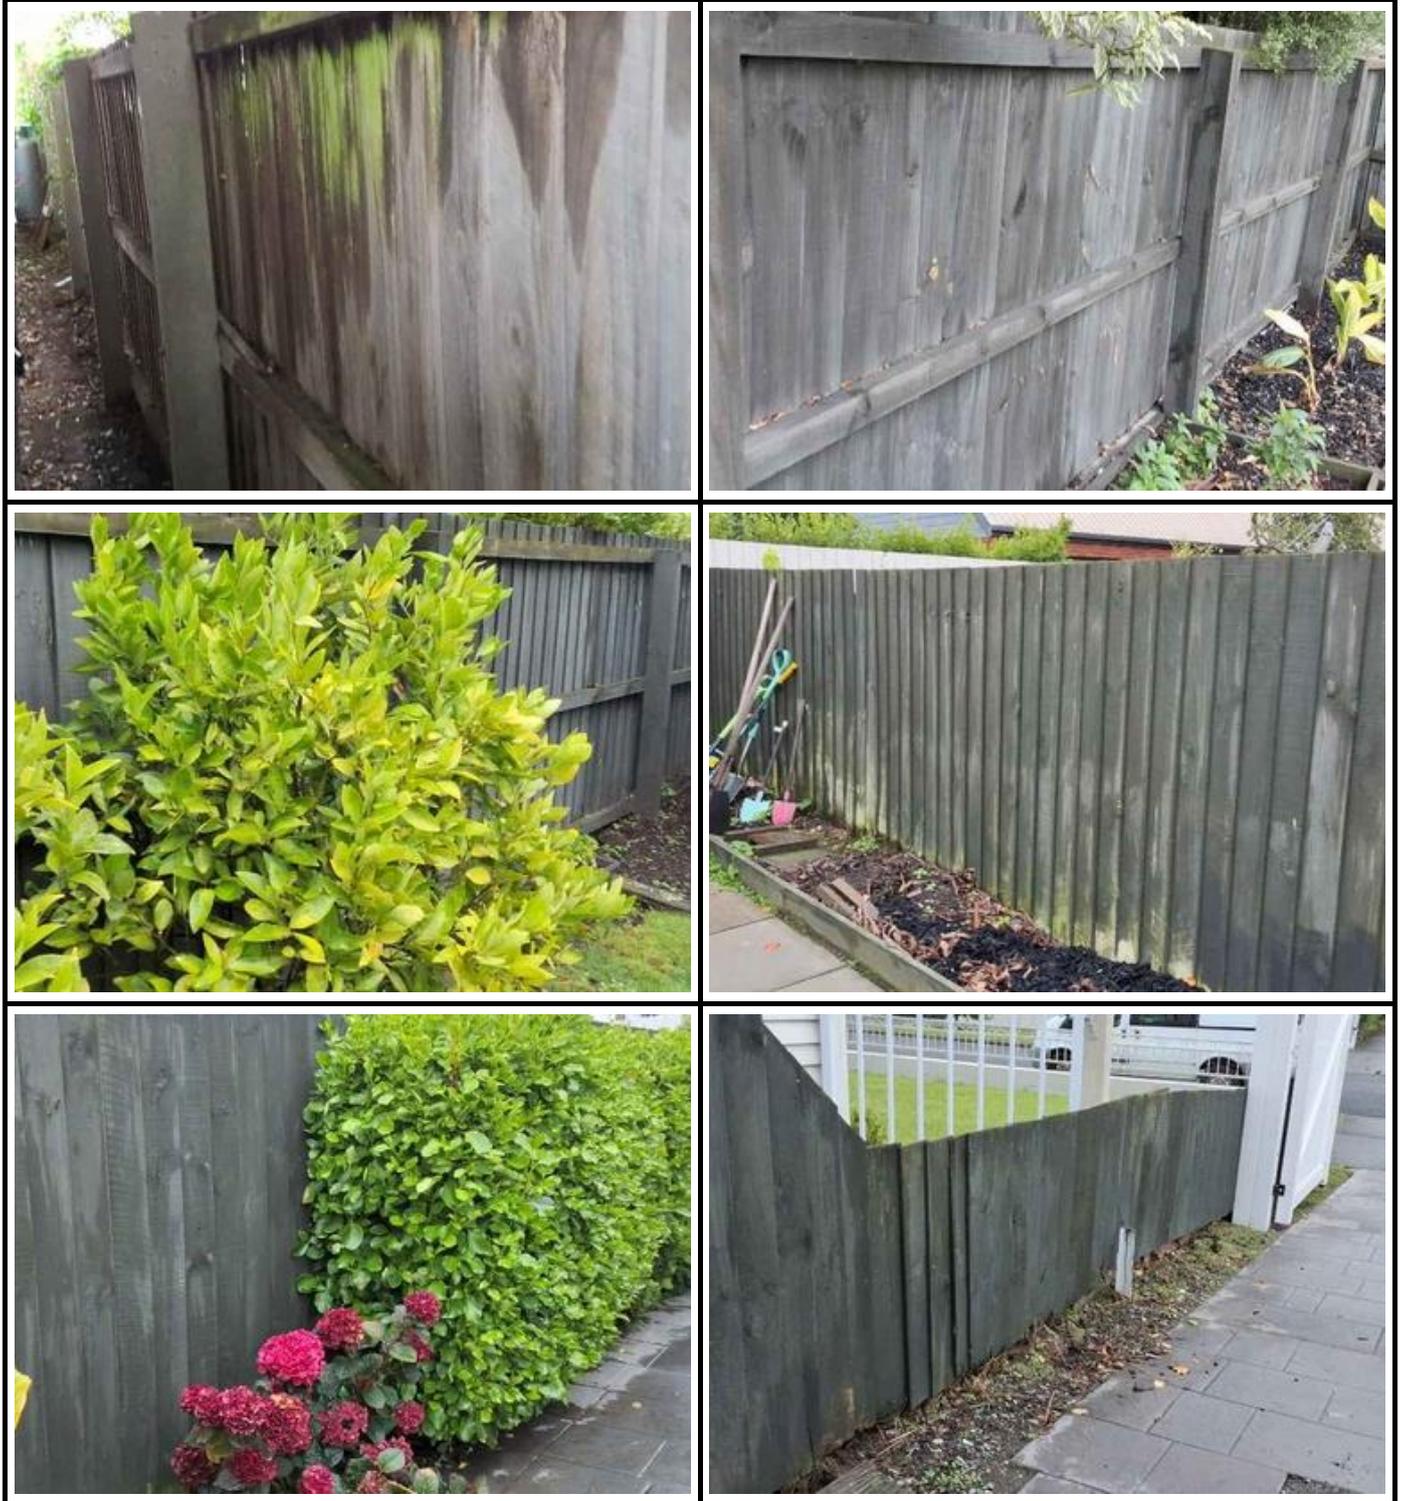
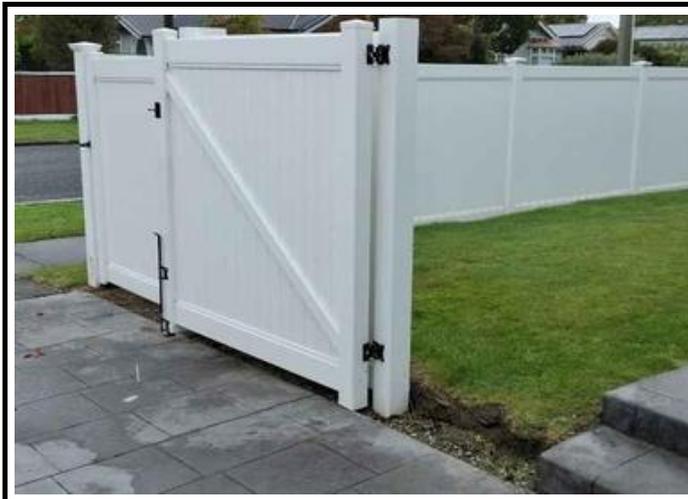
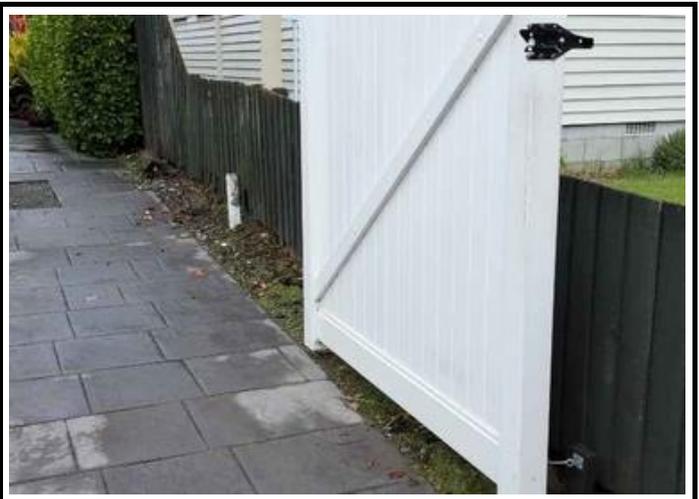
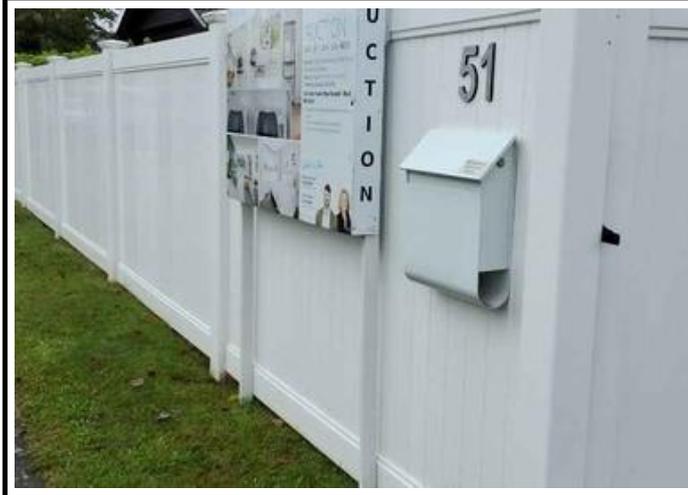
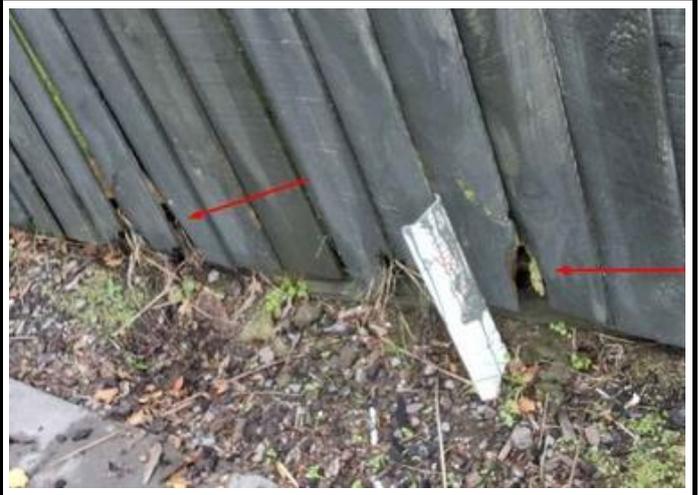
Fencing

Acceptable condition

The fencing is built with timber posts, rail and palings and appears to be in a reasonable condition, however there are some deteriorated items as shown with red arrows.

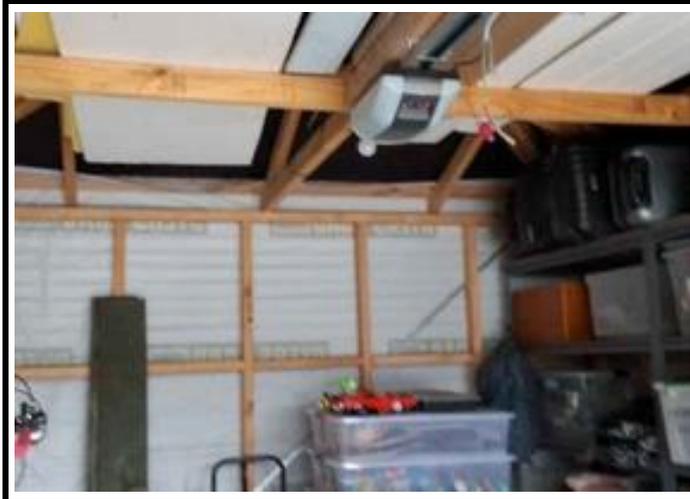
Garage

Acceptable condition

This is a detached single garage with an auto-operated sectional door. There is an attached room with aluminium french doors. Clad with Coloursteel and is in a reasonable condition.

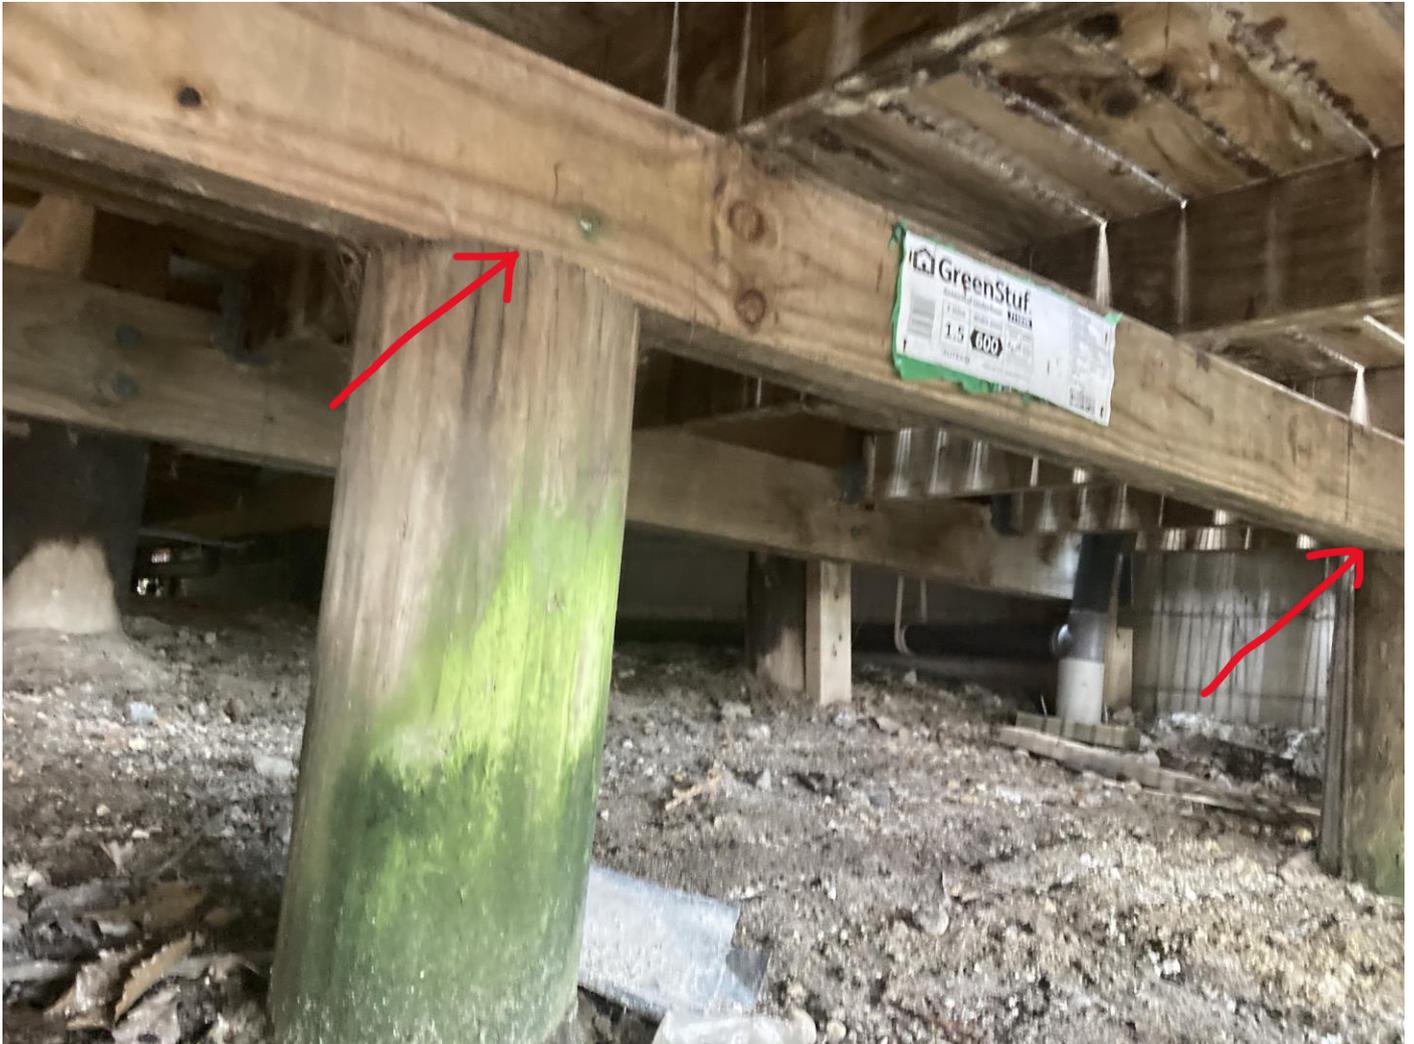
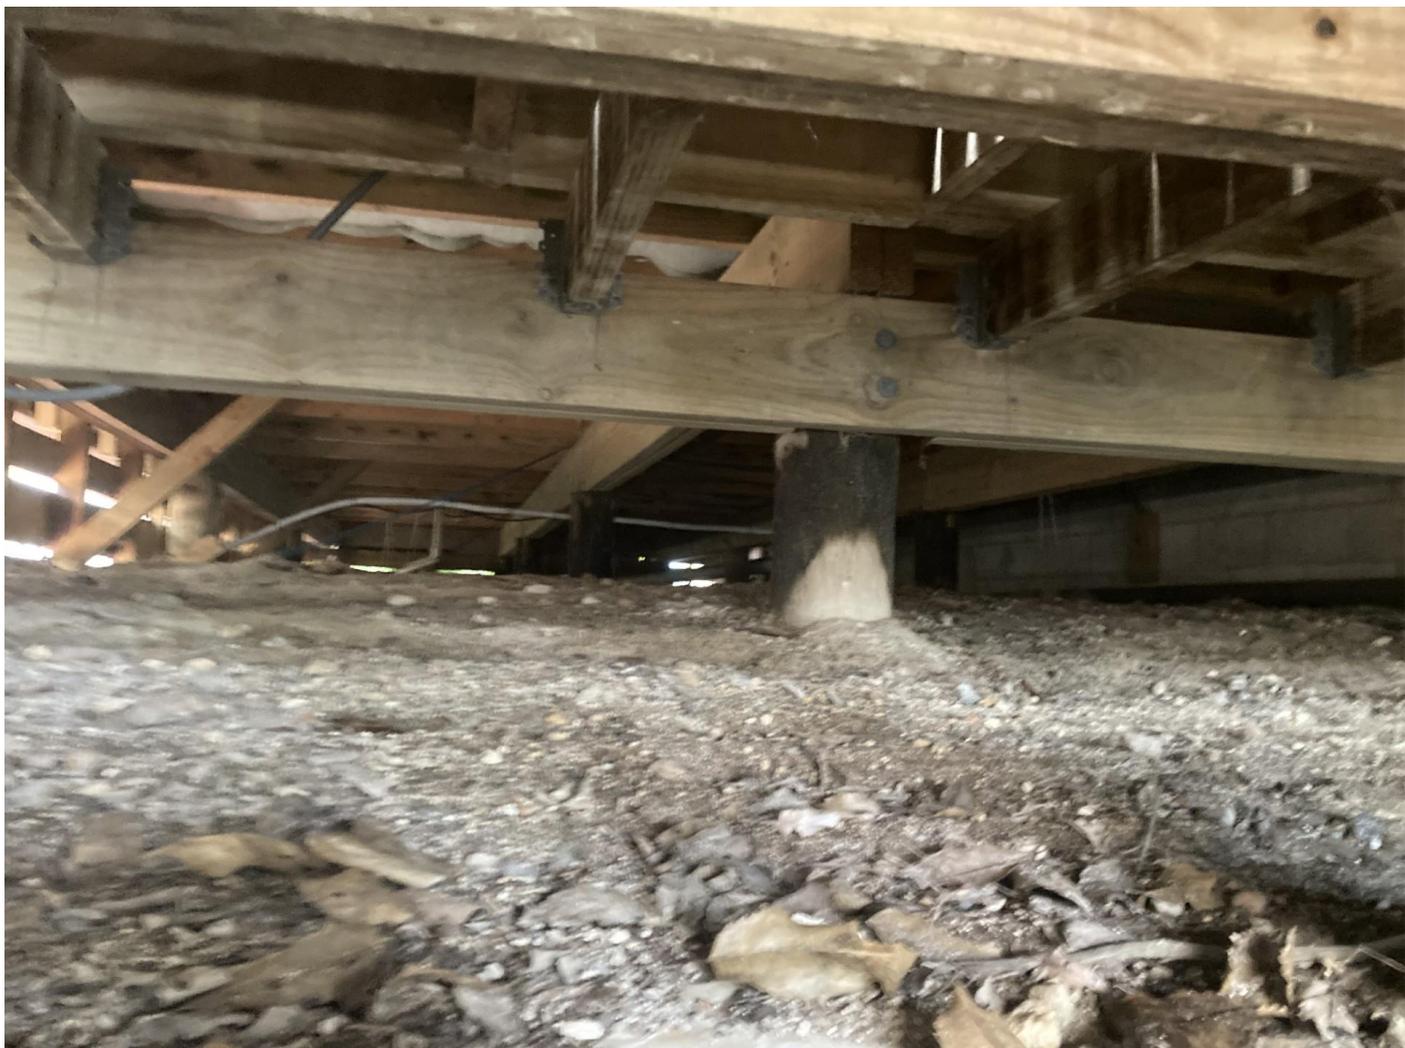
Joist, Bearer and Pile

Not acceptable condition.

Pile straps missing off several piles

Only partial insulation is present.

Recommend further investigation by qualified builder and insulating underfloor.

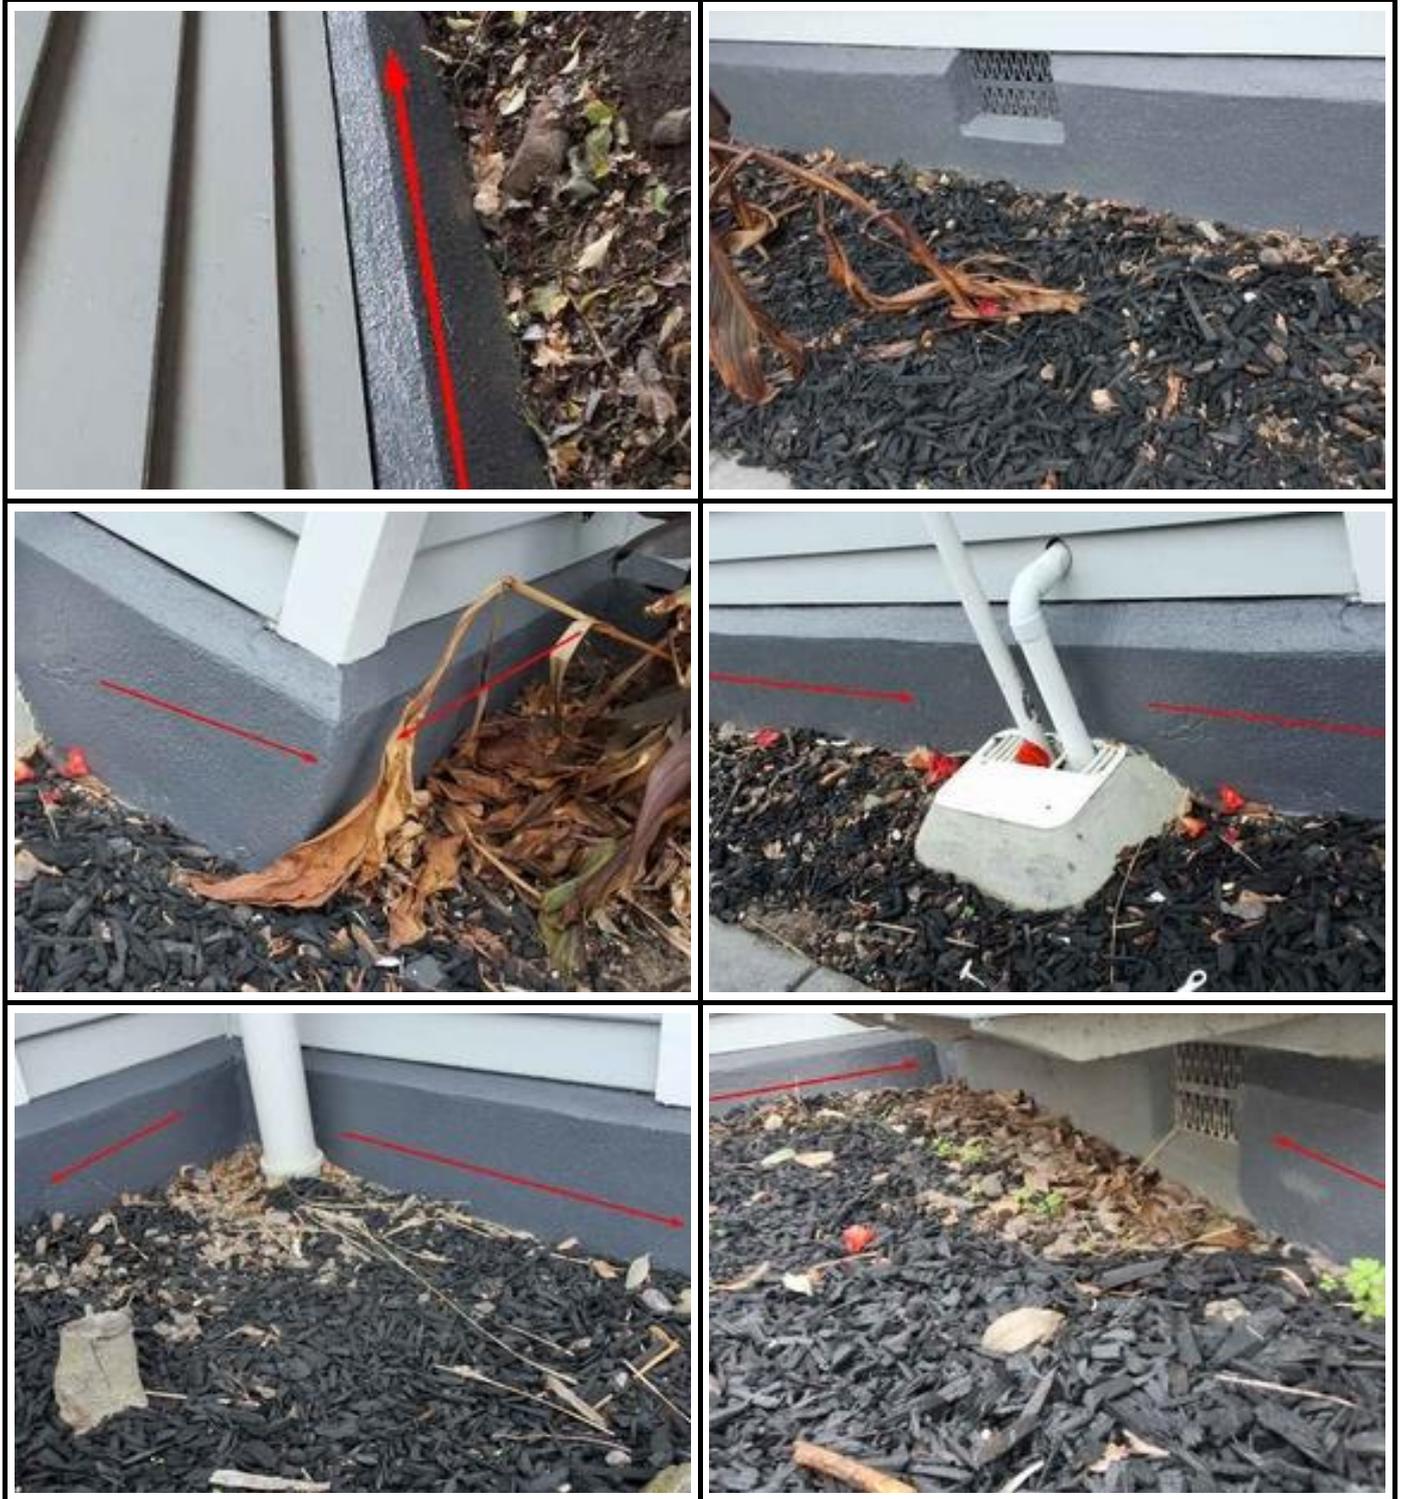
Brick foundation wall

Acceptable condition

This is a concrete parameter foundation wall with vents and appears to be in a reasonable condition.

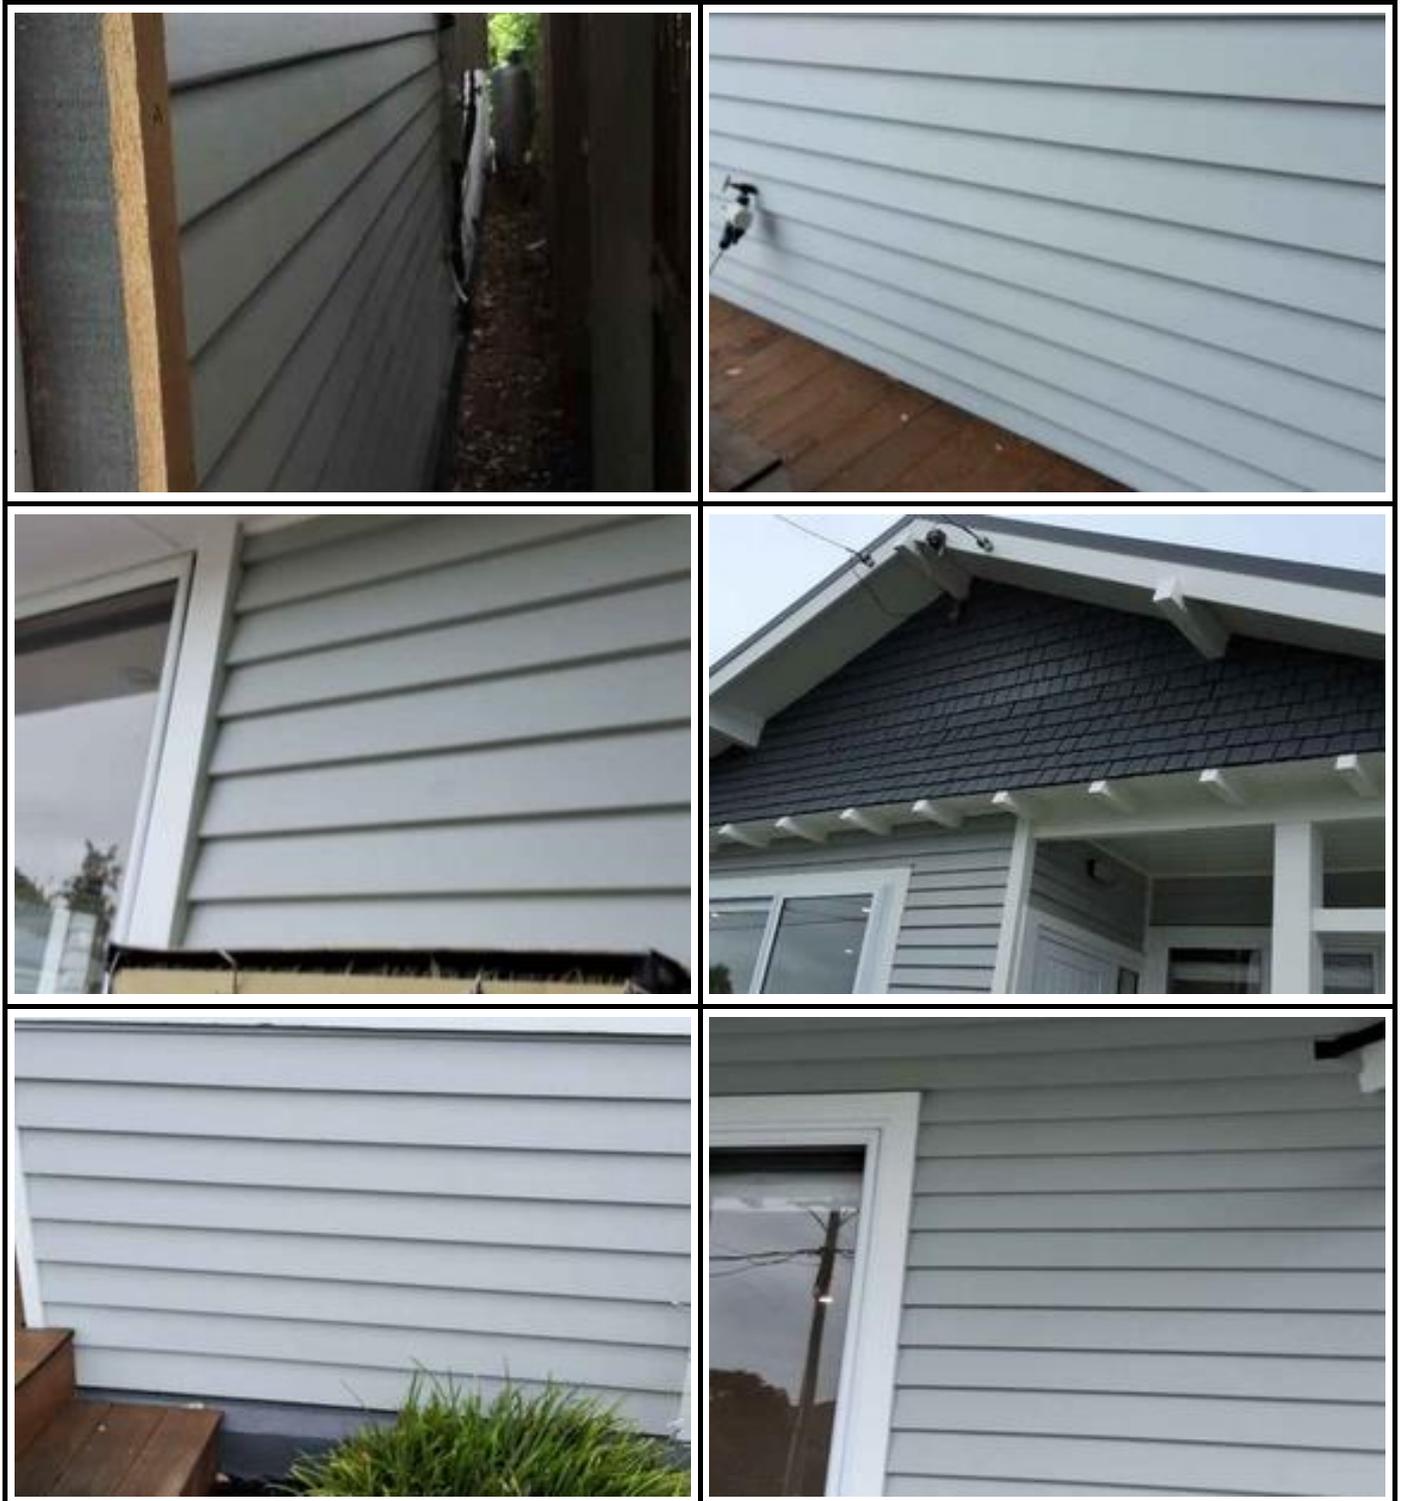
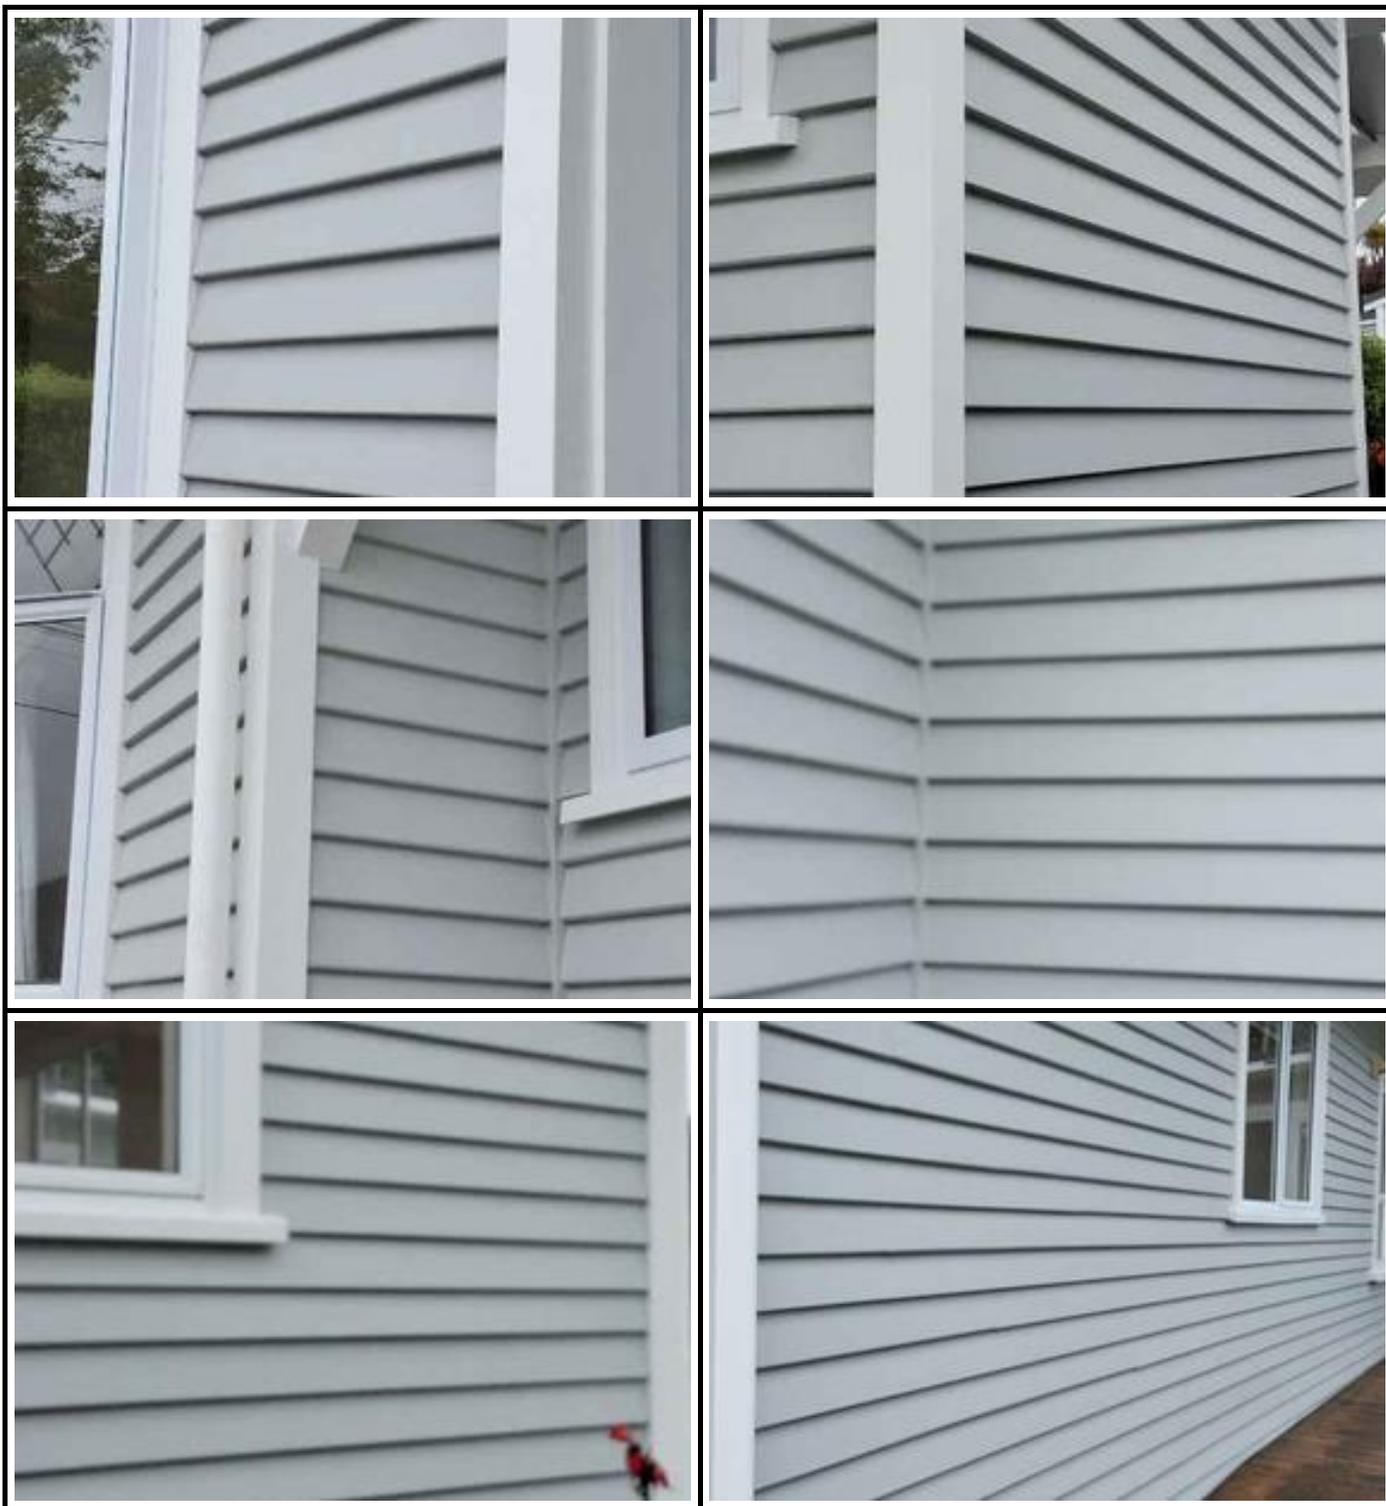
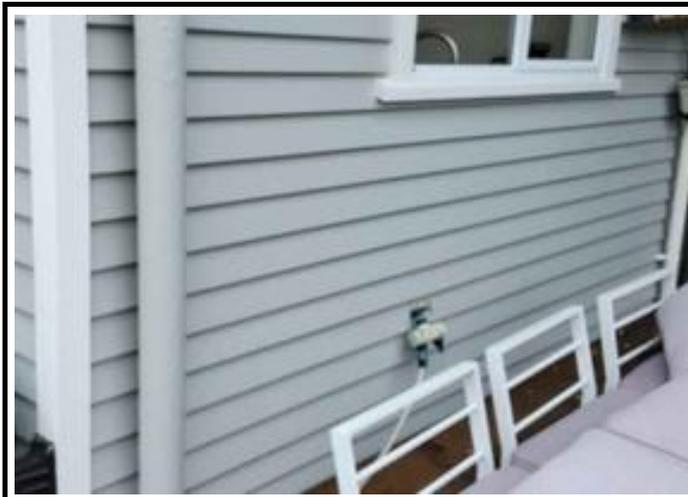
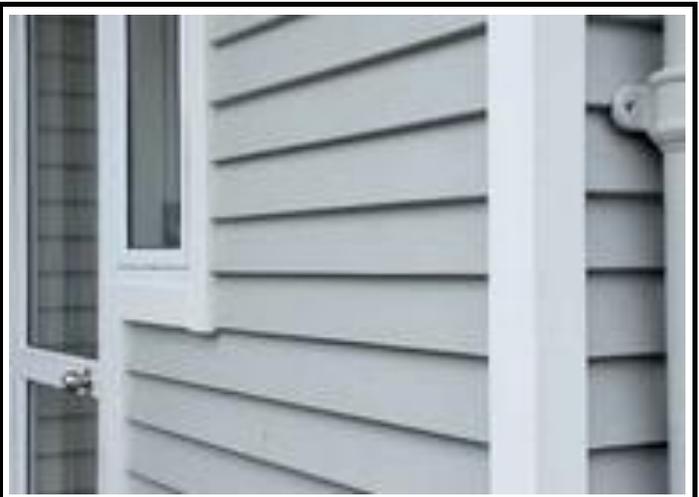
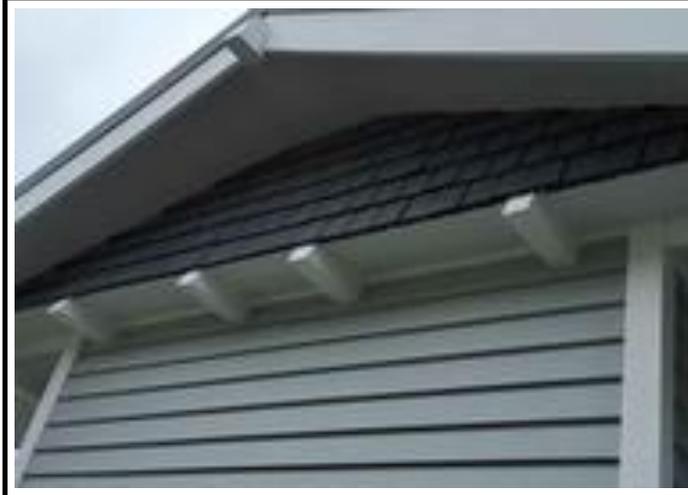
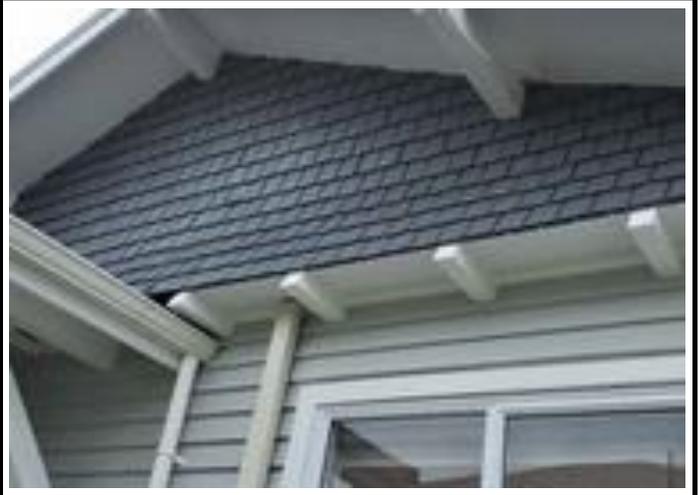
Cladding description

Timber weatherboard - Acceptable condition

The cladding is built with timber weatherboard and shingles and appears to be in a reasonable condition.

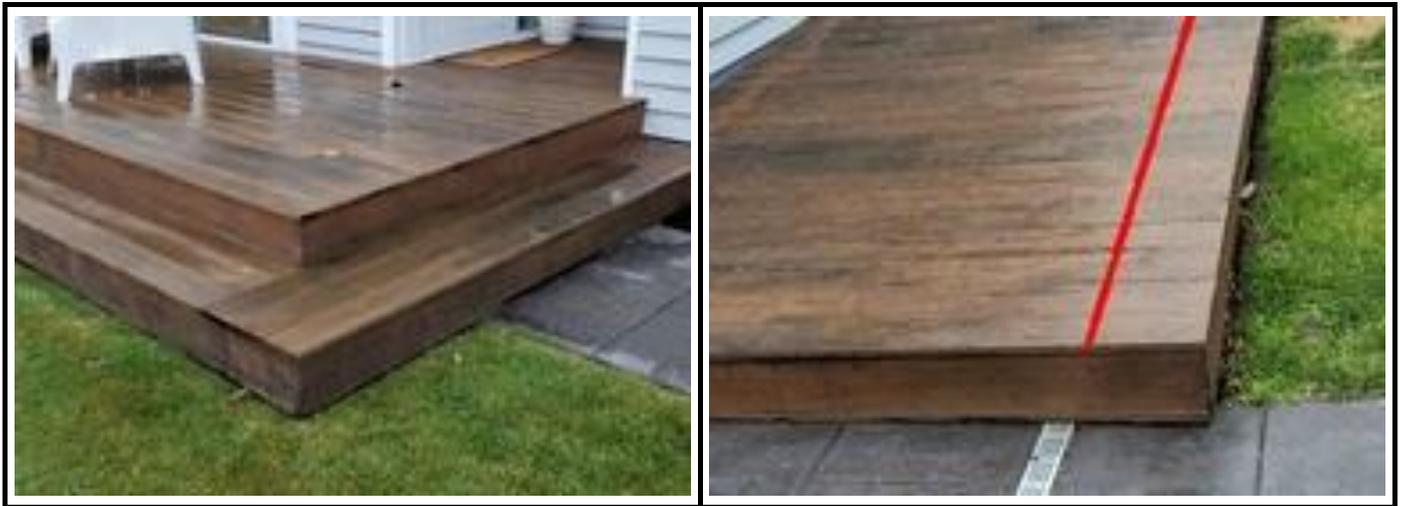
Exterior Stairs

Acceptable condition

These are timber steps and a ramp that appear to be in a reasonable condition.

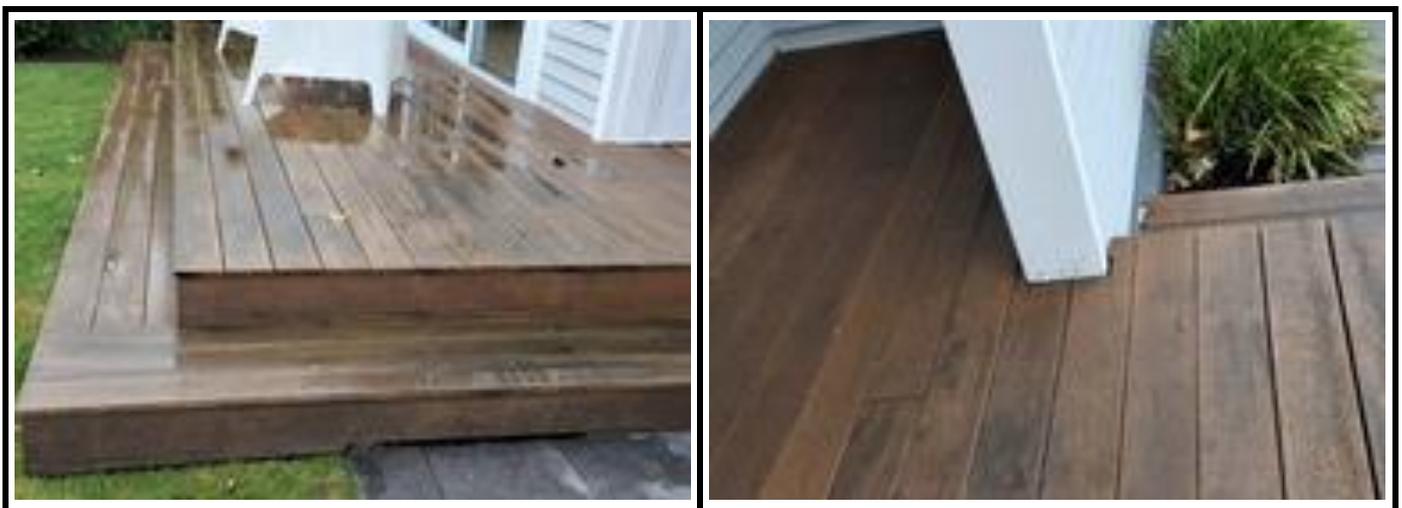
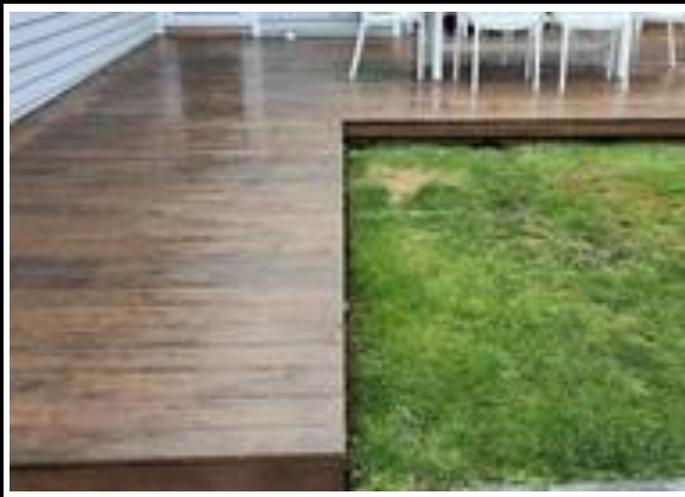
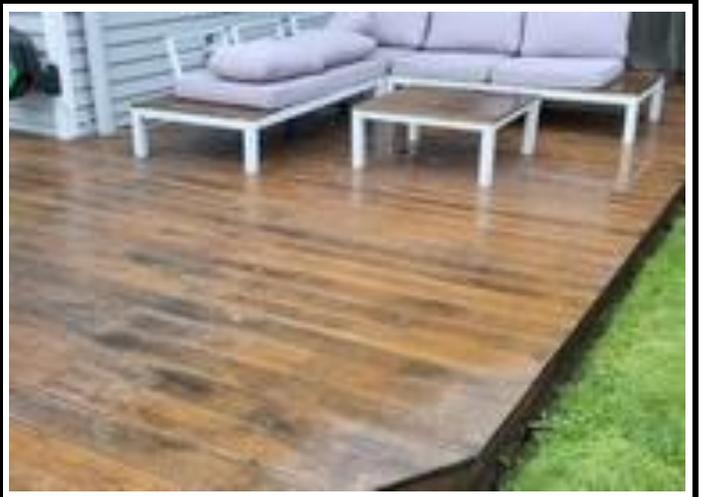
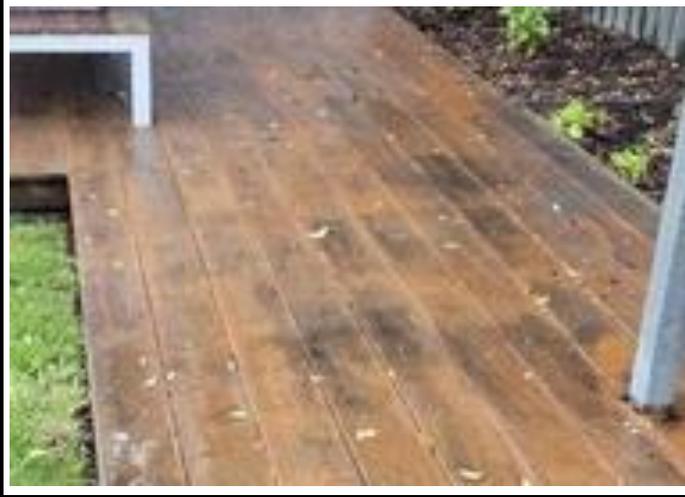
Deck

Acceptable condition

These are timber decks to the entry and rear yard that appear to be in a reasonable condition.
