PRE-PURCHASE PROPERTY INSPECTION REPORT

Inspection Date: 18 February 2026

Alert Building Inspections | Phone: 0800 4 Alert (425 378)
Email: info@alertbuildinginspections.co.nz

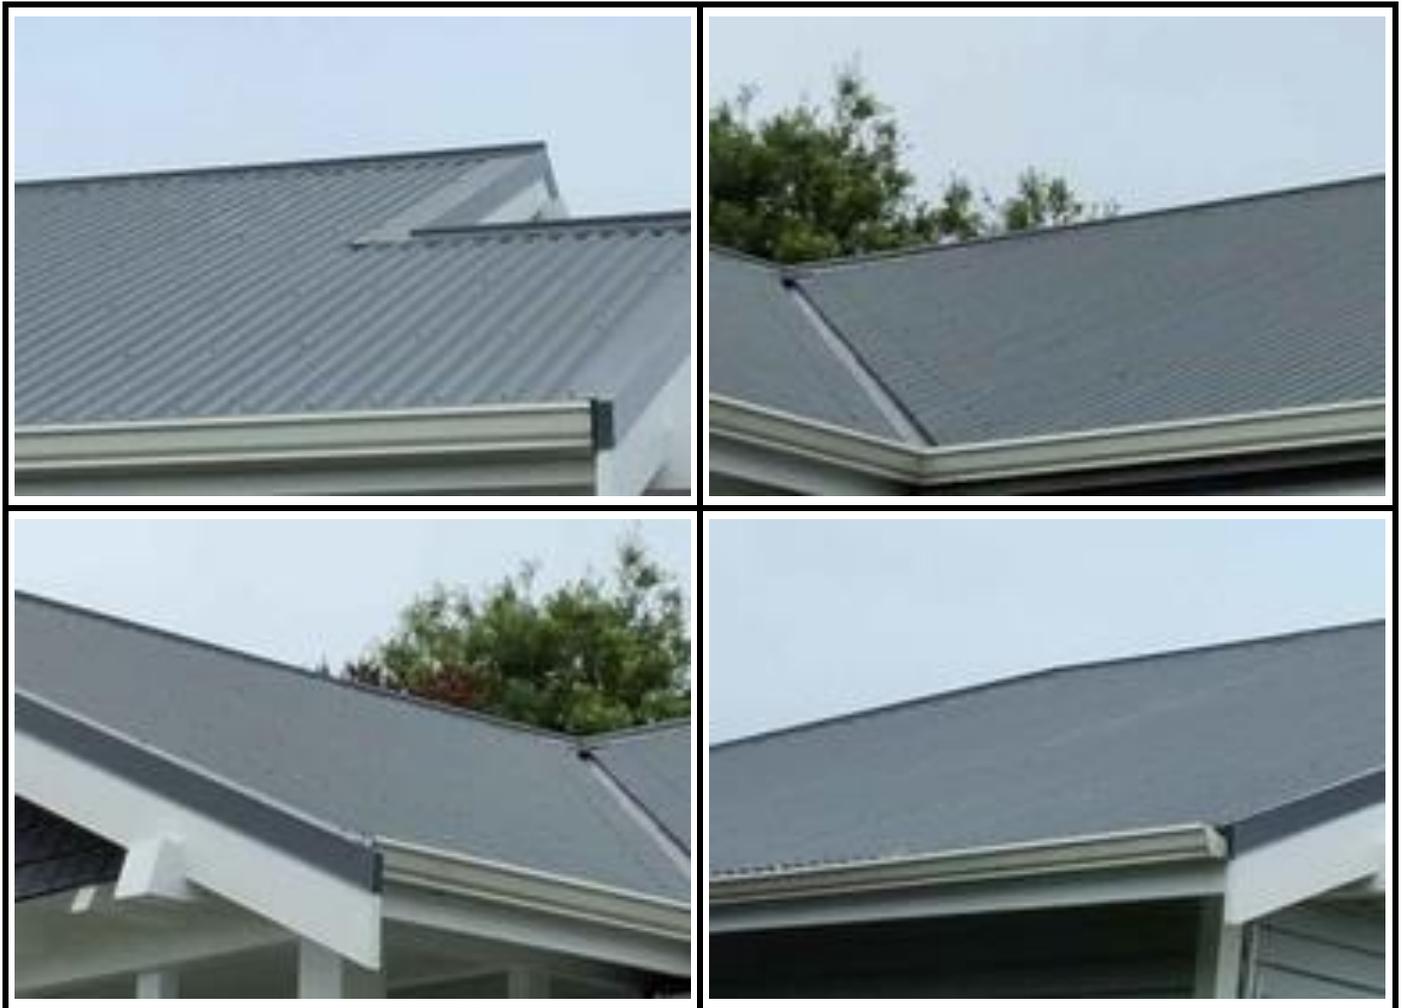
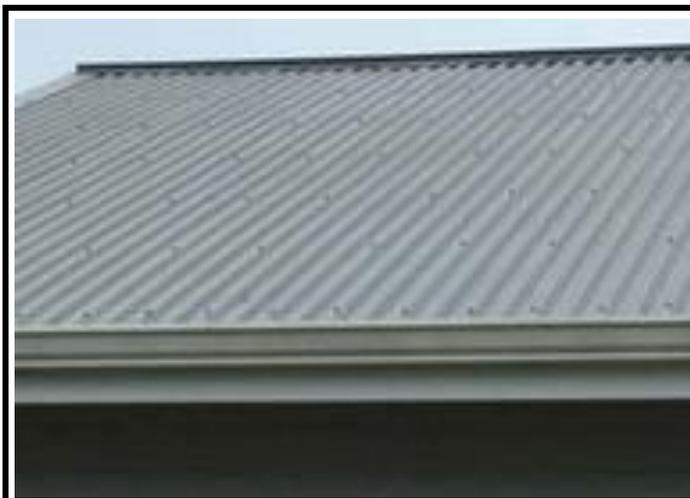
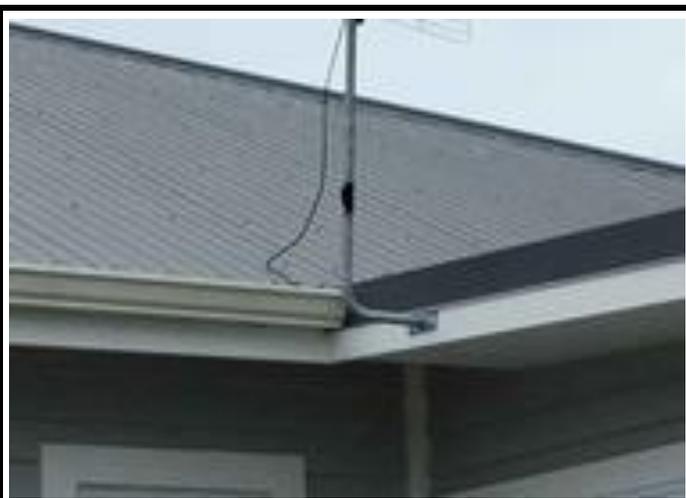
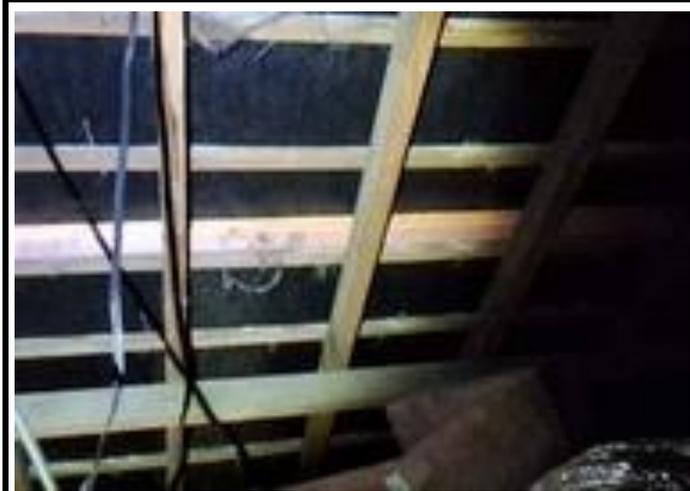
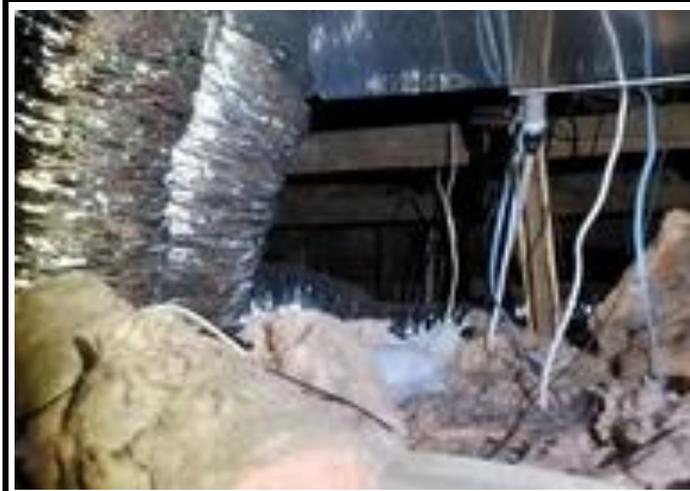
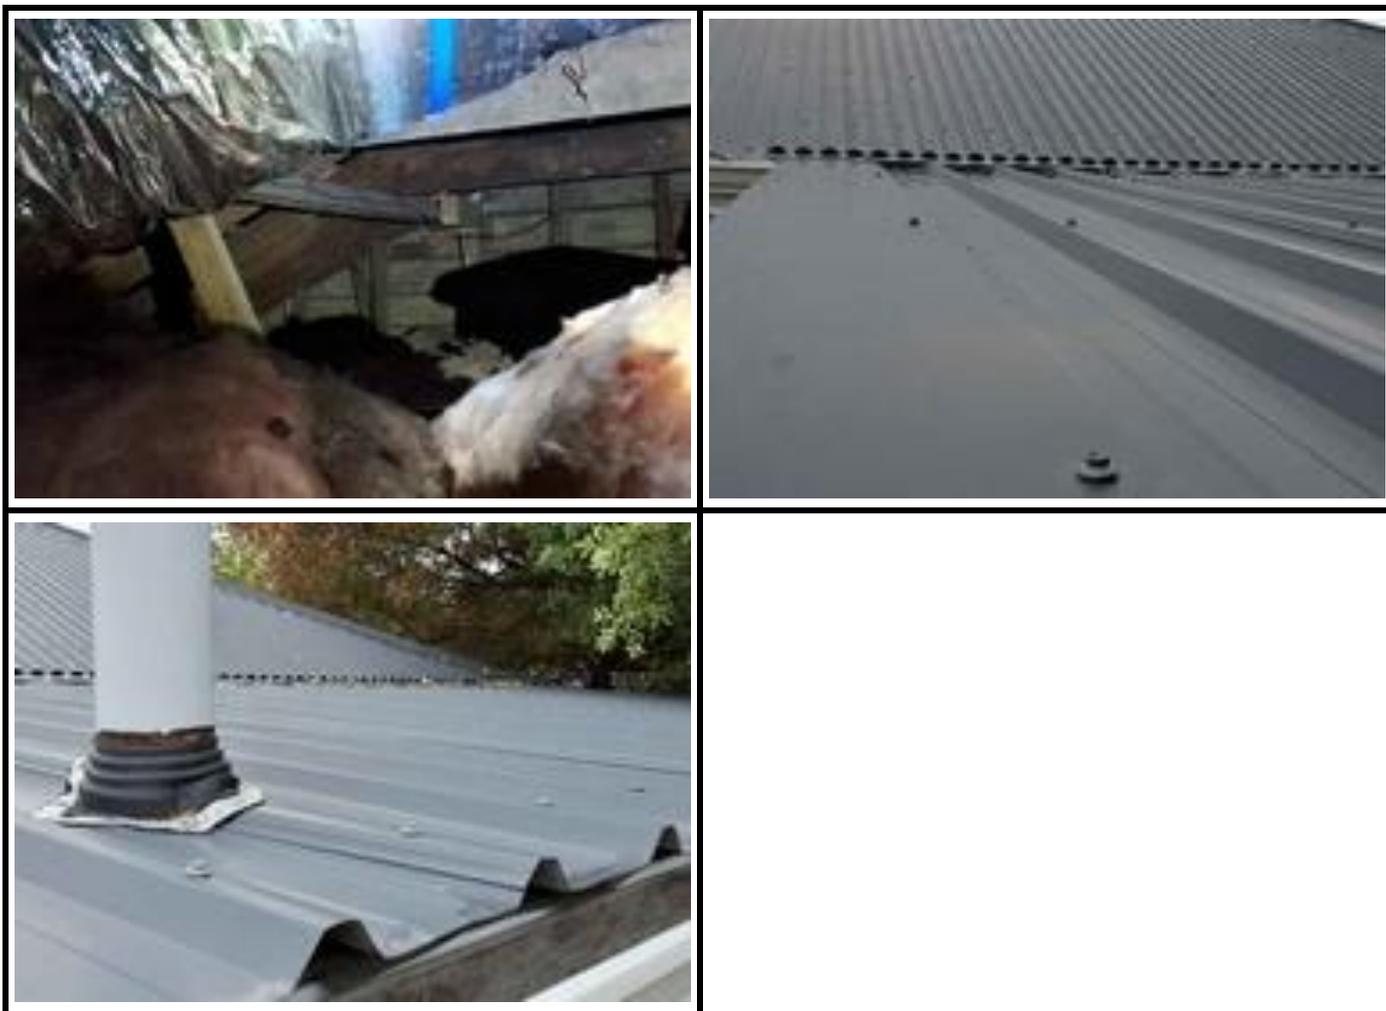
Roofing Steel

Steel - Acceptable condition

The roofing is built with long-run Coloursteel and various flashings and appears to be in a reasonable condition. The roof over the kitchen has a high profile Coloursteel skillion type of roof with various flashings and appears to be in a reasonable condition. I have included photos of the underside of the roof structure that shows additional framing and the black building paper underlay and all appear to be in a reasonable condition.

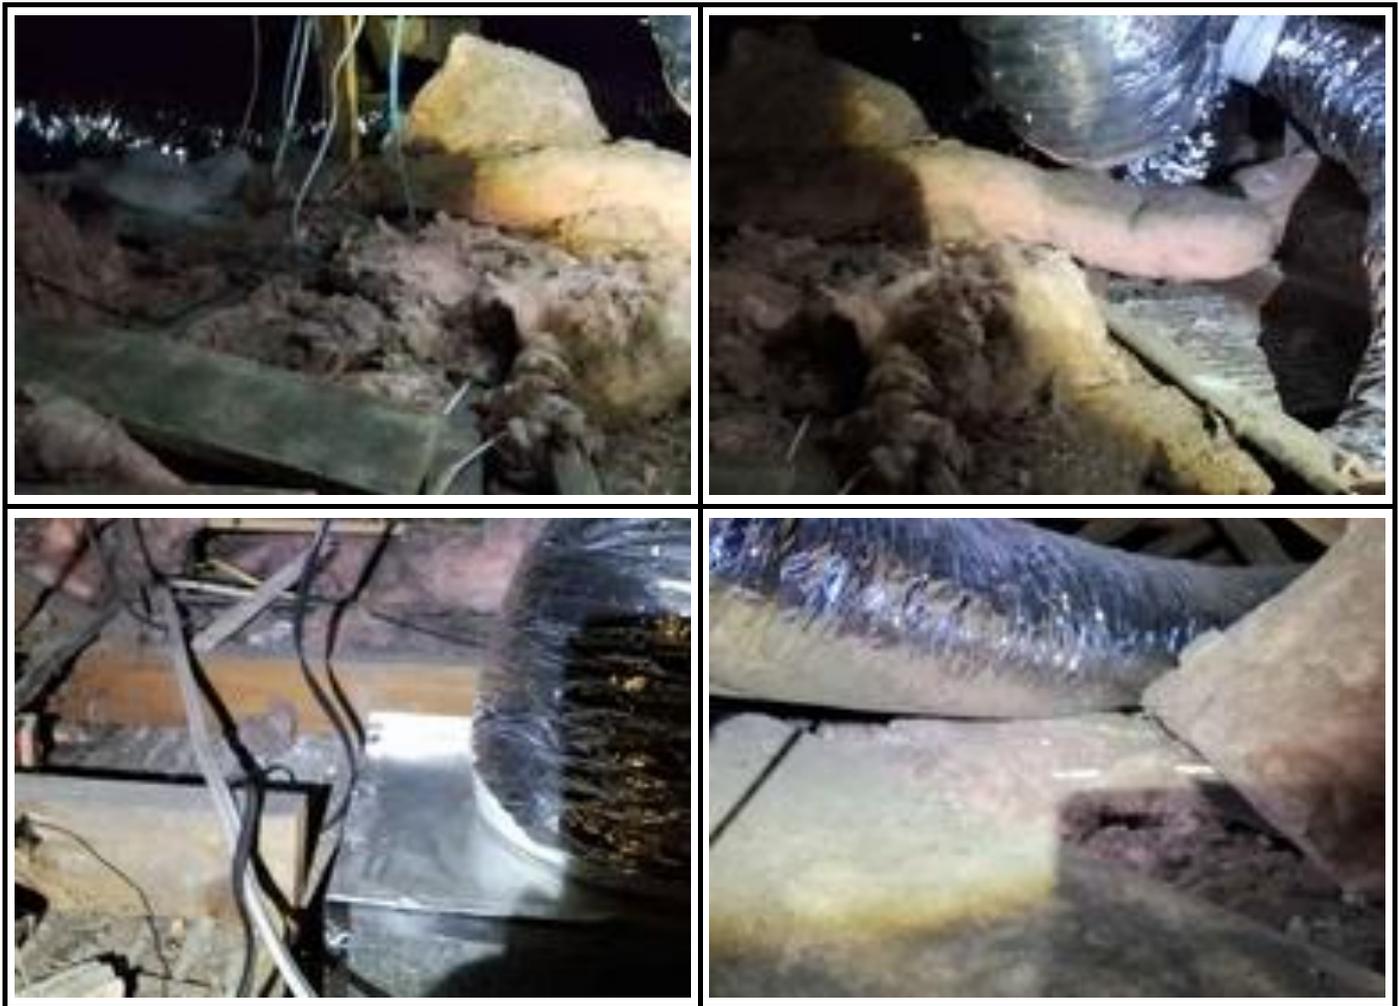
Insulation

Not acceptable condition

The ceiling has remnants of Batts with some bare areas and is not built to current standards. The kitchen has a skillion type of roof structure therefore I have not been able to review this insulation. This house has been renovated and some insulation may be upgraded therefore I would

recommend consulting with the owners on this item.

Recommend further investigation by qualified builder

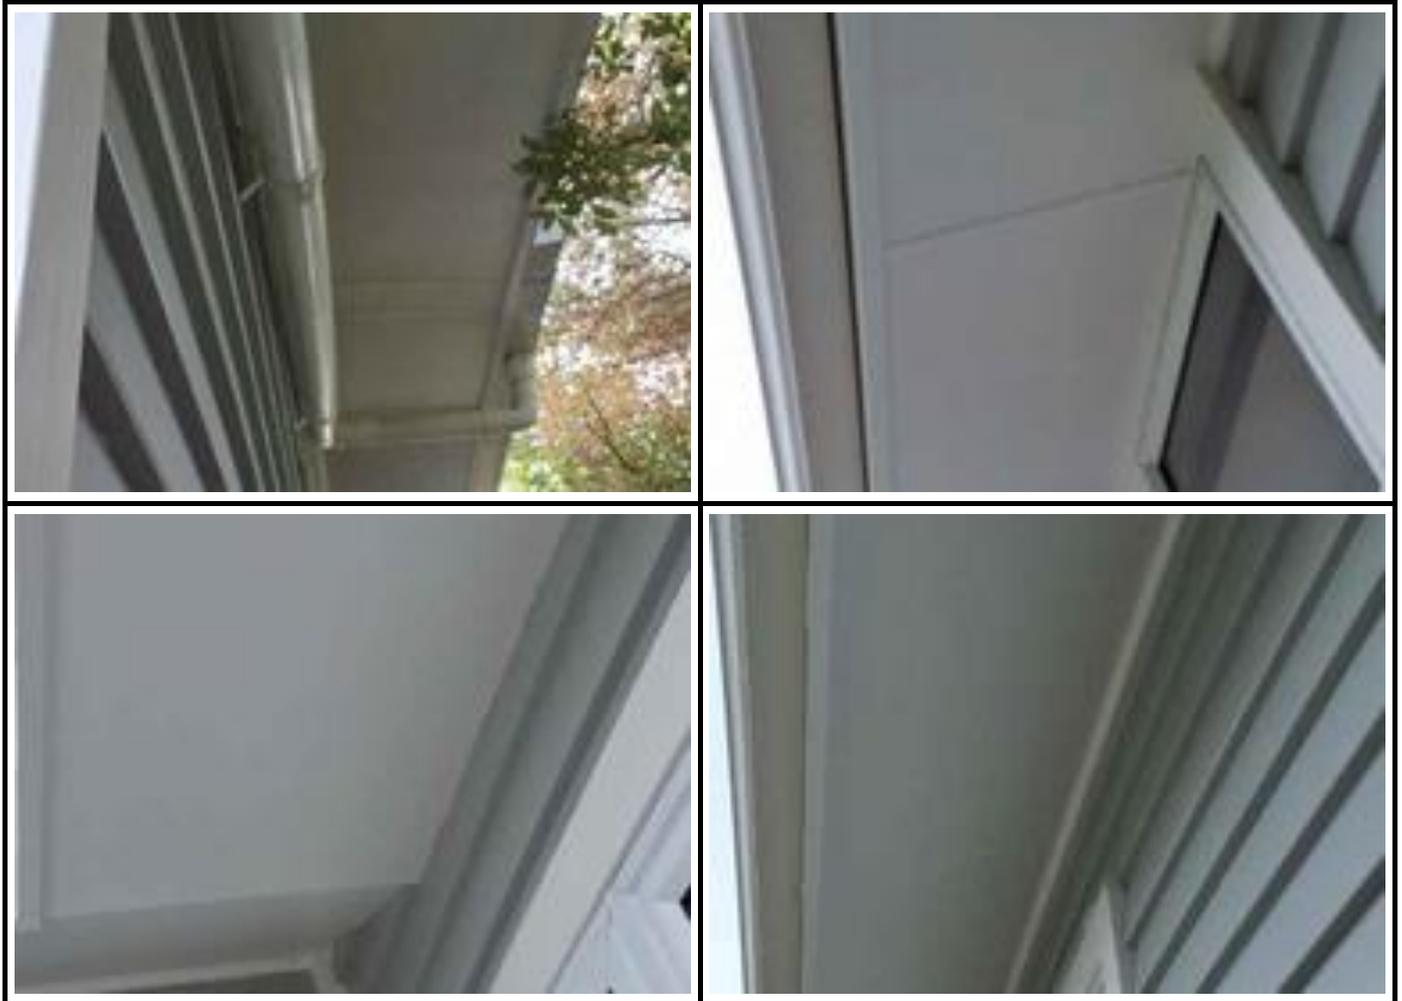
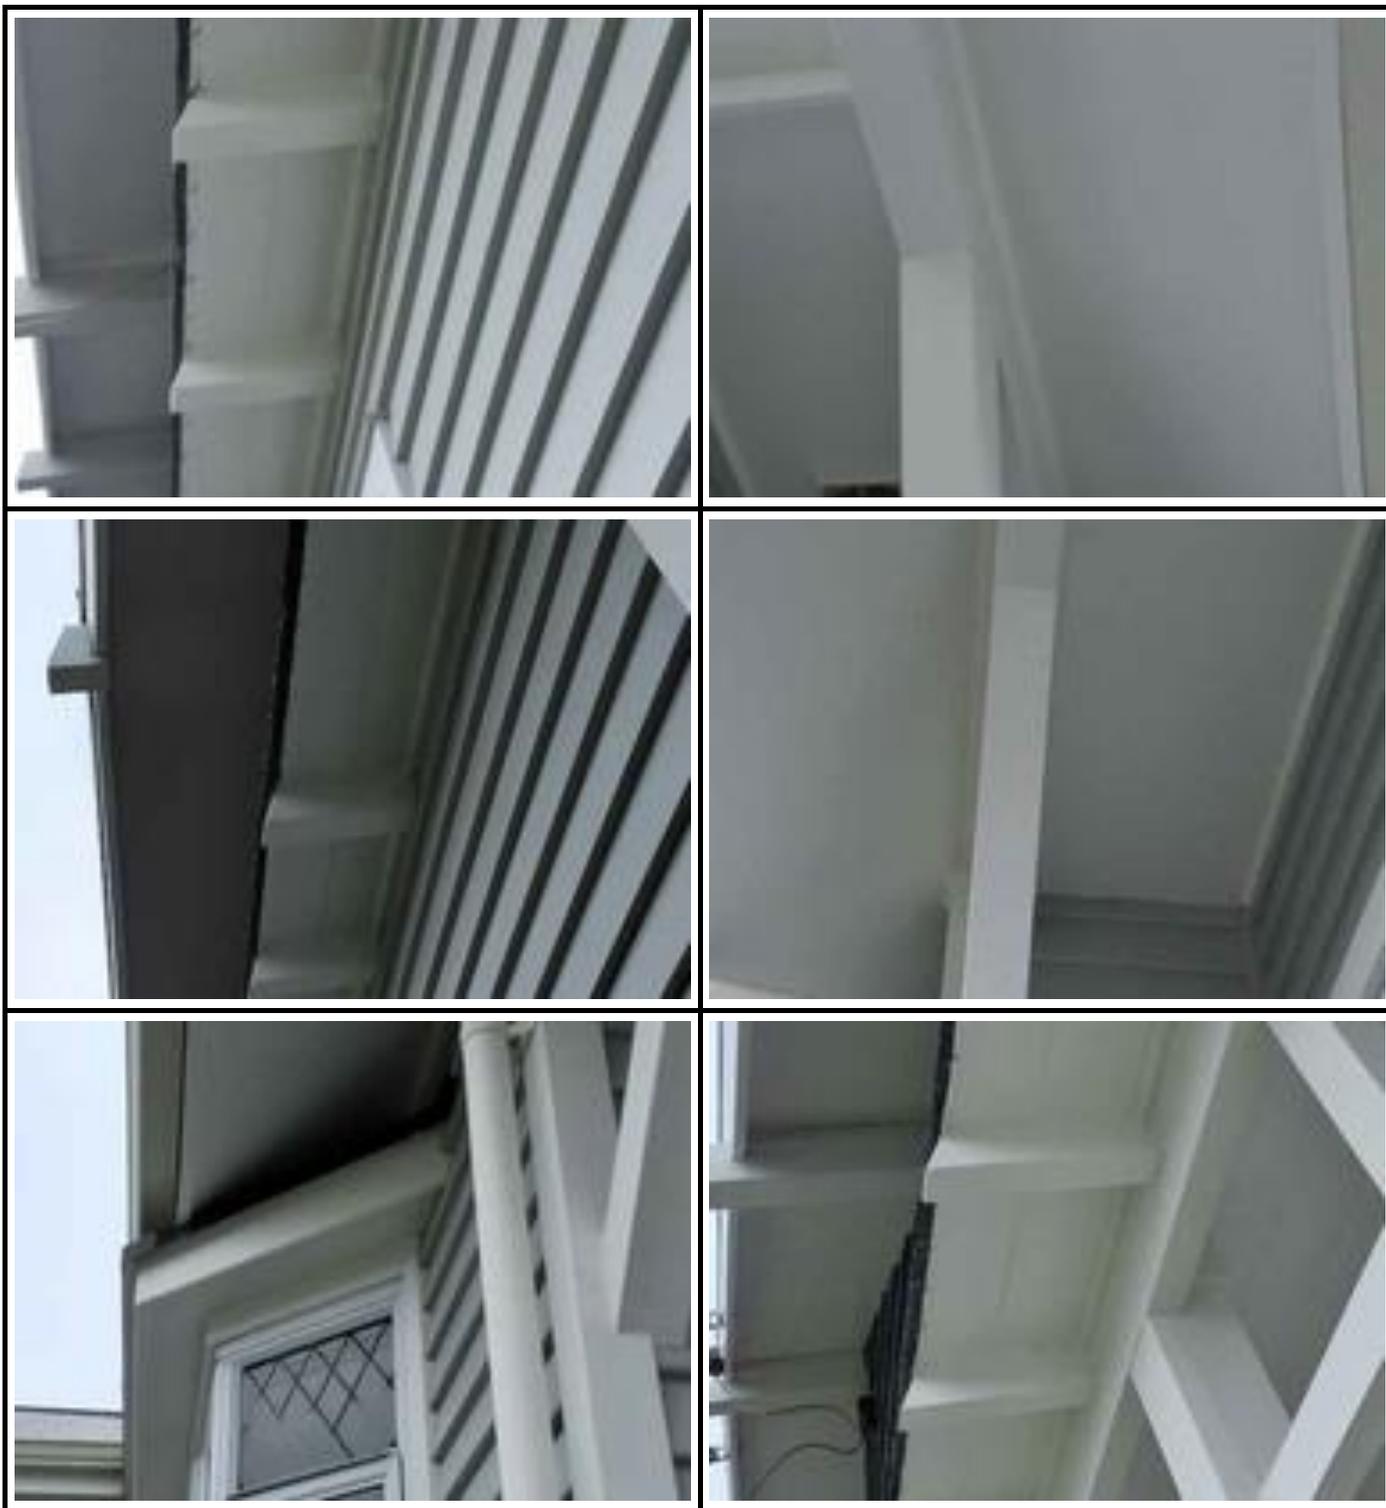
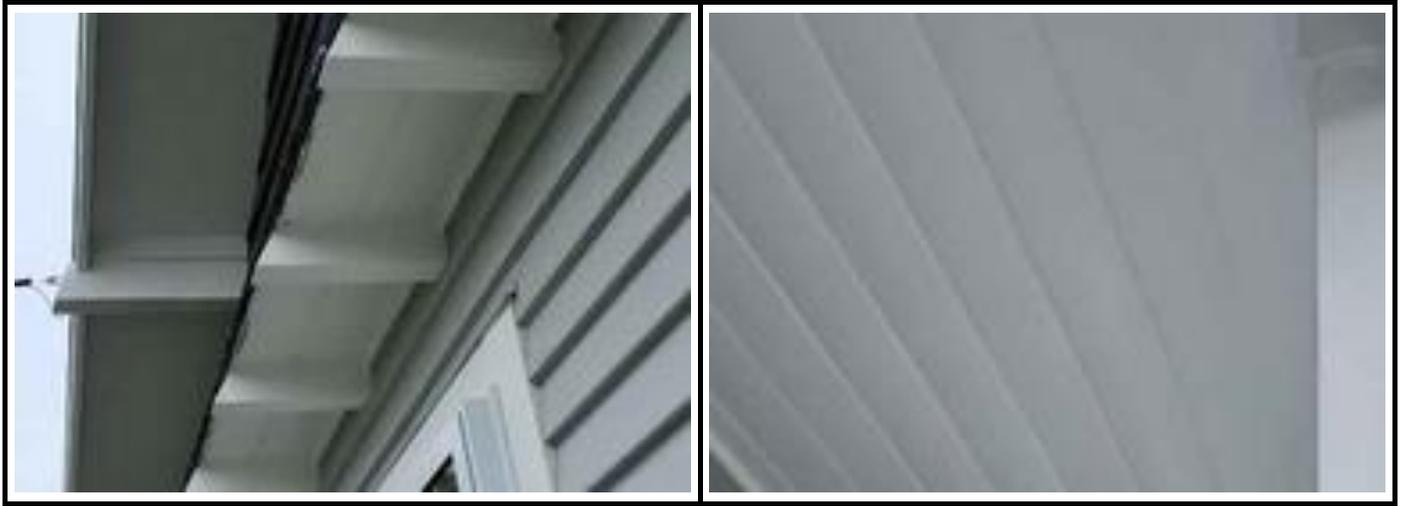
Soffits, Eaves

Acceptable condition

The soffits are built with a sheet material and appear to be in a reasonable condition.

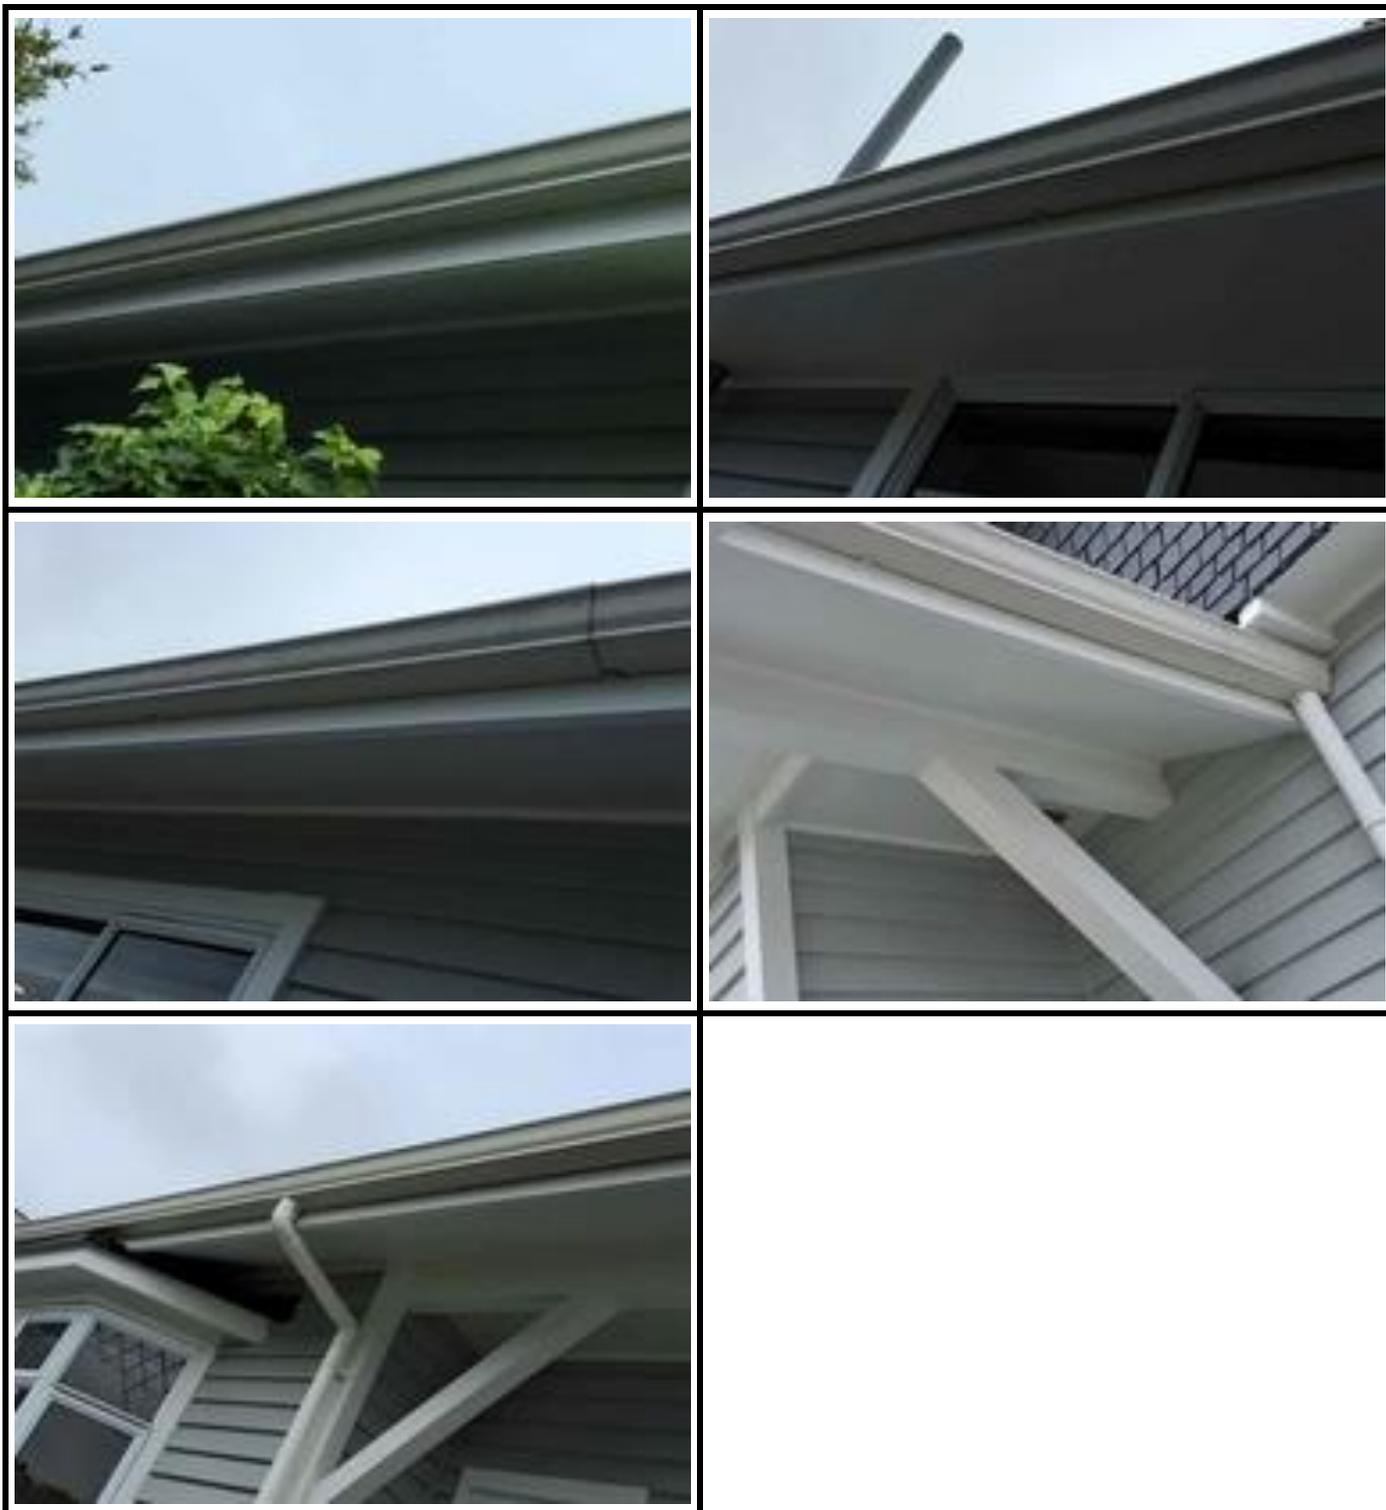
Spouting and Gutters

Steel - Acceptable condition

The spouting is built with long-run Coloursteel and appears to be in a reasonable condition.

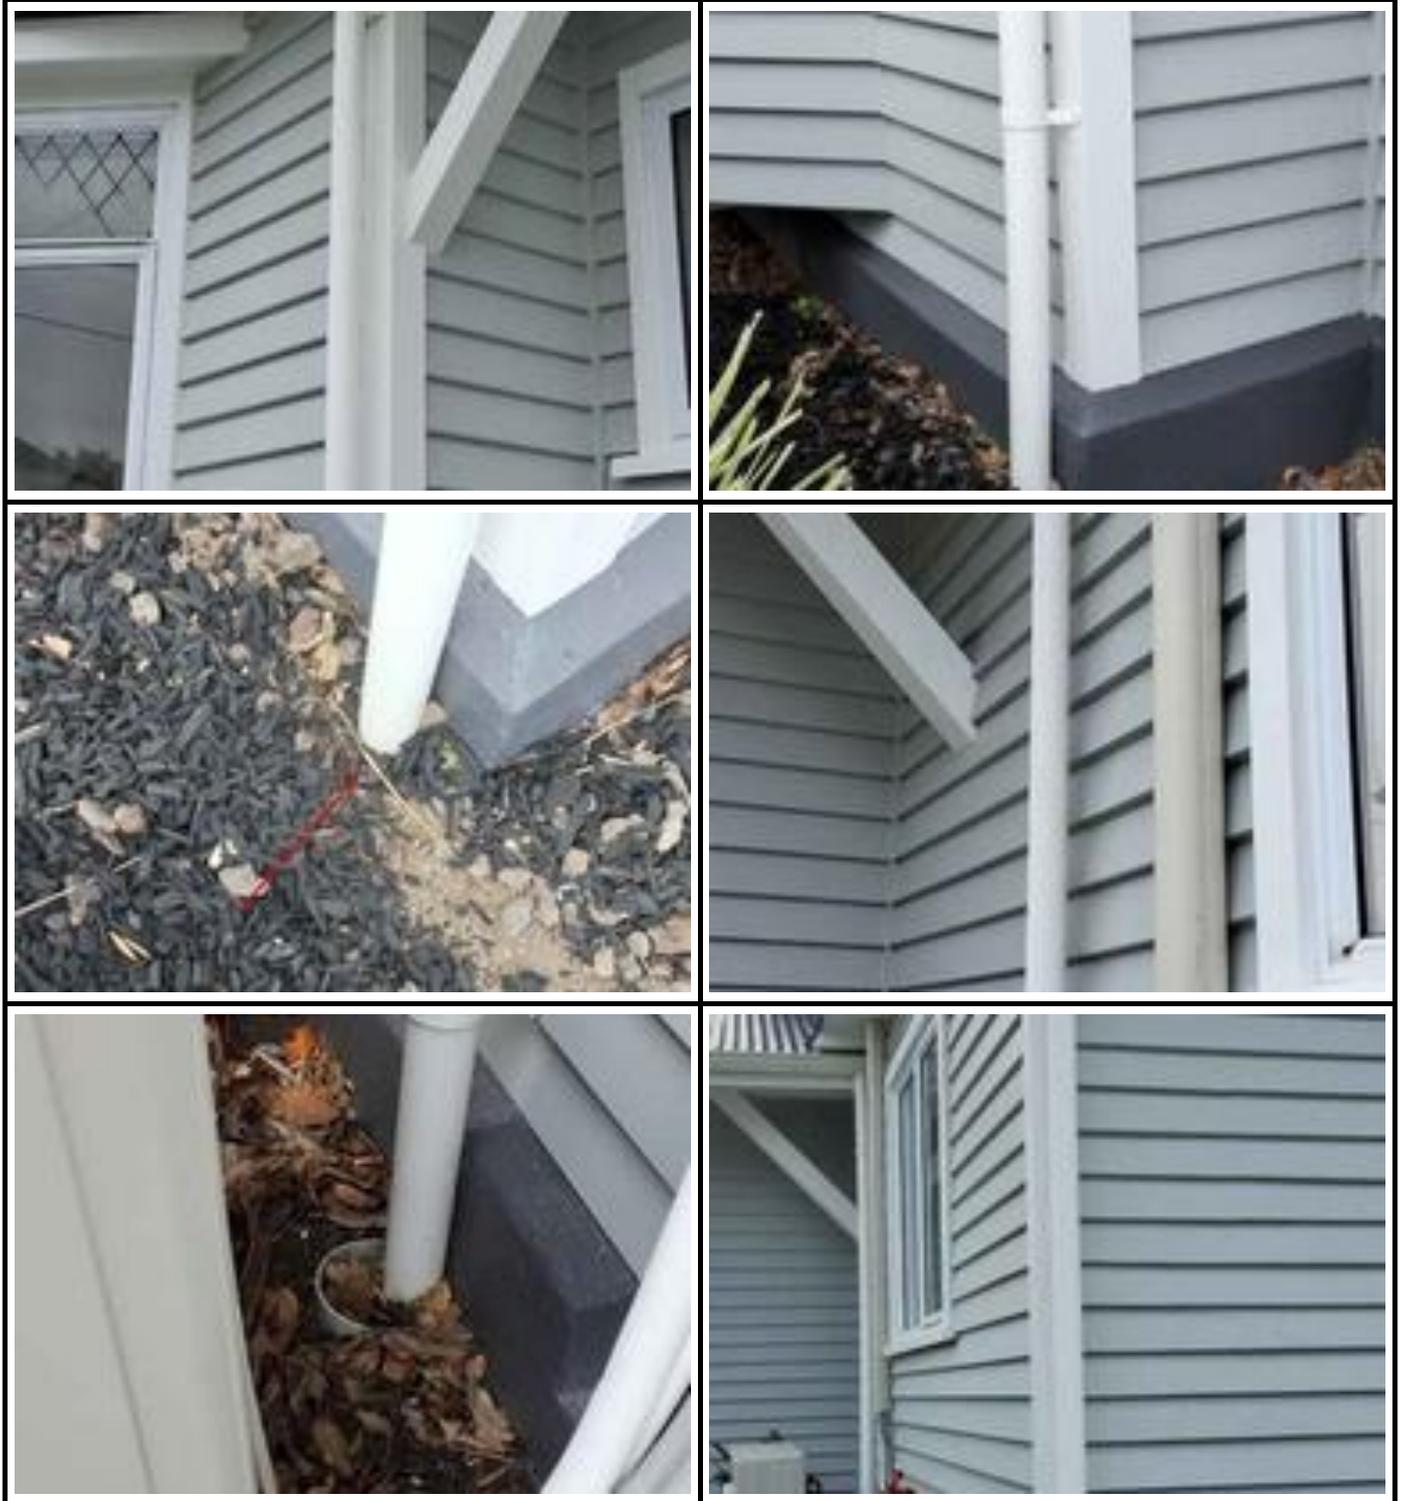
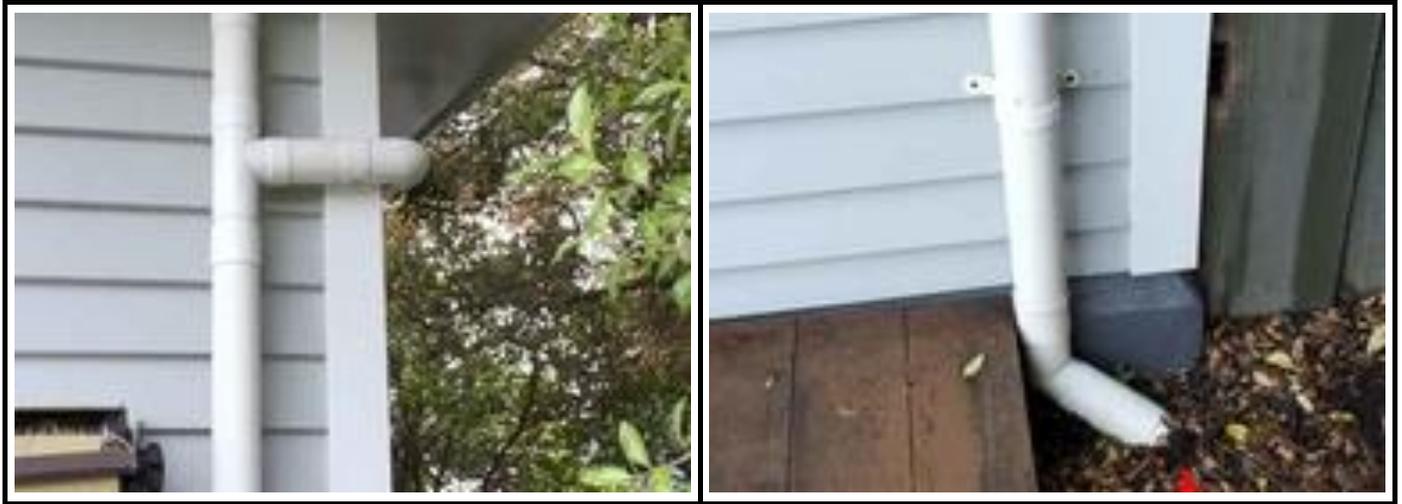
Downpipes

PVC - Acceptable condition

The downpipes are built with PVC and appear to be in a reasonable condition. Some downpipes appear to discharge onto the ground level without a gully trap in place as shown with a red arrow.

The gully traps appear to be in a reasonable condition. However, some downpipes do not appear to discharge into a gully trap as shown with red arrows. Recommend further investigation for this item.

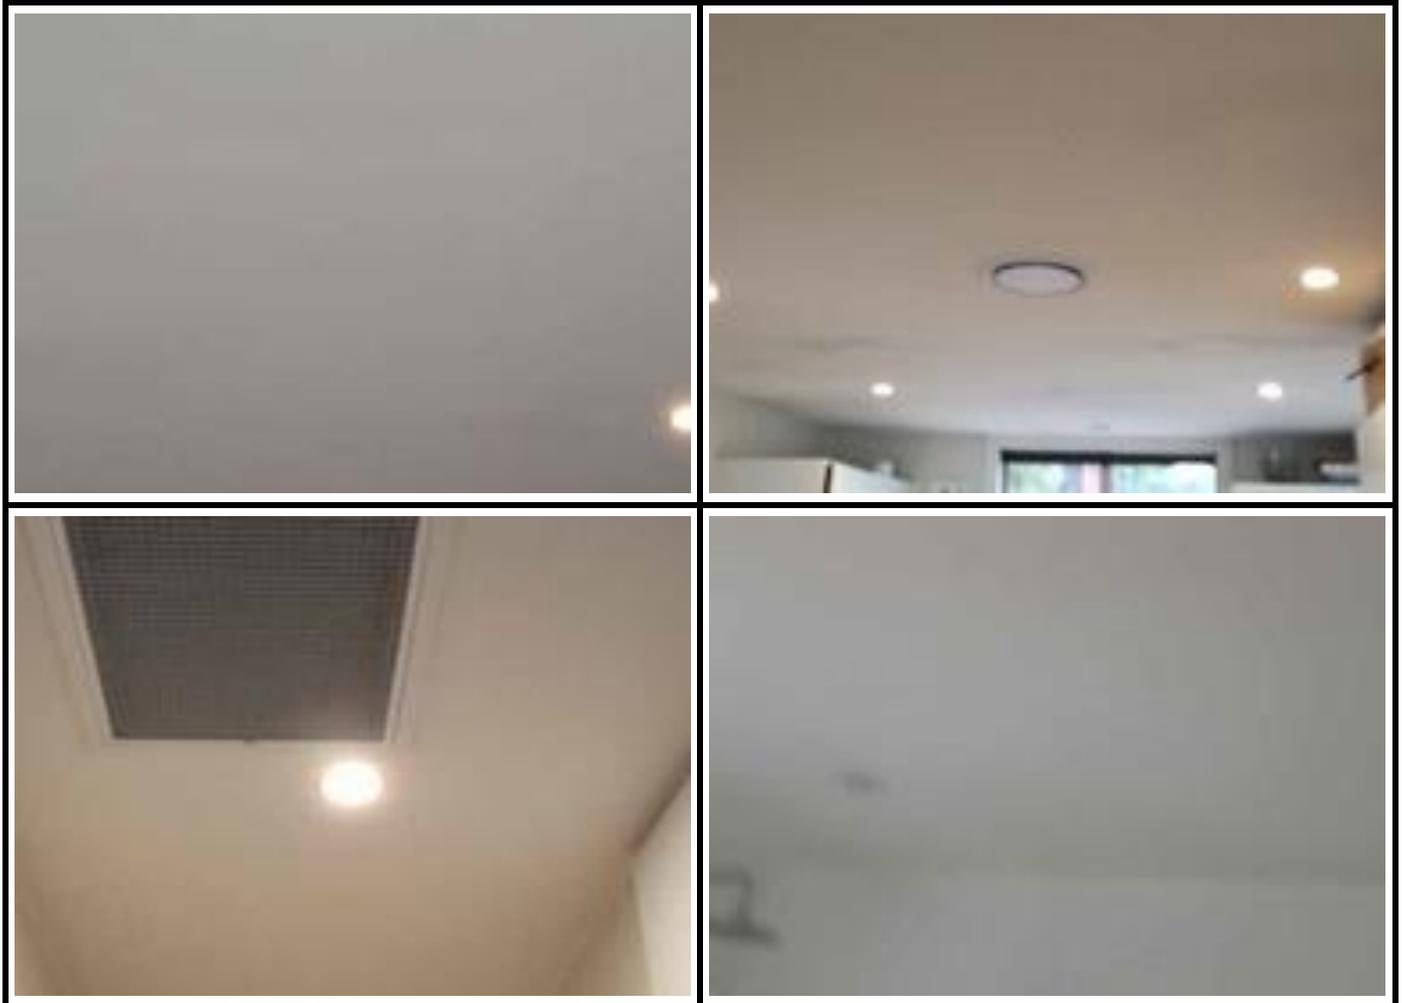
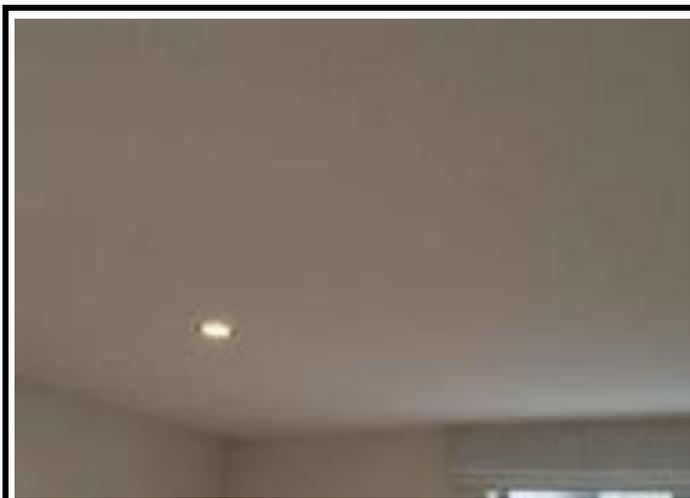
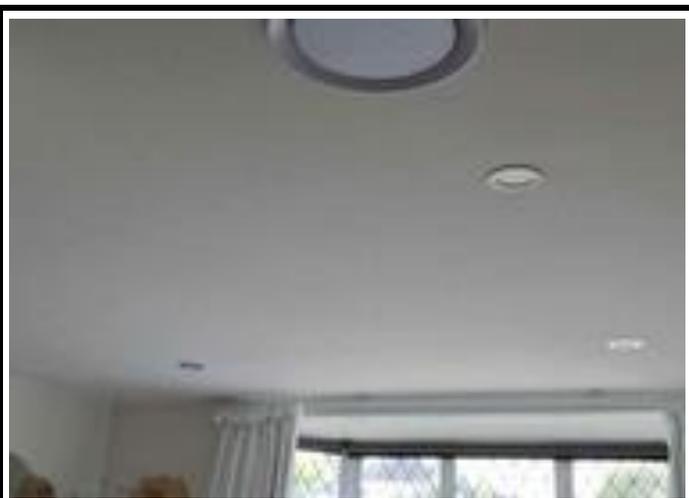
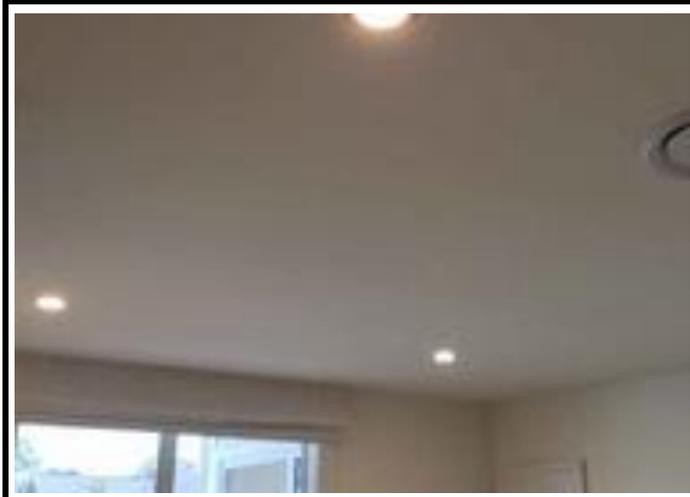
Ceilings

Acceptable condition

The ceilings are built with a sheet material, square stopped to the wall junction and appear to be in a reasonable condition. However, the lounge / kitchen ceiling appears to have incomplete paintwork and may require further attention.

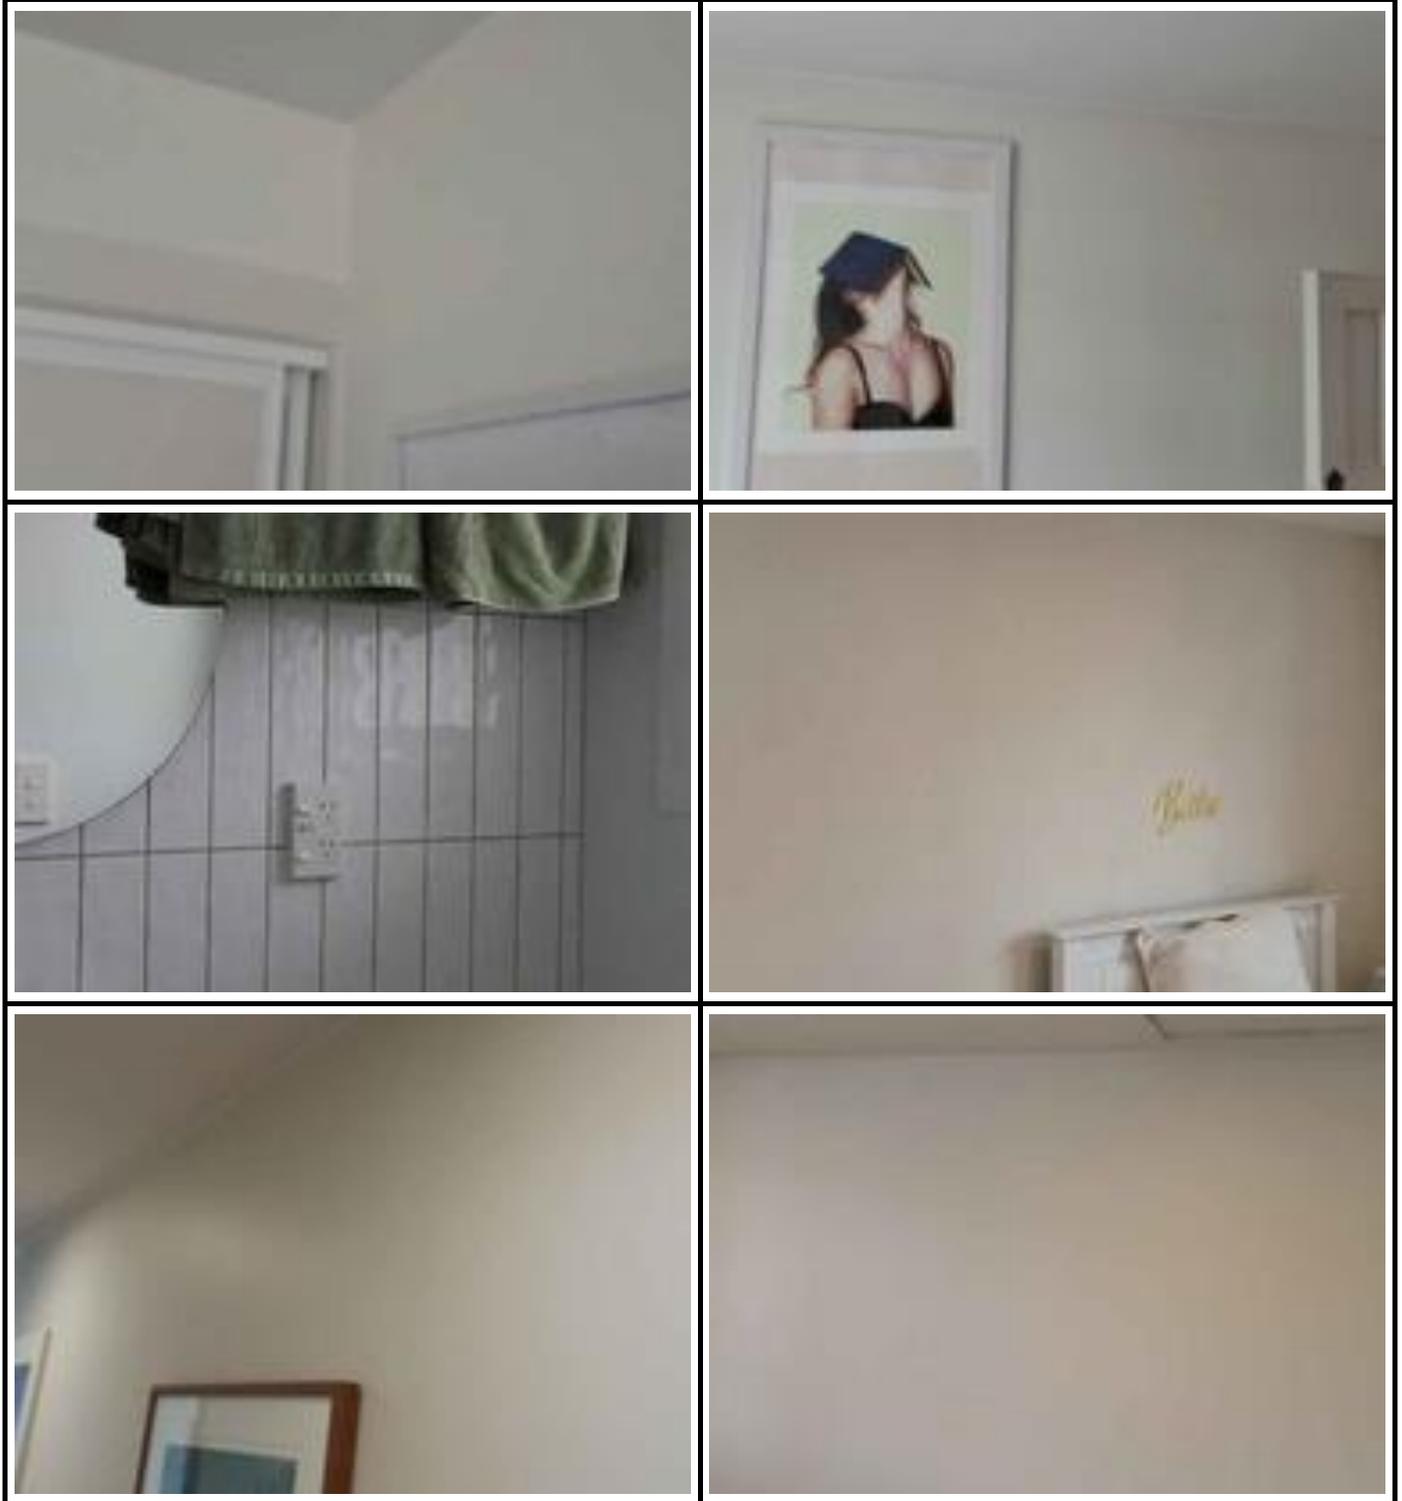
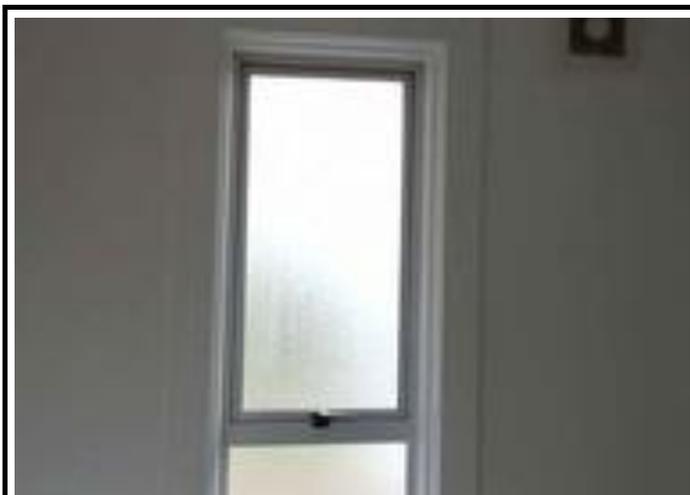
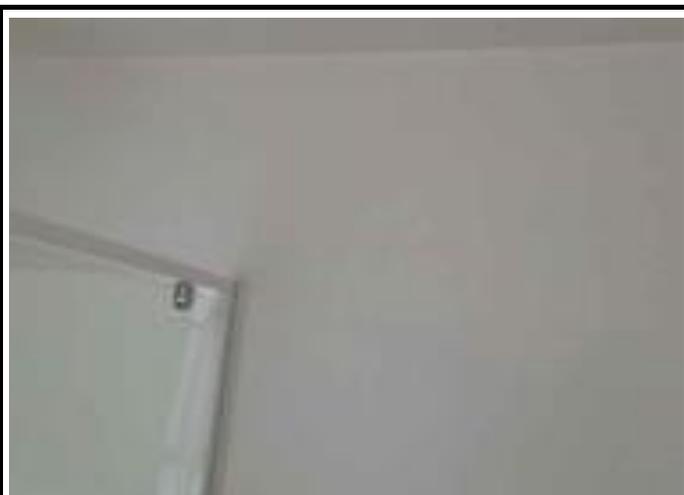
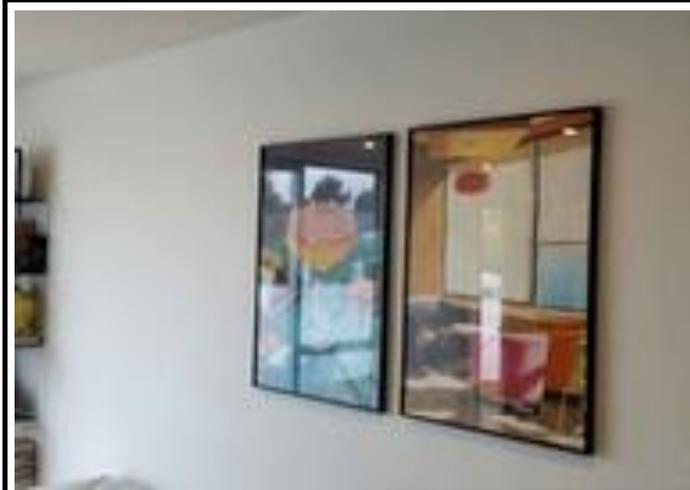
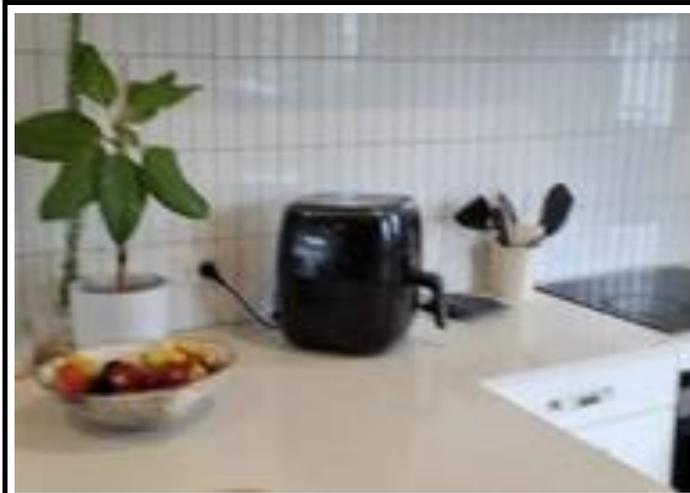
Wall Linings

Acceptable condition

The wall linings are built with a sheet material and appear to be in a reasonable condition. There is ceramic tile to some kitchen and bathroom walls.
