PRE-PURCHASE PROPERTY INSPECTION REPORT

Inspection Date: 18 February 2026

Alert Building Inspections | Phone: 0800 4 Alert (425 378)
Email: info@alertbuildinginspections.co.nz

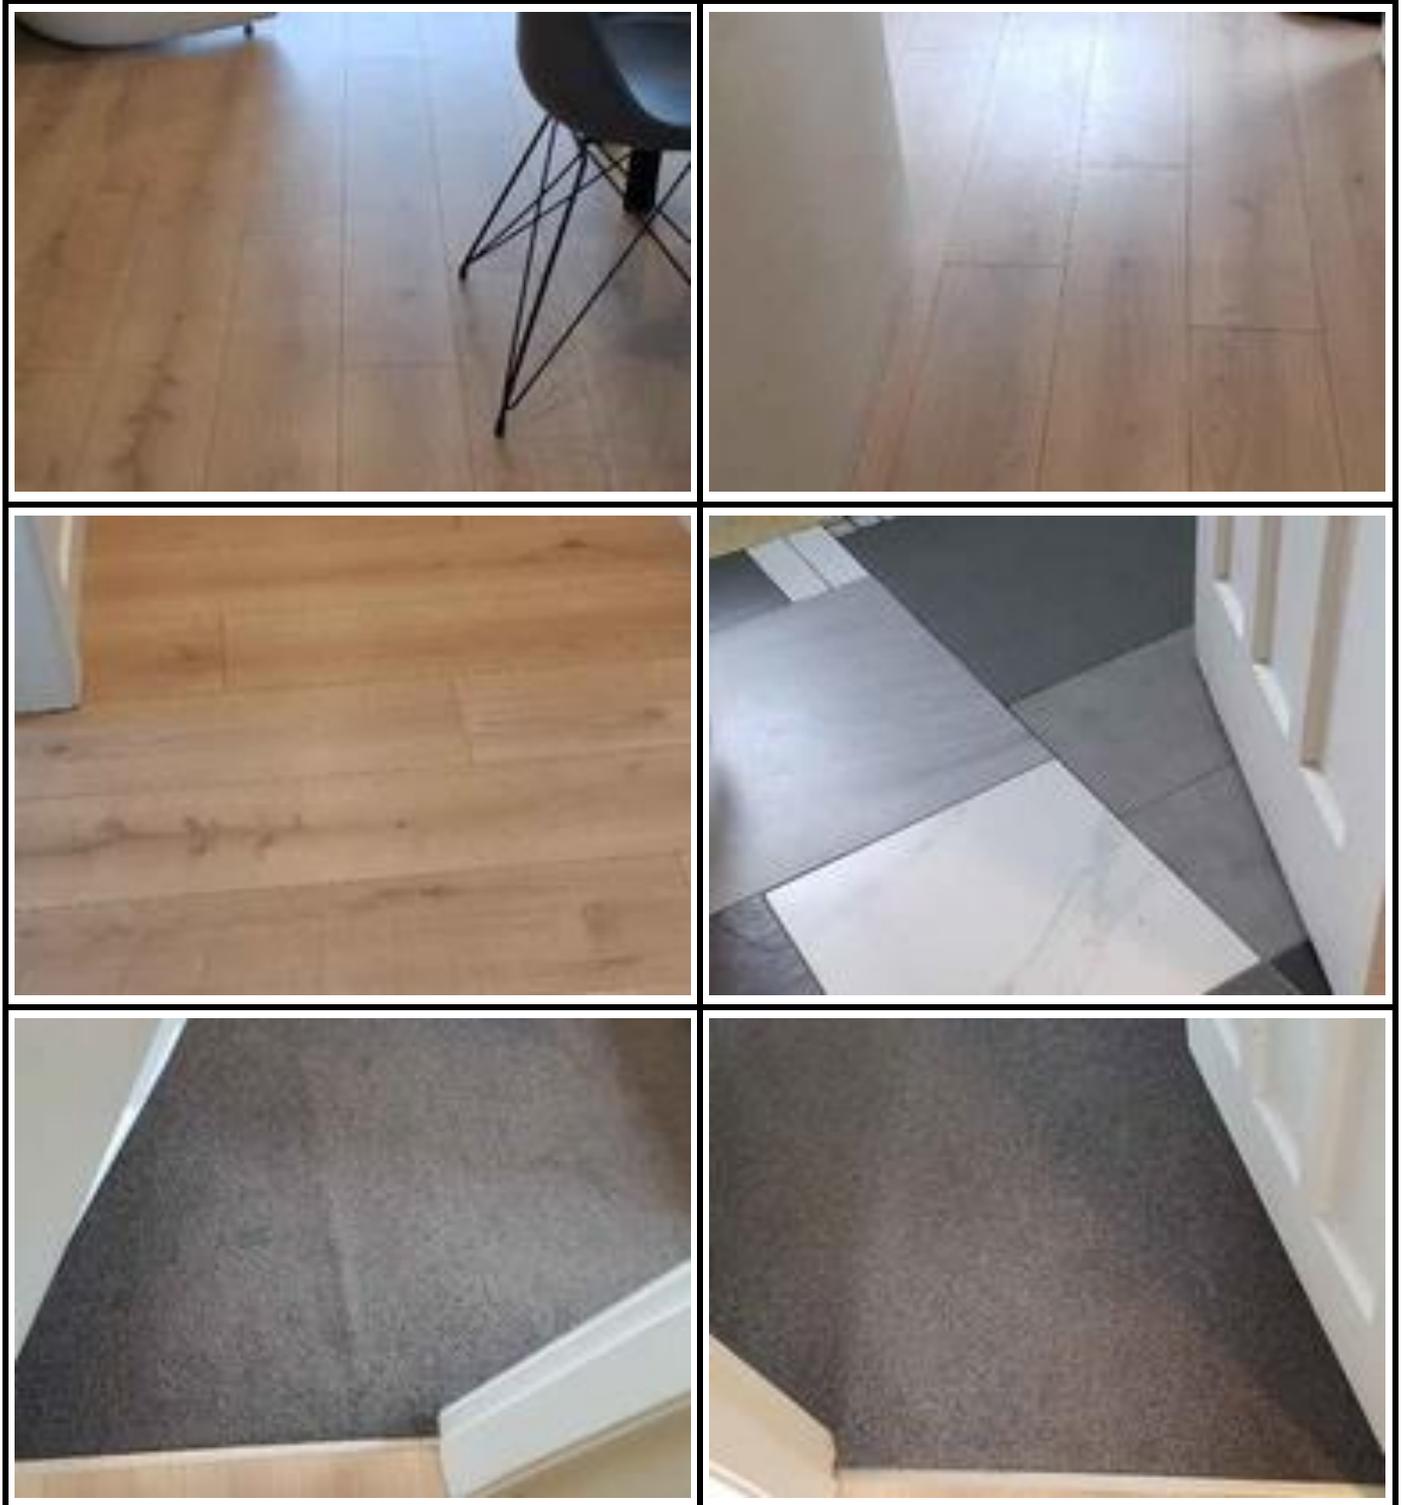
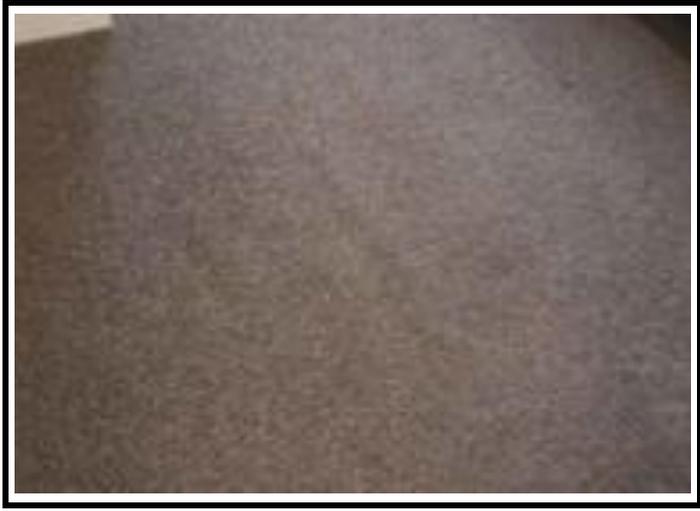
Flooring

Acceptable condition

The lounge, kitchen and hallway have plank overlay and the bathrooms have ceramic tile. The bedrooms are carpeted and all appear to be in a reasonable condition.

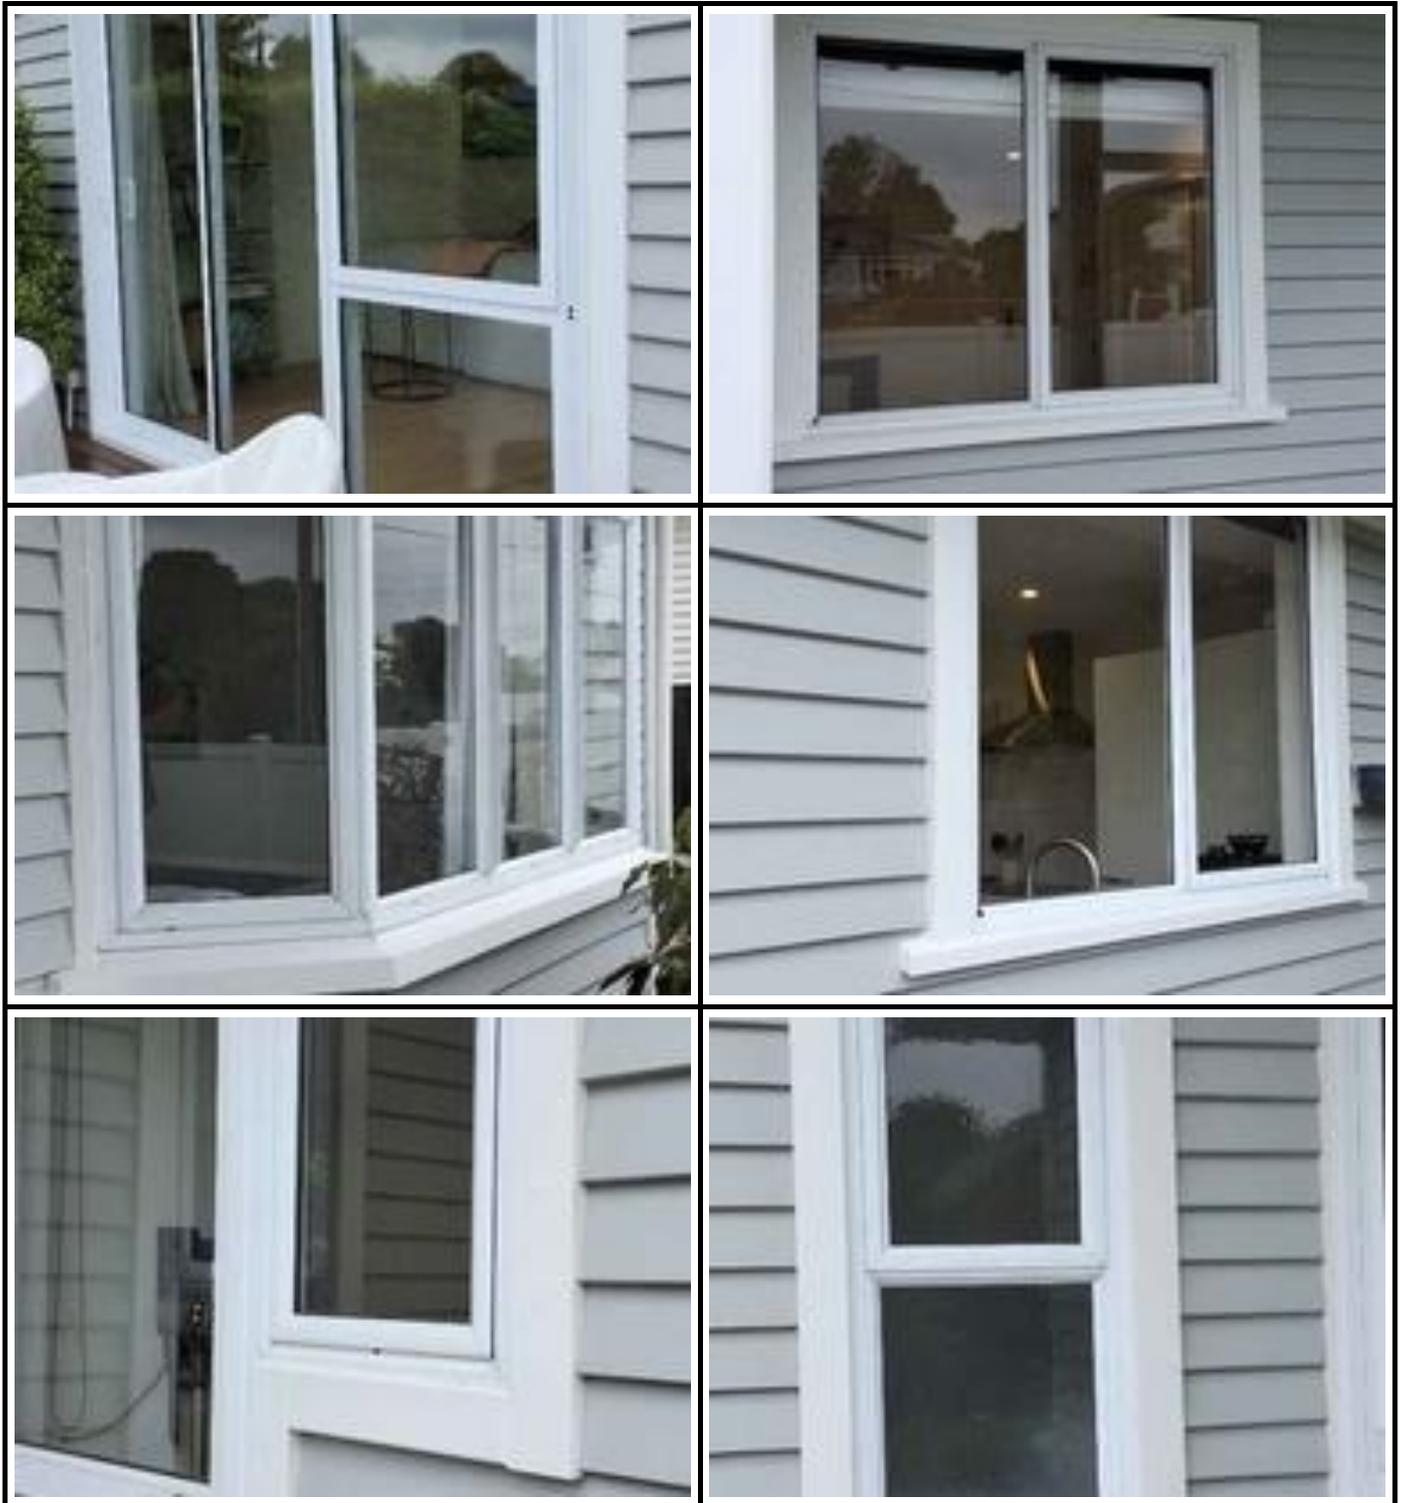
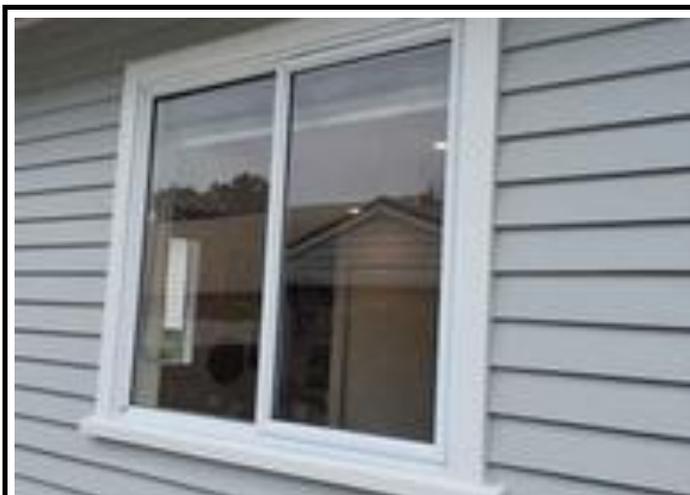
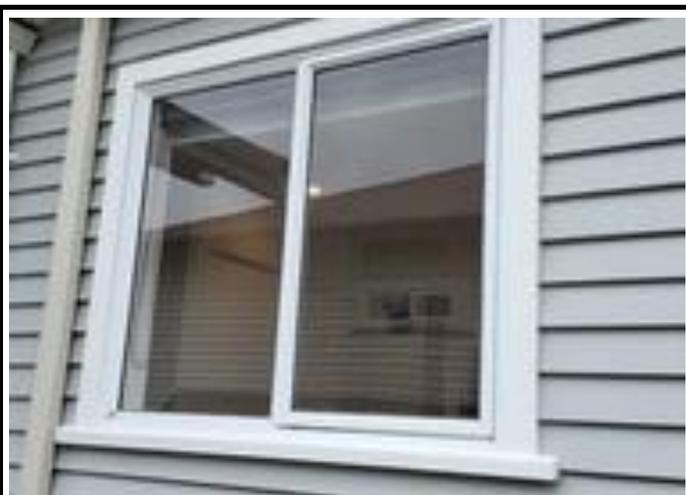
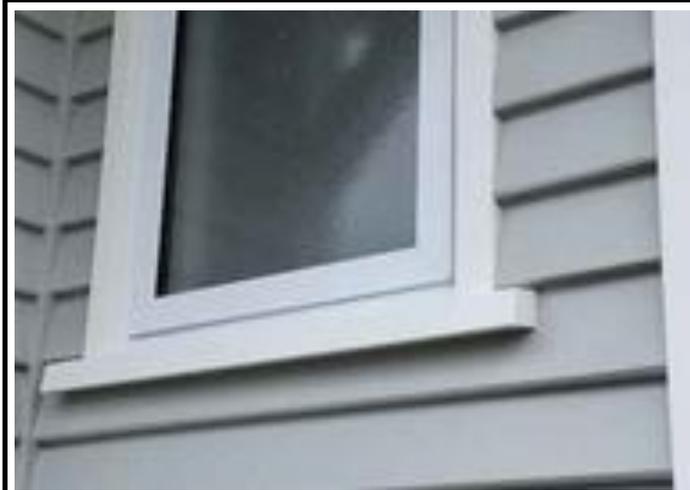
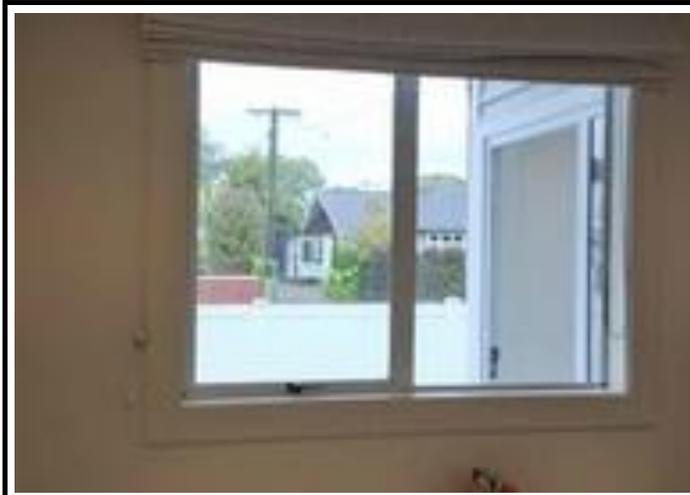
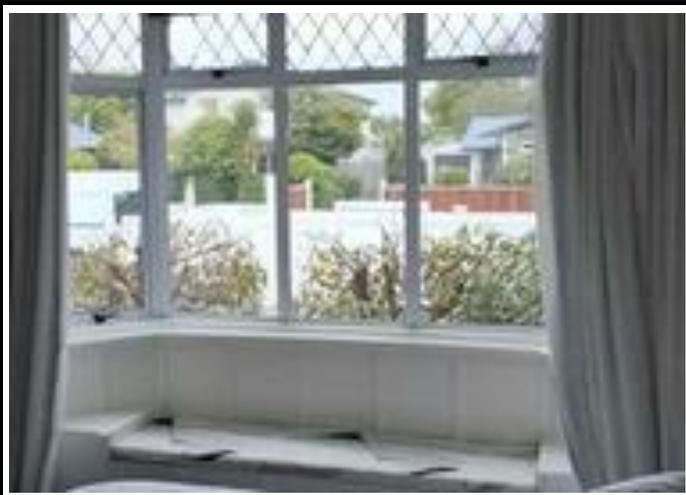
Windows

Aluminium, Timber - Acceptable condition

The windows are aluminium and timber joinery and appear to be in a reasonable condition.

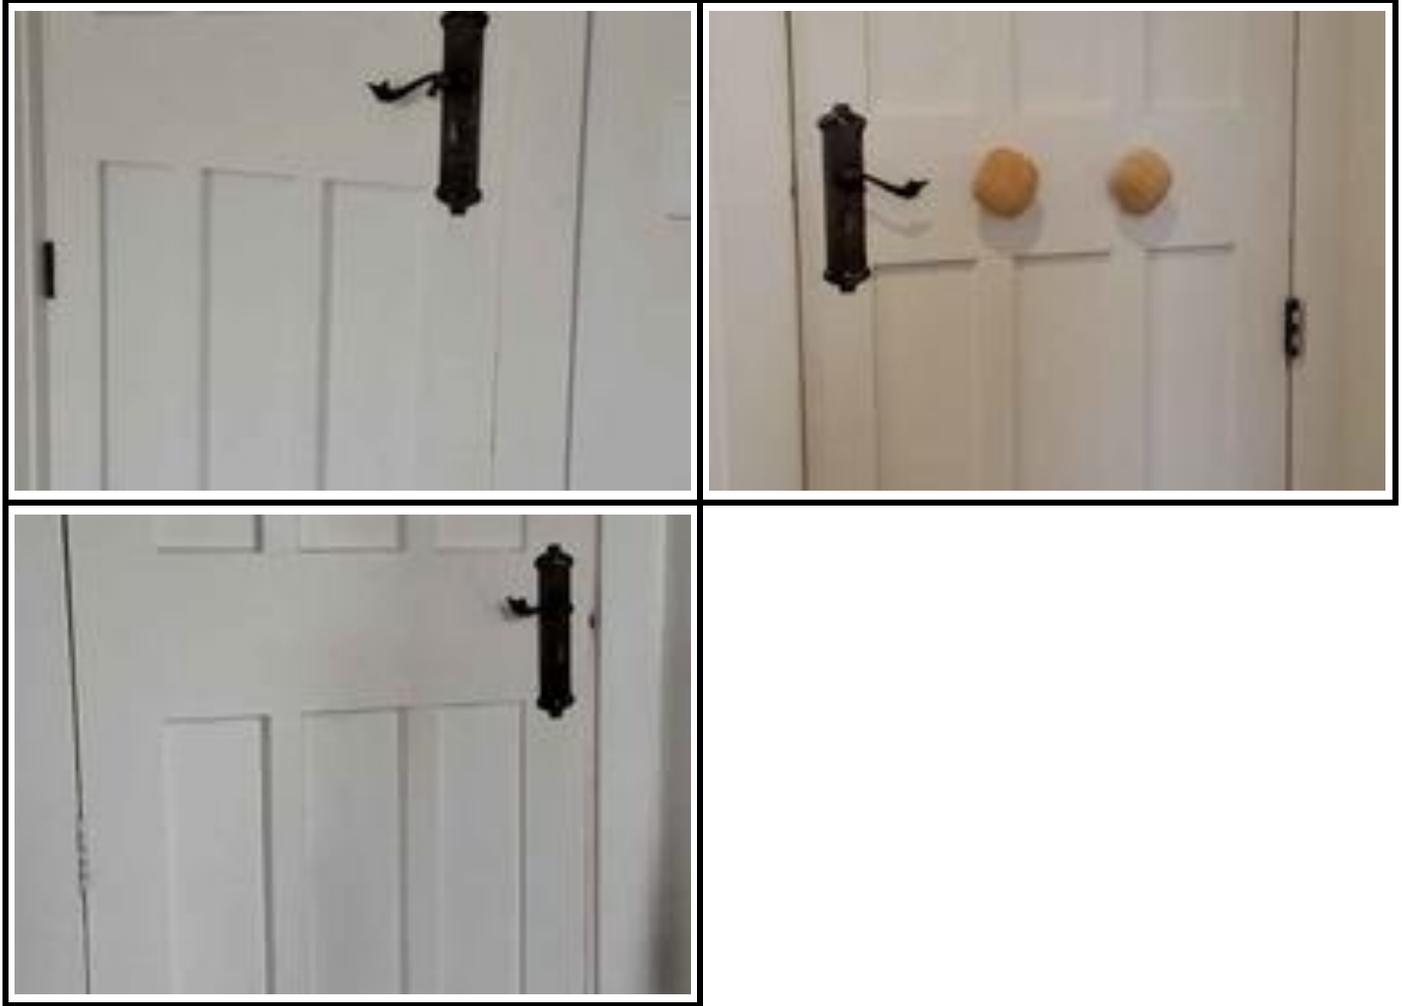
Internal Doors

Acceptable condition

The internal doors are hinged panel type and appear to be in a reasonable condition.

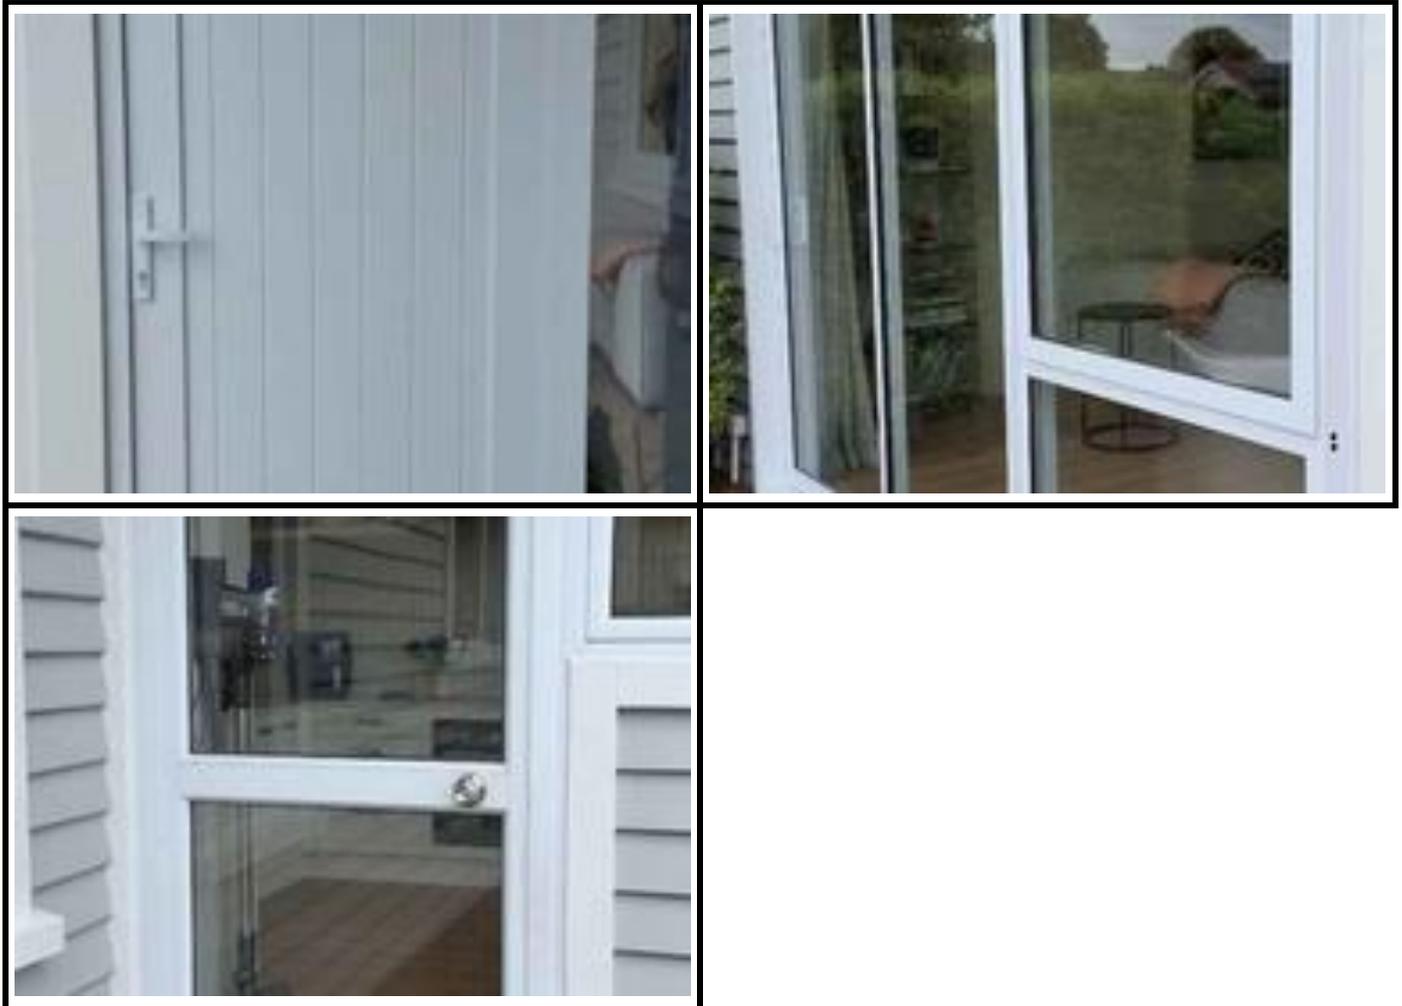
Exterior Doors

Acceptable condition

The entry is aluminium joinery with a solid door and a ranchslider off the front deck area. The kitchen area has aluminium joinery with a glazed door. The exterior doors appear to be in a reasonable condition.

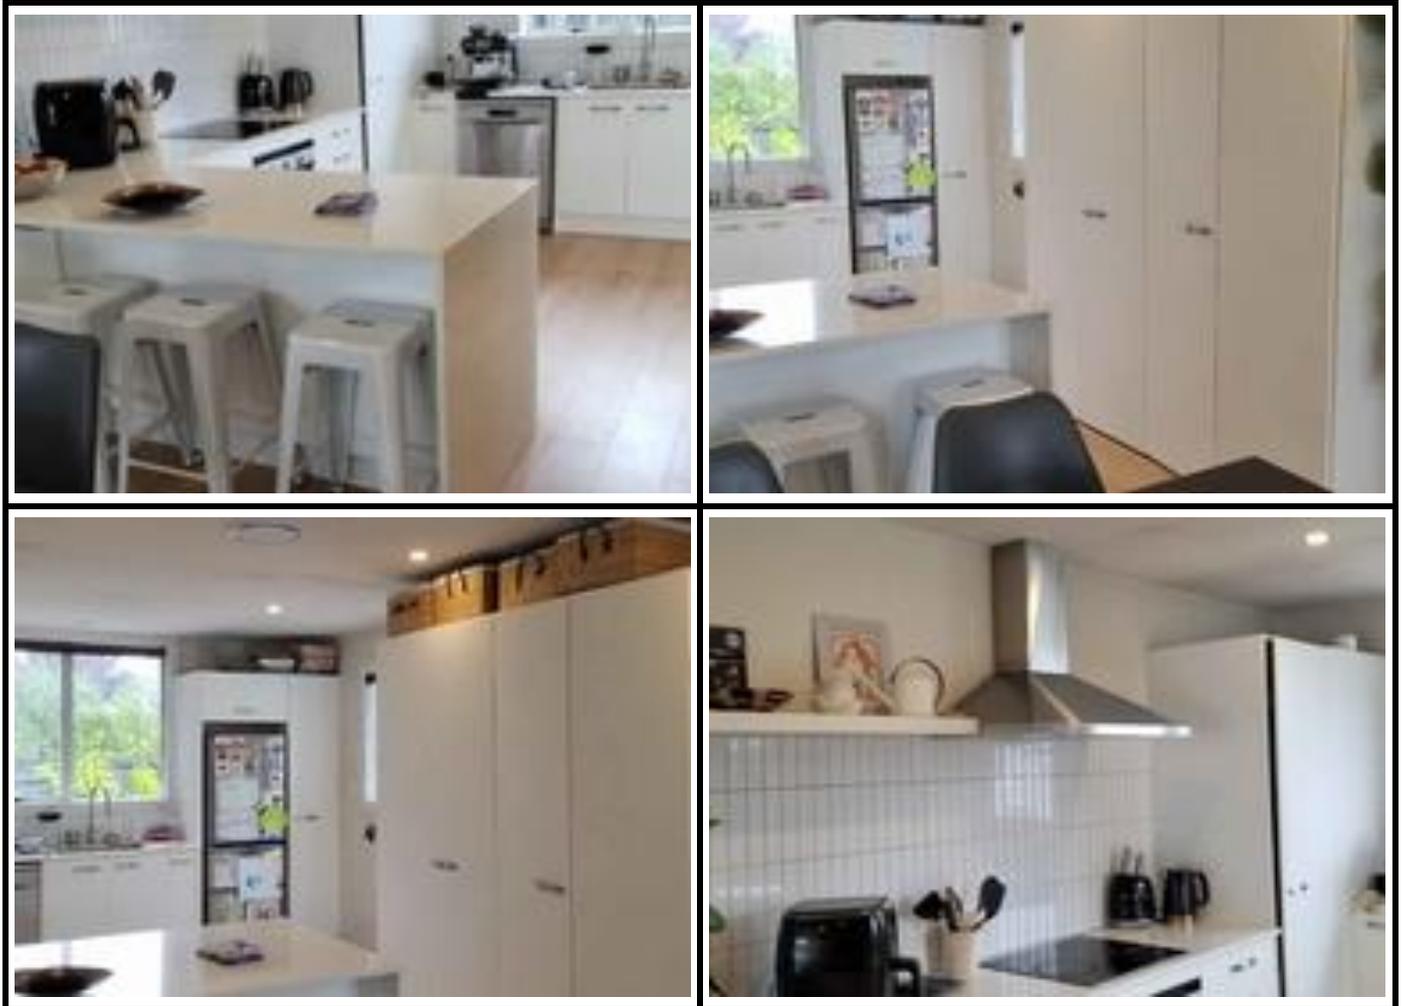
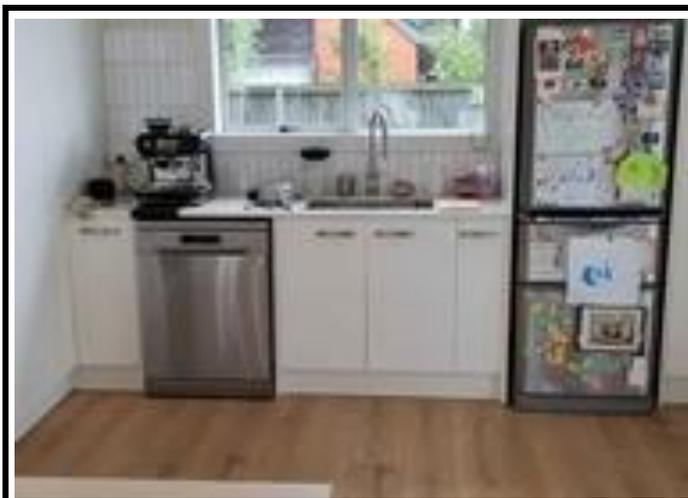
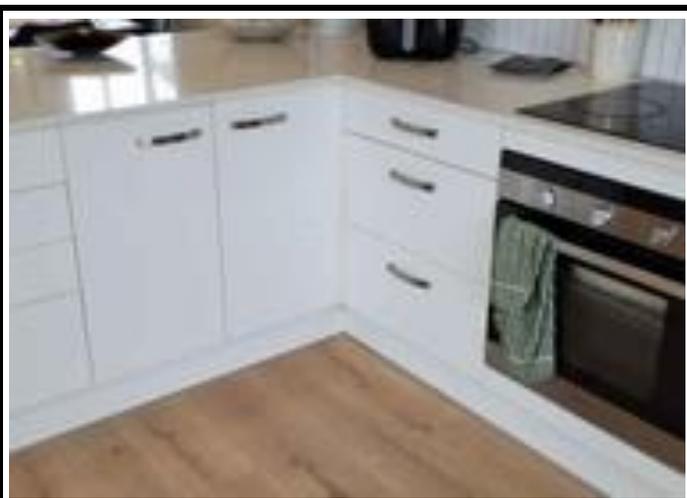
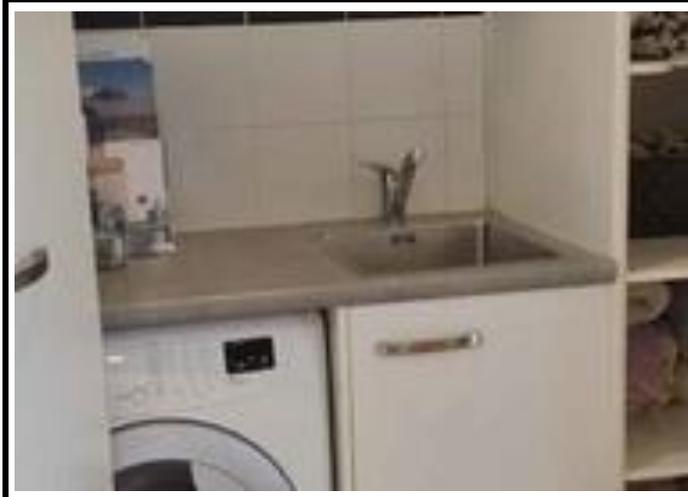
Kitchen

Acceptable condition

The kitchen has a bench unit with a double sink, cupboards and drawers. There are other bench and pantry units. There is a wall oven with a smooth top cooker and an overhead rangehood. The laundry is situated within a cupboard in the kitchen area. The kitchen appears to be in a reasonable condition.

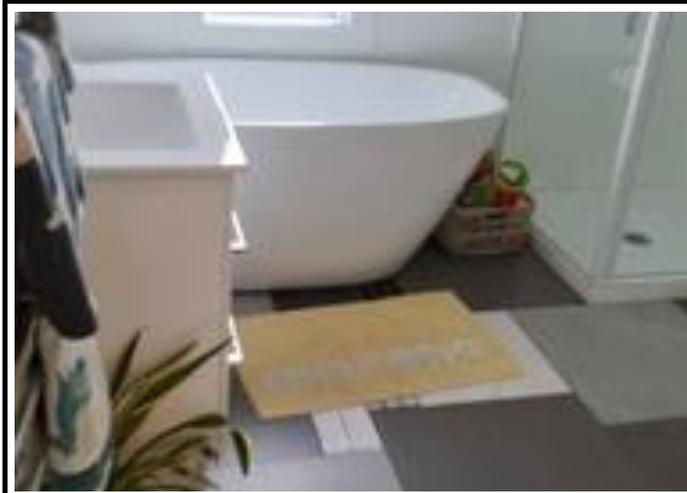
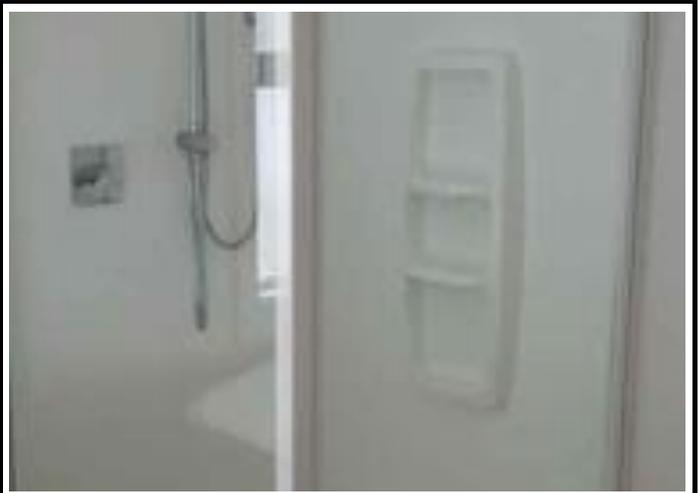
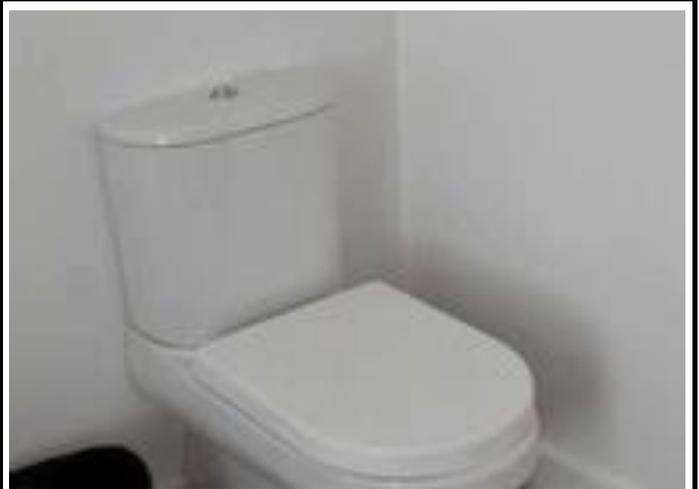
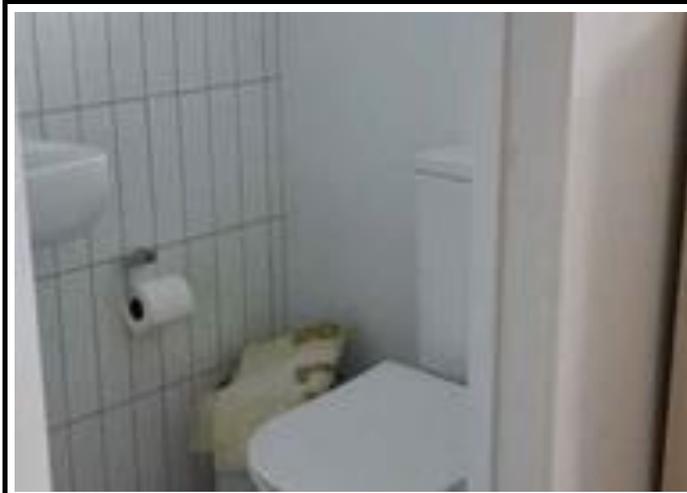
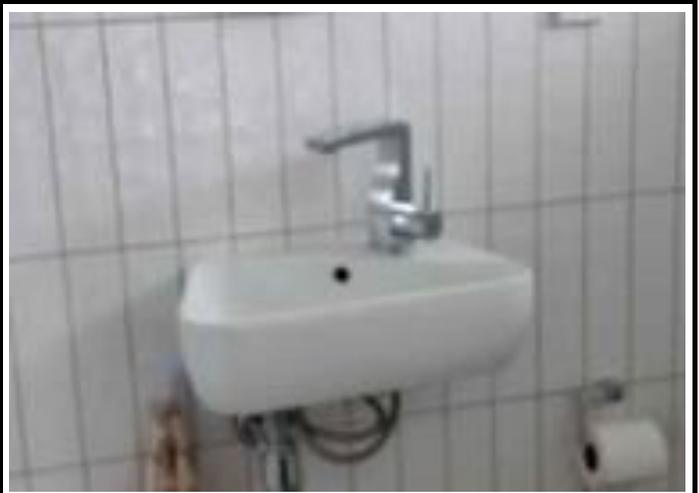
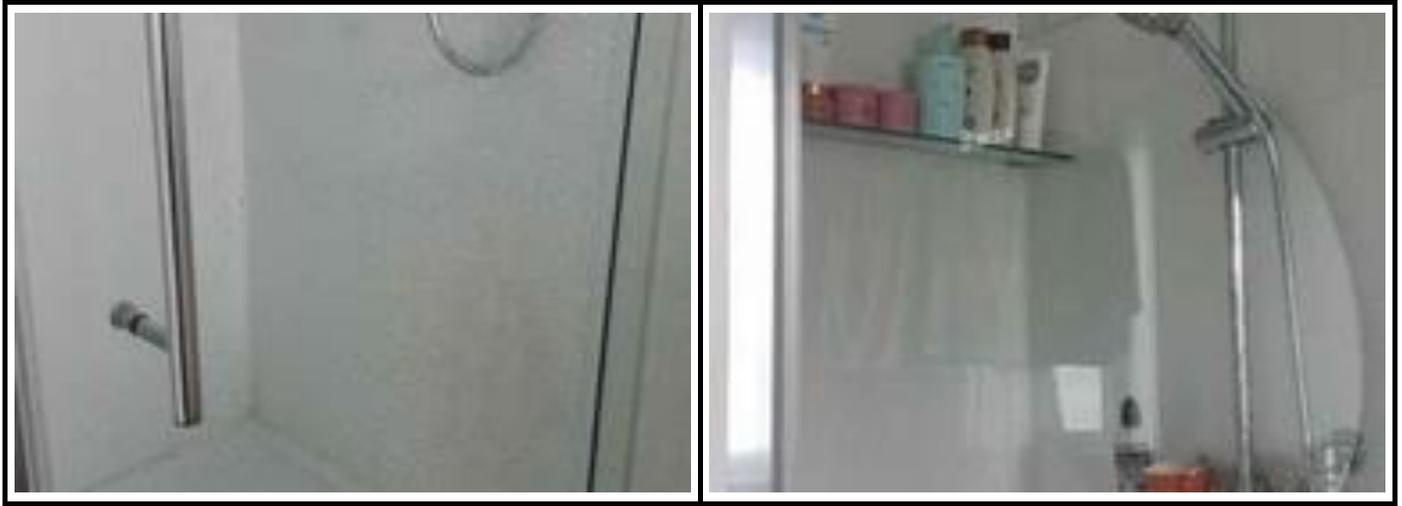
Bathrooms

Acceptable condition

The bathroom has a bath, shower compartment, toilet and a vanity unit. There is ceramic tile flooring. The ensuite bathroom has a toilet, shower compartment and a hand basin. There is ceramic tiling to the floor and walls. The bathrooms appear to be in a reasonable condition.

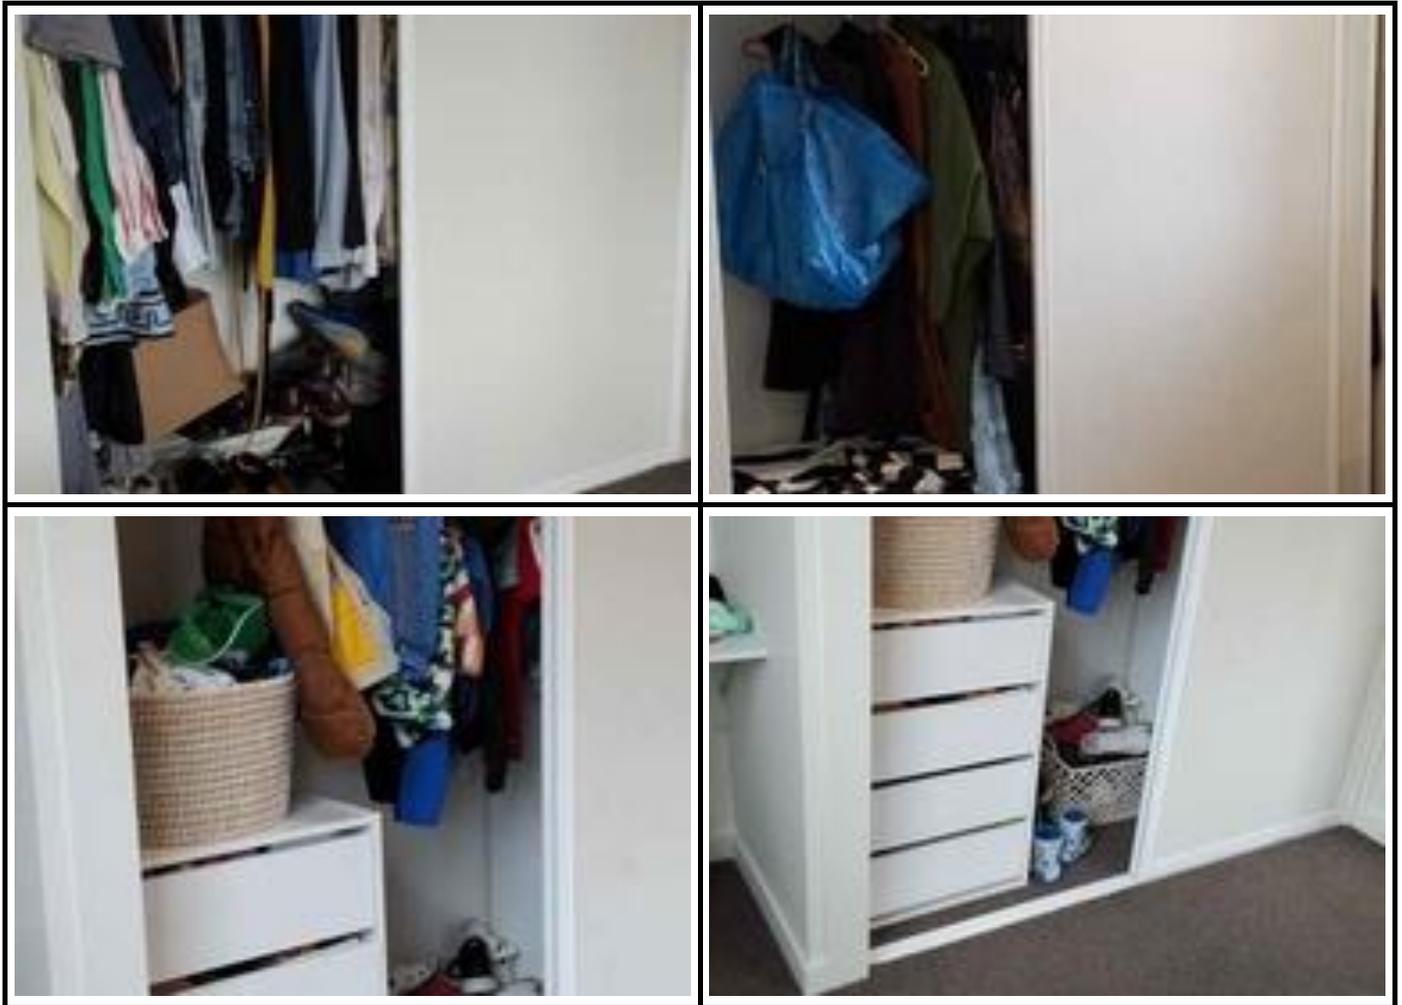
Wardrobes

Acceptable condition

The wardrobes have sliding panel doors with rail and shelves and appear to be in a reasonable condition.
