PRE-PURCHASE PROPERTY INSPECTION AT

(Some photos in the sample report have either been removed or cropped / shrunk to protect the client's privacy)

The property is a single story, timber weatherboard clad house on concrete pile foundation with a steel long run roof, with timber joinery. The section is sloping & terraced at the back with some grass with shrubs. Access is via a path only.

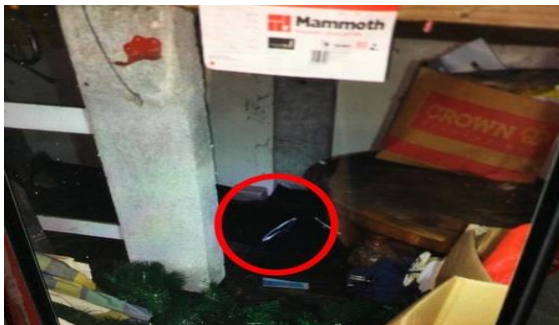
Water ponding

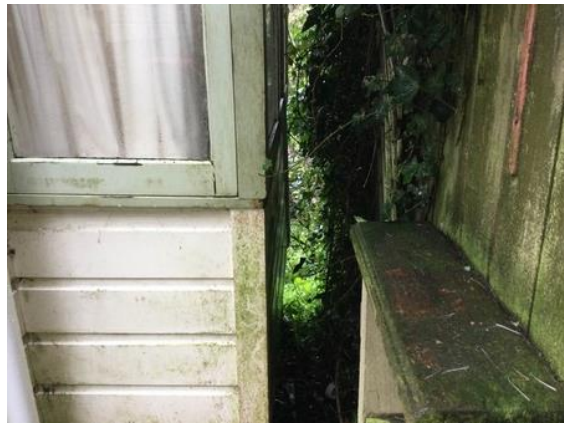
No access to right side of sleepout

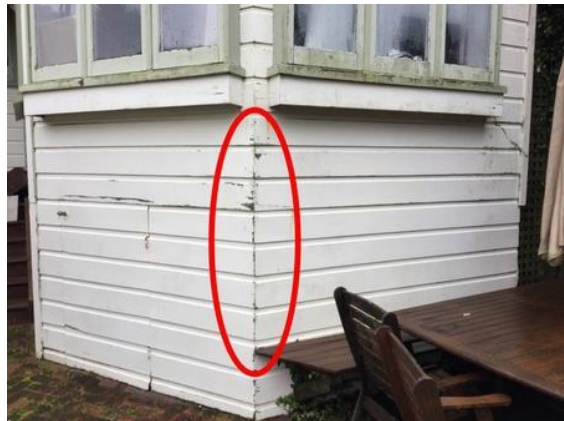
Maintenance required

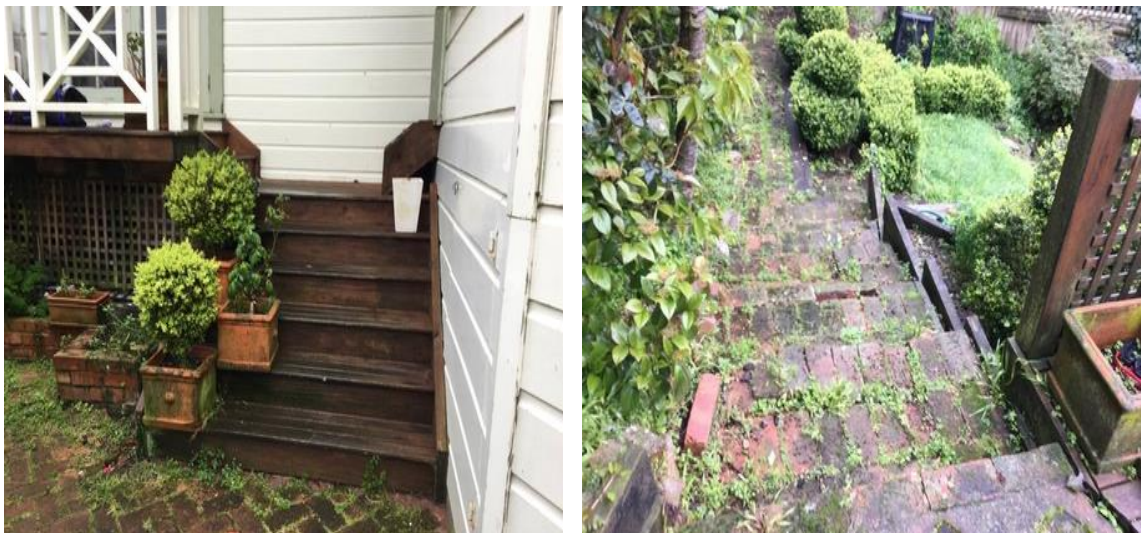
Acceptable condition
Timber stairs are slippery.
No handrails installed.

The brick stairs at the rear are in a bad condition

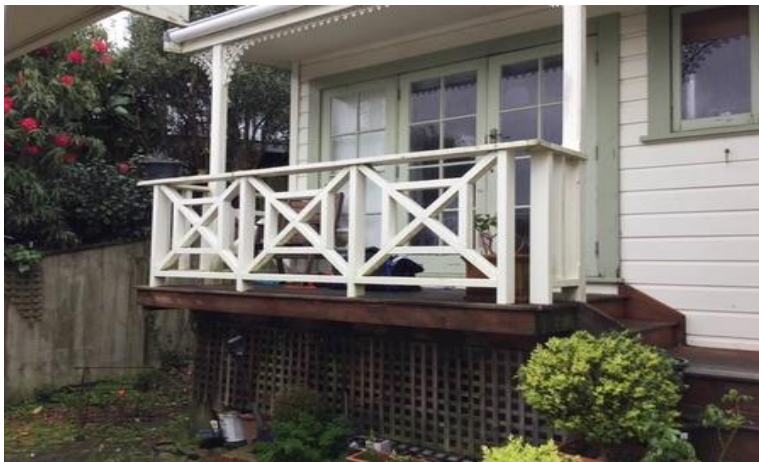
Acceptable condition
Balcony decking is slippery

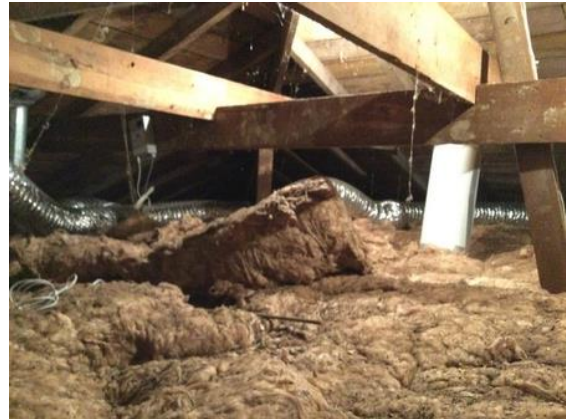
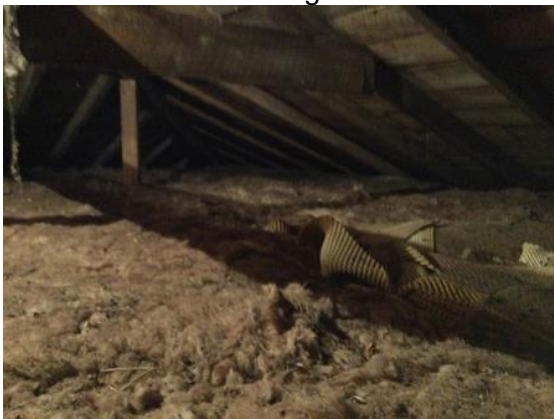
Some insulation missing in some areas

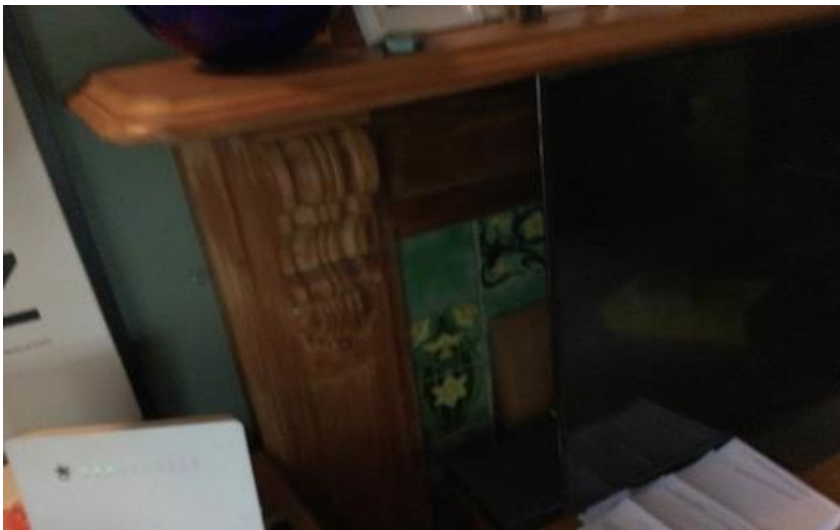
Top of the chimney removed possibly prior to re-roof.
Lounge has a fireplace that appears to be blocked off.
I wasn't able to view properly as per photo.

Fireplace appears blocked off

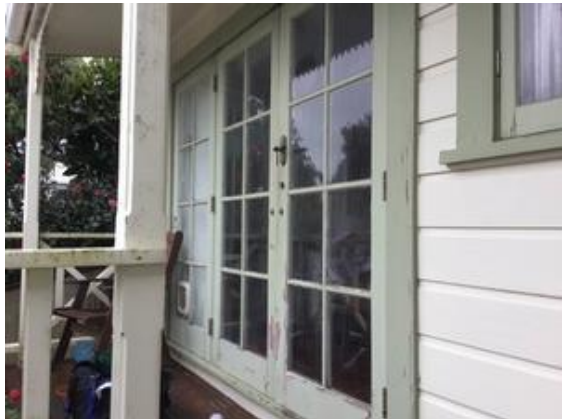
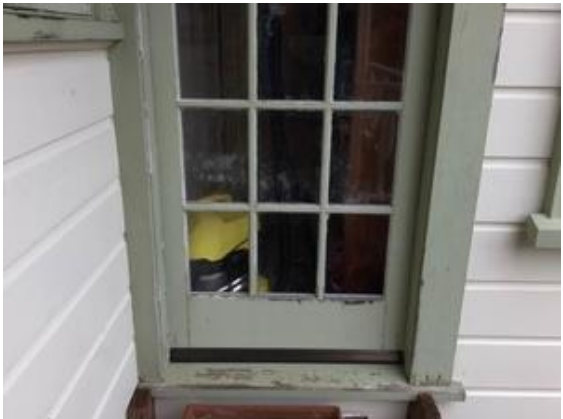
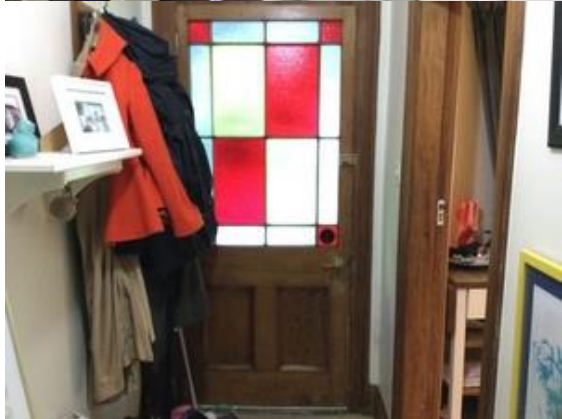
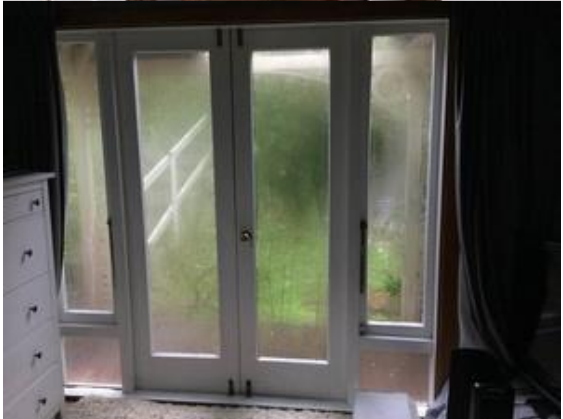
Exterior Doors

Acceptable condition

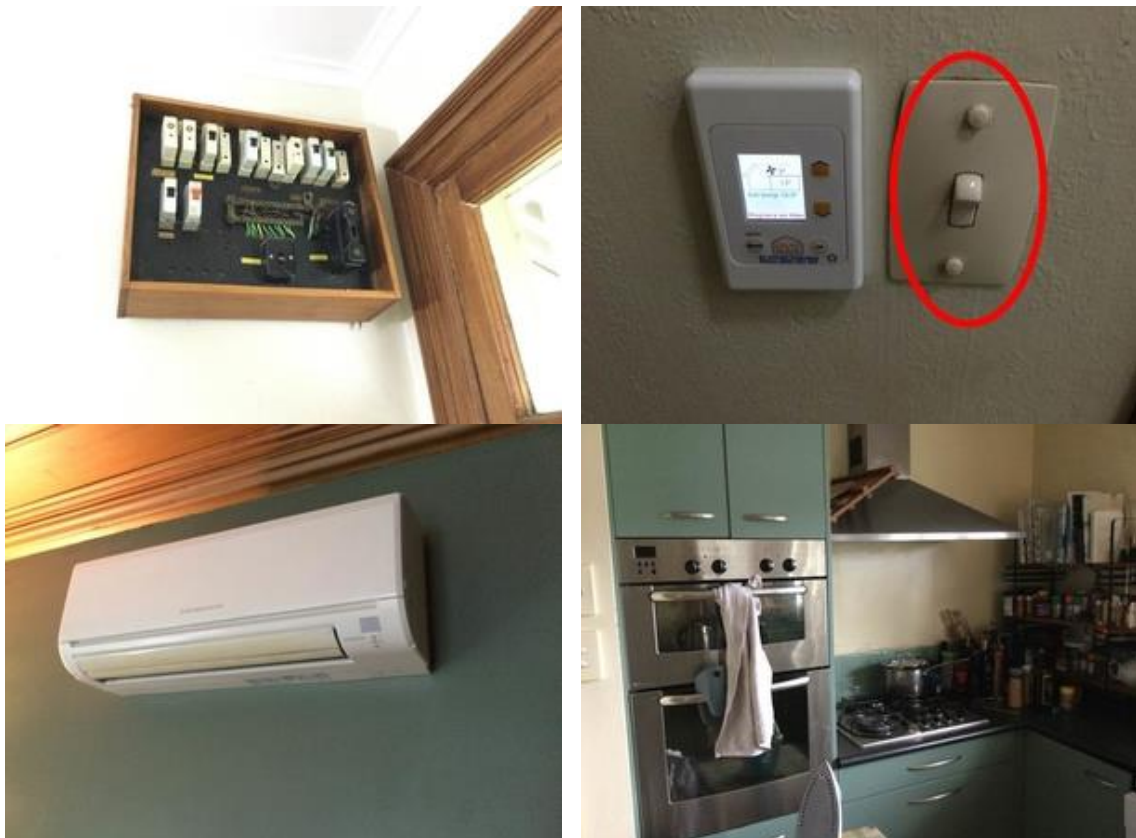
Electrical

Acceptable condition

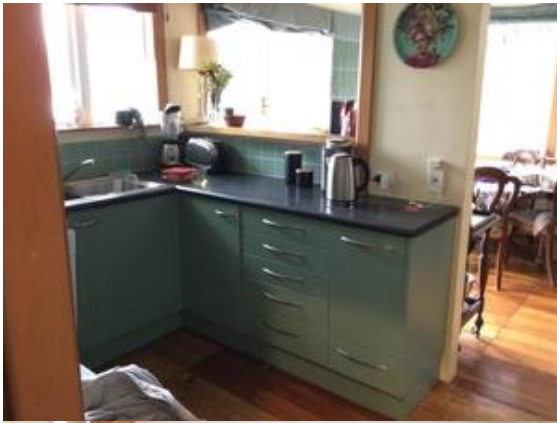
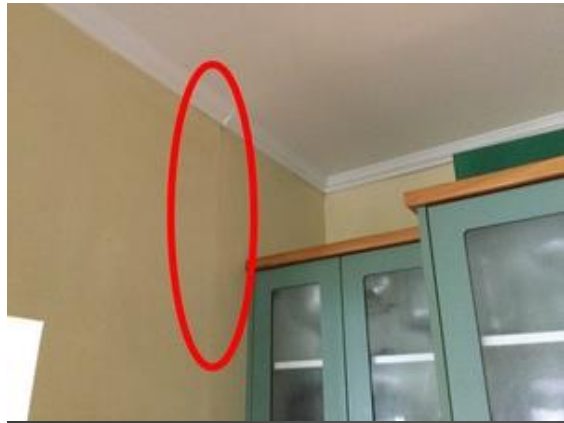
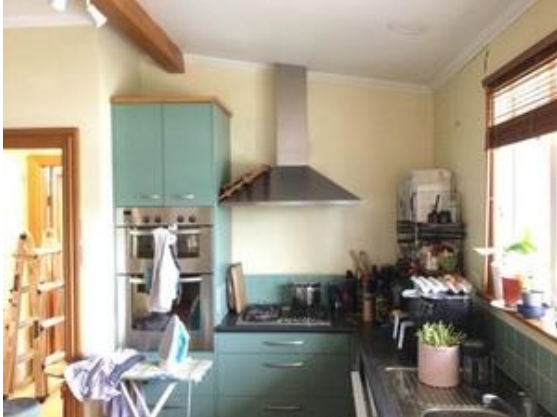
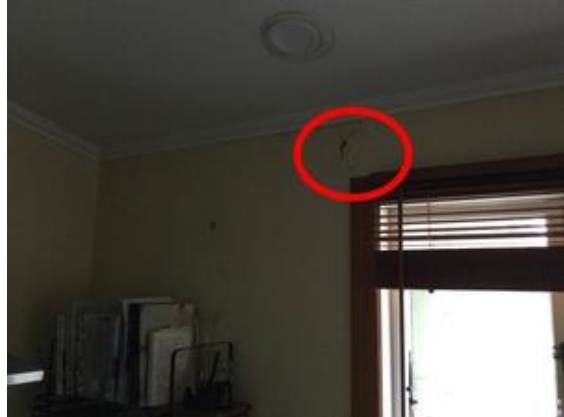
Kitchen

Acceptable condition although

Damage

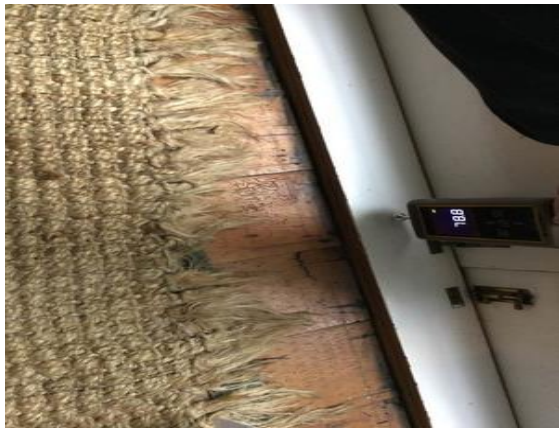
Access was limited

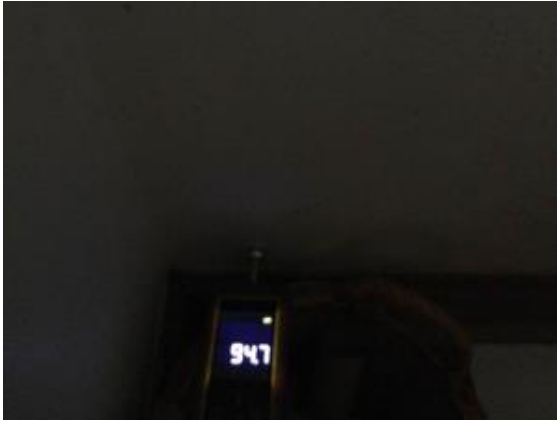
Bedroom 3, Readings of 70
